民間航空機の主な航空事故一覧

Major Air Disasters Involving Commercial Airlines

1937-2025

作成者: 前川 博和(Hirokazu (Mike) Maekawa)

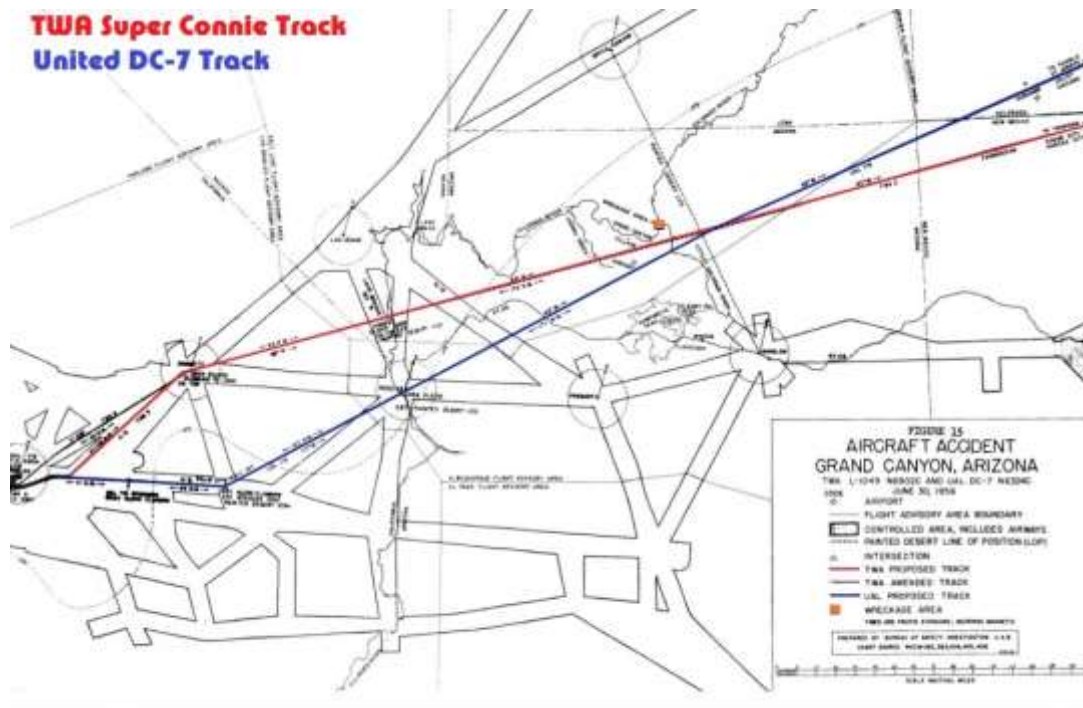
Routes of flight of UAL DC-7 and TWA L-1049

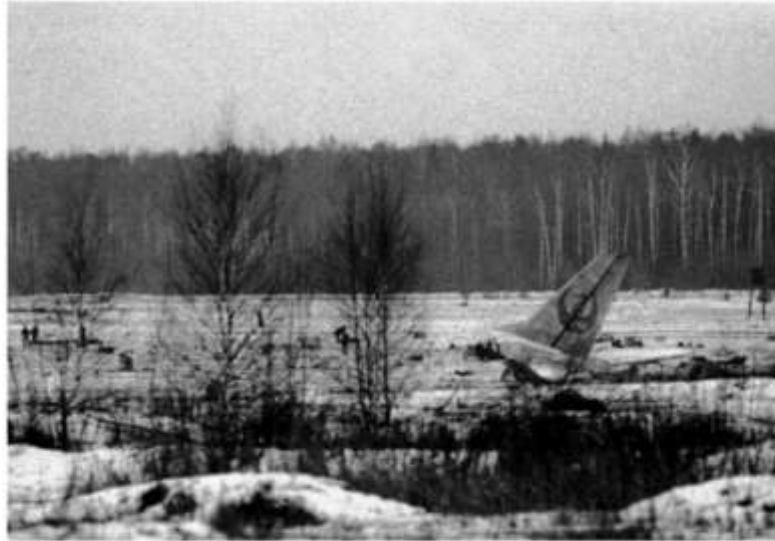
Probable Cause: The cause of the disaster to aircraft DC-8-62 JA-8040 resided in the fact that during take-off and following attainment of the safety speed V2, the crew put the aircraft into a supercritical angle of attack which resulted in loss of speed and altitude.

モスクワのシェレメテボ空港近くで墜落した日本航空DC8-62型ジェット旅客機。1972年11月29日【PANA=時事】

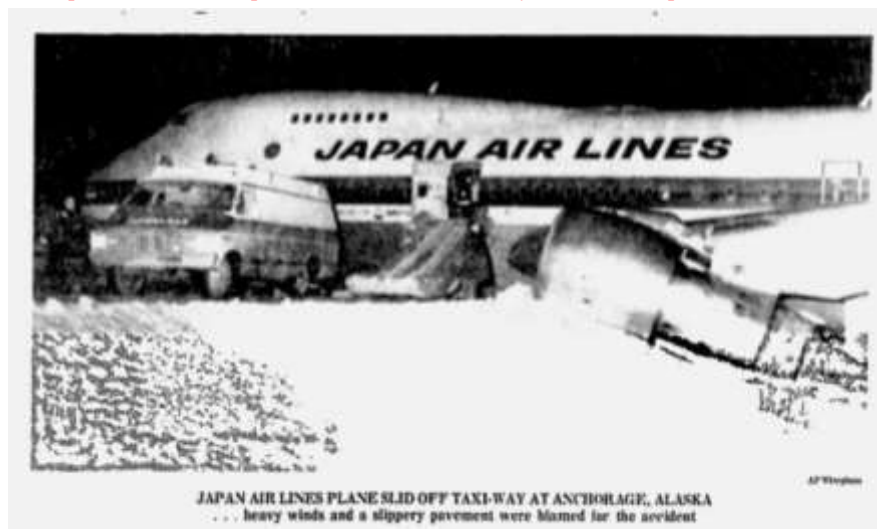
JAPAN AIR LINES PLANE SLID OFF TAXI-WAY AT ANCHORAGE, ALASKA
... heavy winds and a slippery pavement were blamed for the accident

Hynes said the plane's fuselage was cracked in three places and the turbine on each wing was bent by the force of its slide.

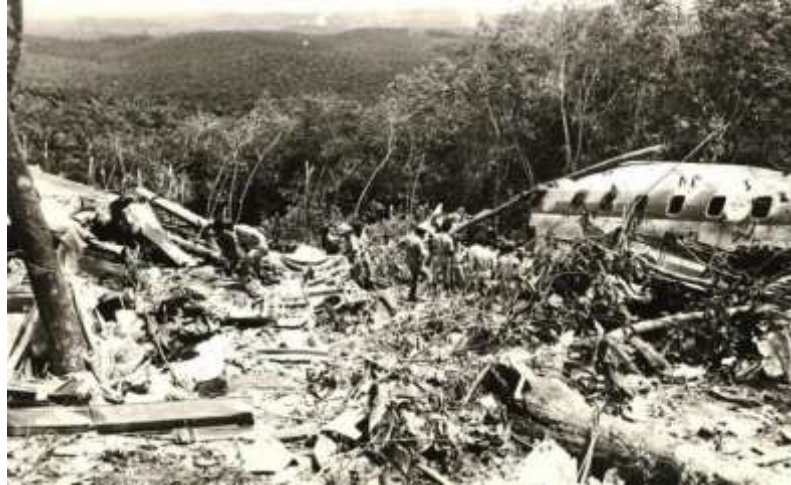
The accident was caused by the captain descending below minimum descent altitude without having the runway in sight, and continuing the descent until the aircraft struck terrain four nautical miles short of the runway threshold. A subsidiary contributory factor was insufficient monitoring of the aircraft's flight path by the captain under the adverse weather conditions with several aircraft in the holding pattern awaiting their turn for approach and, more importantly, the co-pilot's failure to challenge the captain's breach of company regulations.

JAL715 crashed short of Kuala Lumpur in 1977

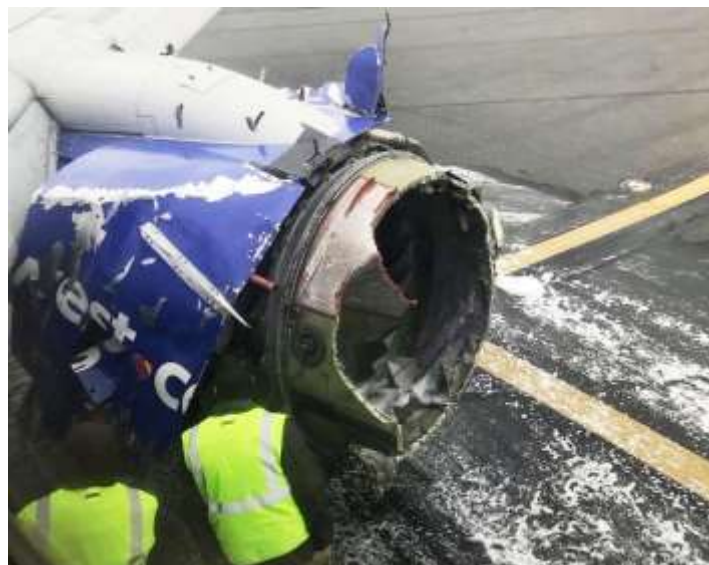
B737-200 aircraft that actually crashed

17/04/2018 Southwest Airlines B737-700, WN1380 diverted to Philadelphia, Pennsylvania, USA, after suffering an in-flight uncontained engine failure. The flight originated from New York-La Guardia Airport at 10:43 for a flight to Dallas-Love Field, Texas. 1/149

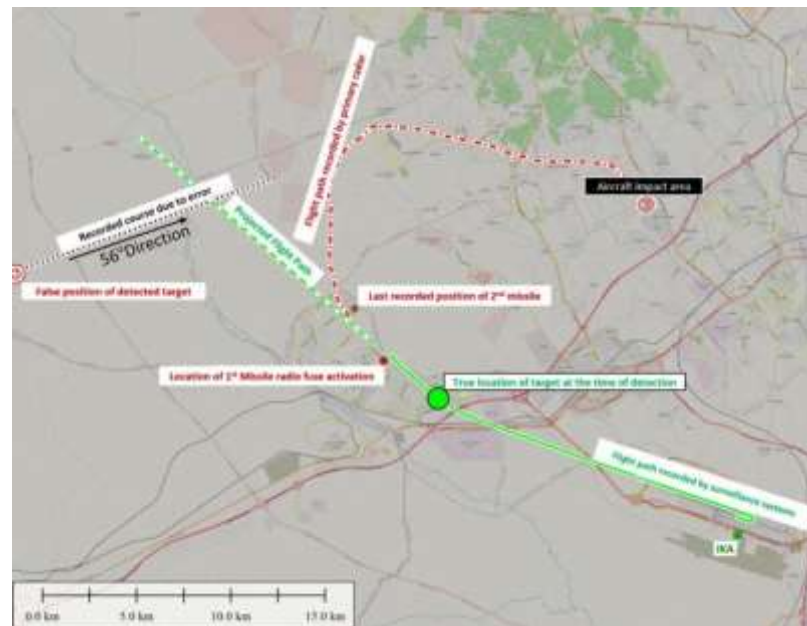
Complete flight trajectory and missile last positions (Graphics: Iran's AIB)

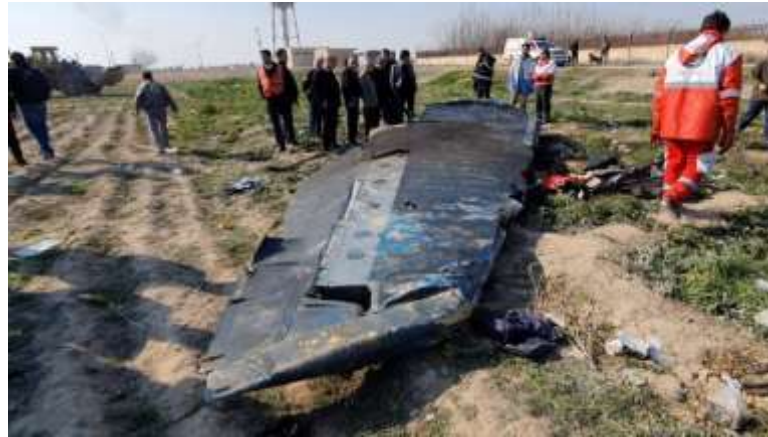
Iran's Revolutionary Guard Corp fired two surface-to-air missiles at PS752, killing all 176 people onboard, on Jan. 8, 2020. (Reuters)

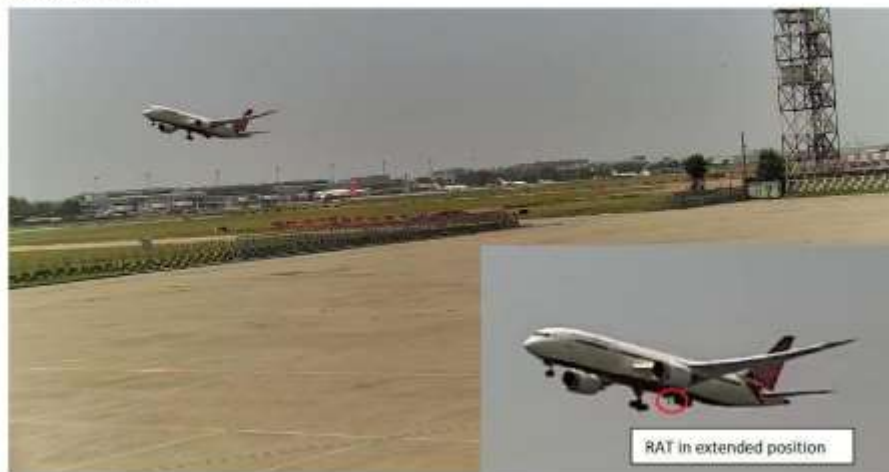
Figure 15 CCTV screenshot of RAT Deployment
