民間航空機の主な航空事故一覧

Major Air Disasters Involving Commercial Airlines

1937-2025

作成者: 前川 博和(Hirokazu (Mike) Maekawa)

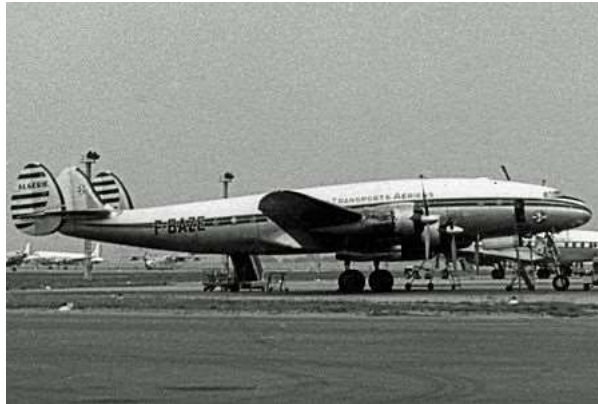
Lockheed L-749A Constellation

28/10/1949 Pico da Vara, São Miguel Island, Azores, Portugal, Air France AF009, L-749A from Paris-Orly Airport, France to New York City, USA with a Stopover at Santa Maria Airport, Azores, Portugal. **CFIT, 48/37 pax + 11 crew**
Air France Flight 009 was a scheduled international flight that crashed into a mountain while attempting to land at Santa Maria Airport, Azores on a stopover during a scheduled international passenger flight from Paris-Orly Airport to New York City. All 48 people on board were killed.

F-BAZN departed Paris-Orly at 20:05 for a flight to New York with an intermediate stop at Santa Maria, Azores. At 01:41 the crew reported 150nm from Santa Maria with an ETA of 02:45. The ETA was later changed to 02:55. At 02:51 the flight reported flying at 3000 feet with the airfield in sight. After acknowledging landing instructions, nothing more was heard from the flight. The Constellation had struck the Redondo Mountain at an elevation of 900 m. Probable Cause:

- Failure to carry out either of the approach procedures for Santa Maria airport.
- False position reports given by crew. Inadequate navigation.
- Failure to identify Santa Maria Airport, when flying in VFR conditions.

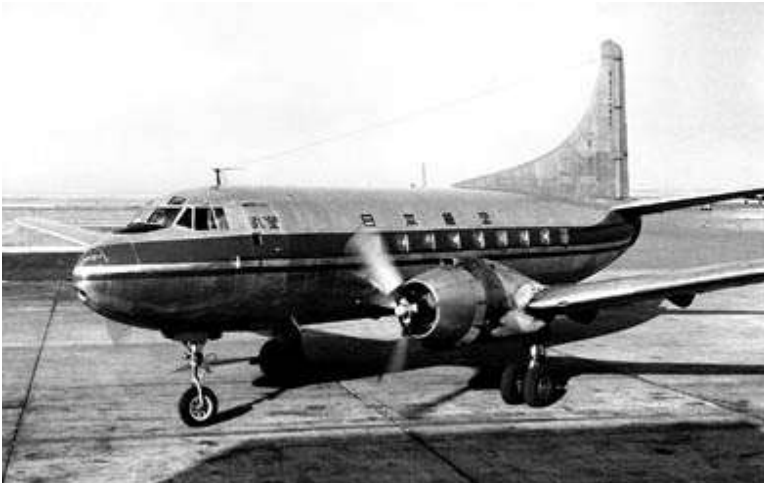
Japan Airlines (leased from Northwest Orient Airlines) Martin 2-0-2 30 seats

09/04/1952 Mt. Mihara, Japan, Martin-202, Japan Airlines, Hit a mountain, CFIT, 37/37
 The aircraft, leased from Northwest Airlines, crashed into a mountain: The plane was named "もく星号".

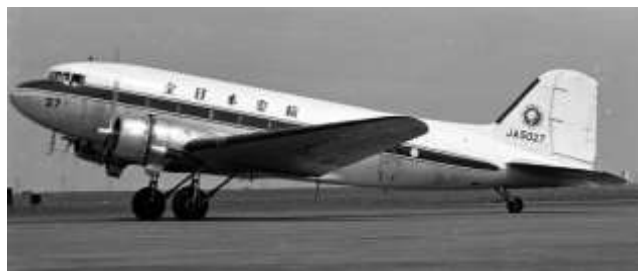
Douglas DC-3 (C-47)

06/01/1960	Wilmington, Bolivia, DC-6B, National Airlines, Bomb, 34
18/01/1960	Charles City, USA, Viscount 745D, Capital Airlines, Engine Failure, 50
19/01/1960	Ankara, Turkey, Caravelle, SAS, Crashed into Hill, CFIT , 42
05/02/1960	Laguna de Hunana - Costa, Bolivas, DC-4, Lloyd Aereo Boliviano, Engine Fire, 59
26/02/1960	Shannon, Ireland, DC-7C, Alitalia, Not Available, 52
16/03/1960	Nagoya, Japan, DC-3, ANA, On Runway Collision with F86D, ATC Error: 3/33

After landing at Nagoya, JA5018 made a u-turn and taxied towards the terminal. At the same time, a Japan Air Self Defense Force (JASDF) North American F-86D Sabre fighter (94-8137) took off from the same runway. The fighter plane collided with the aft fuselage and tail of the All Nippon aircraft. The Sabre crashed and burned but the pilot survived.

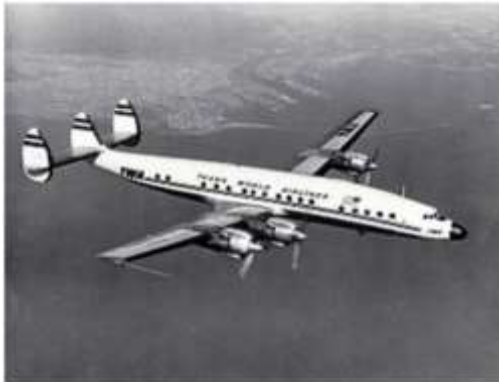
TWA L-1049 Super Constellation

16/12/1960 New York, USA, Lockheed Constellation L-1049, TWA266, from Columbus OH, Mid-air collision, 44/44

United Airlines DC-8-11, N8013U, UA826 and Trans World Airlines Lockheed L1049 Super Constellation, N6709C, TW266, Midair collision over Staten Island, New York

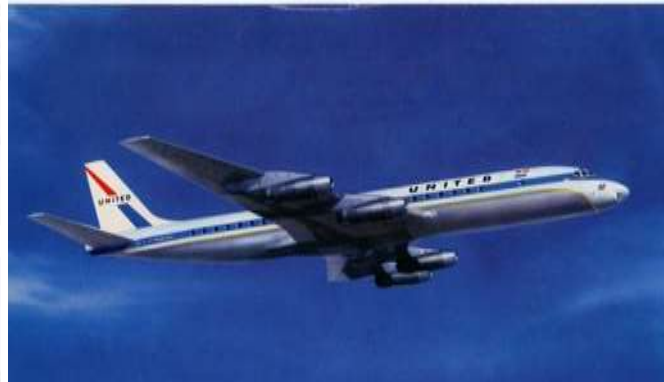
United Air Lines Douglas DC-8

*DC-8 continued for another 13,5 km before crashing in a residential area of Brooklyn, killing 5 (?) people on the ground.

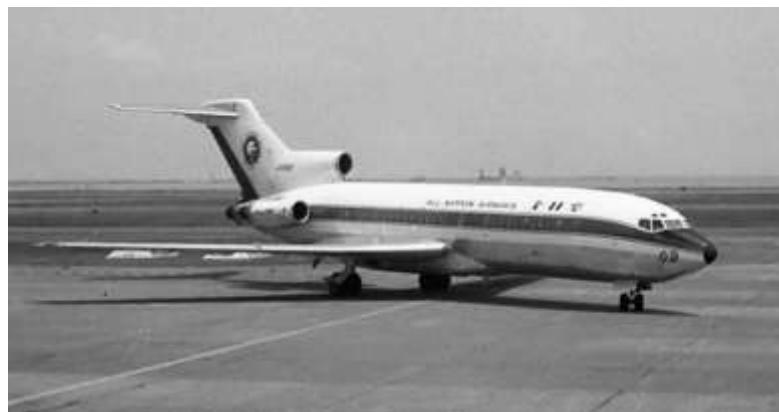
Boeing 727

04/02/1966 Tokyo Bay, Japan, 727-81, All Nippon Airways, Crashed during approach, CFIT, 113/133

The Boeing 727-81 (JA8302) departed Sapporo-Chitose (CTS), about 1800i for Tokyo-Haneda (HND). While approaching the airport, the crew cancelled IFR and radioed their intentions to continue VFR. At 1859 hours the flight was instructed to report when entering the right base leg for an approach to runway 33R. Winds were 020 degrees at 10 knots. The flight reported on a long base at 19:00 hours. This was the last radio contact with the flight. The aircraft impacted the water, 12 km east-southeast of the airport, disintegrated and sank.

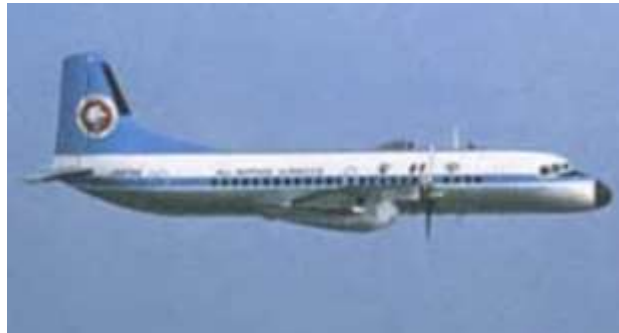
16/11/1966 Matsuyama, Japan, NAMC, YS-11, All Nippon Airways NH53, Overshot runway, 50/50

The flight from Osaka to Matsuyama was uneventful and cleared to land at runway 31. The approach was slightly higher than usual and touchdown was at 460m past the runway threshold. After a 170m ground run the plane became airborne again and a go-around was initiated. A height of 230-330 feet was reached, followed by a left turn. The YS-11 descended and crashed into the water.

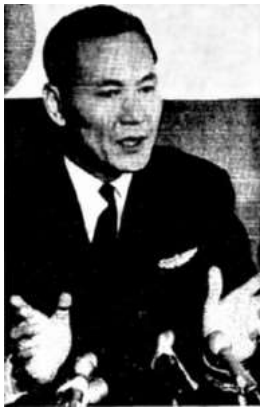
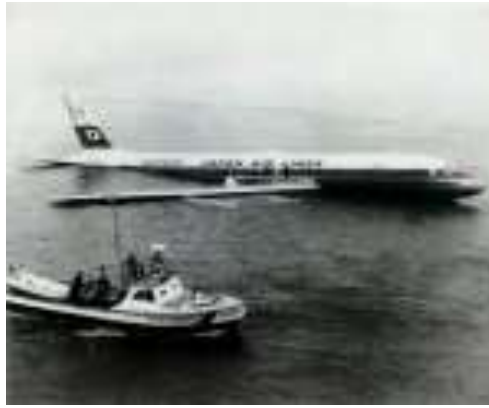
Capt. Kohei Aso at NTSB JAL DC8 JA8032 ditched short final RWY28L

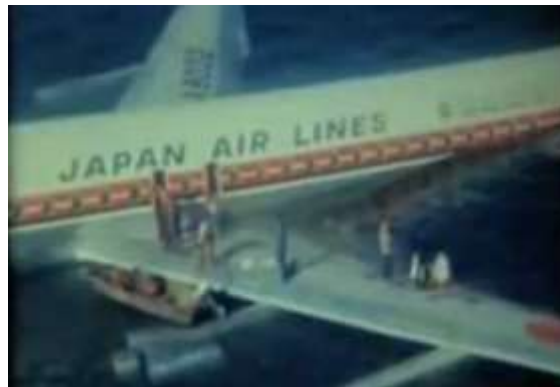
People stand on wing of DC8 awaiting rescue

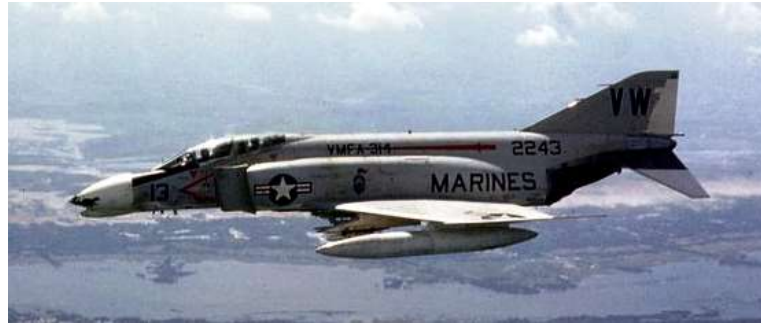
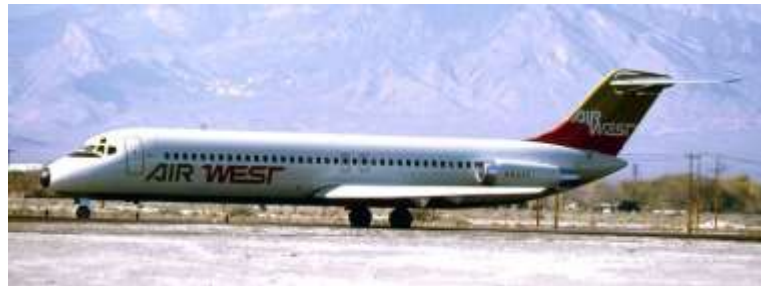
F4B (top) and DC-9 (bottom)

- Airwest 706, DC-9, Los Angeles, CA (LAX) to Seattle, WA (SEA) with intermediate stops at Salt Lake City (SLC), Boise (BOI), Lewiston (LWS), Pasco (PSC) and Yakima (YKM) departed Los Angeles at 18:02. At 18:09 the crew reported leaving FL120 and Los Angeles ARTCC cleared them direct to Daggett. At 17:16 h a USMC McDonnell F-4B Phantom 151458 departed Naval Auxiliary Air Station (NAAS) Fallon for a flight to MCAS El Toro at low altitude. The aircraft had several technical difficulties, including an inoperative transponder and a leak in the oxygen system. Due to deteriorating visibility northwest of Palmdale, the crew climbed to 15,500 feet. Shortly after level-off, aircraft was 50 miles from MCAS El Toro. The pilot executed a 360° aileron roll at this time, which took approximately 3 seconds to complete. The Radar Intercept Officer (RIO) estimated that the true airspeed in the climb and after

level-off was 420 knots. The F-4B collided with the Airwest DC-9 about 1 minute and 20sec after the roll, at 15150 feet. After the collision, the F-4 began to tumble violently about the lateral axis. The RIO waited about 5 seconds, and, after seeing numerous warning lights in the cockpit, he ejected from the aircraft. The ejection was successful, and he parachuted to the ground without injury. The other F-4 crewmember did not survive the accident. Probable Cause: The **failure of both crews to see and avoid each other** but it is recognized that they had only marginal capability to detect, assess, and avoid the collision. Other causal factors include a very high closure rate, **commingling of IFR and VFR** traffic in an area where the limitation of the ATC system precludes effective separation of such traffic, and failure of the crew of BuNo458 to request radar advisory service, particularly considering the fact that they had an inoperable transponder."

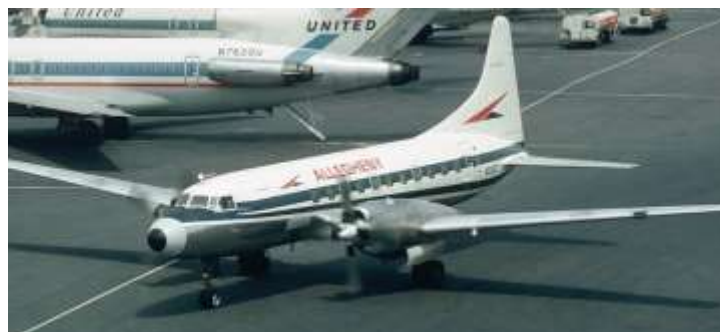
Allegheny Convair 580

07/06/1971 New Haven, USA Convair 580 Allegheny Airlines Crashed on approach **28/31**

The aircraft struck cottages, located 4890 feet short of runway 02, and crashed. The aircraft was on a non precision instrument approach. The Convair was originally manufactured as a Convair CV440 and converted to a CV580.

Probable Cause: "The captain's **intentional descent** below the prescribed minimum descent altitude under adverse weather conditions without adequate forward visibility or the crew's sighting of the runway environment. The captain disregarded advisories from his first officer that minimum descent altitude had been reached and that the airplane was continuing to descend at a normal descent rate and airspeed. The Board was unable to determine what motivated the captain to disregard prescribed operating procedures and altitude restrictions and finds it difficult to reconcile the actions he exhibited during the conduct of this flight."

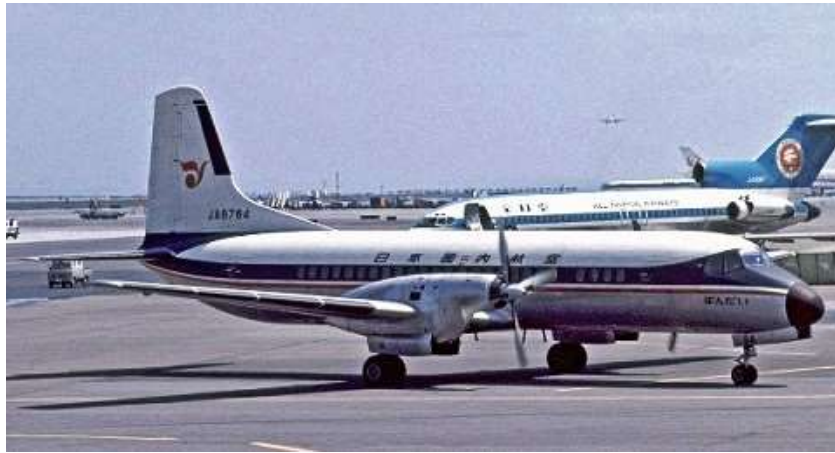
TDA YS-11

03/07/1971 Hokkaido, Japan, NAMC YS-11A, TOA Domestic, Hit a mountain, CFIT, 68/68

The crew mistook a point approximately 5 nautical miles north of the Hakodate NDB as being just over the Hakodate NDB, a navigation aid, and initiated their descent from an estimated altitude of 6,000ft in an attempt to cross the high station at 2,500ft by making a single circle. The outbound flight leg was extended westward and because of a strong southwesterly wind, the aircraft drifted further to the north than the crew expected, striking the mountain.

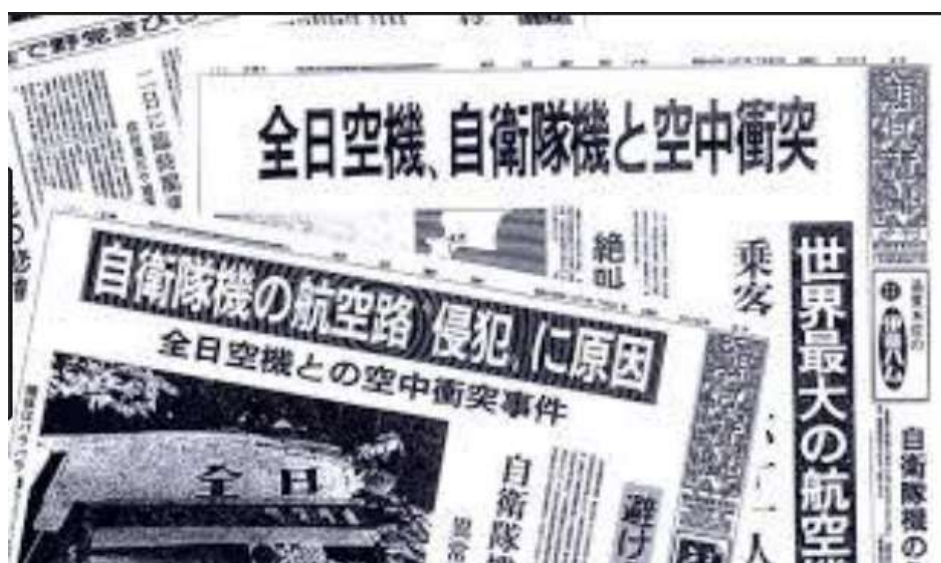
31/07/1971 Shizukuishi, near Morioka, Japan, 727-200, All Nippon Airways (ANA), NH58, Mid Air Collision with F86, 162/162

ANA JA8329 (NH58), Sapporo-Chitose (CTS) to Tokyo-Haneda (HND) climbed to an altitude of FL280. While cruising at this altitude, it approached an area where a Japan Air Self Defense Force student and his instructor were flying in their Mitsubishi-built North American F-86F fighters. The trainee was not watching out for traffic when the 727 approached. The instructor ordered him to break away from the 727. It was too late. He banked to the left but the leading edge of the right wing of his F-86F (92-7932) struck the left horizontal stabilizer of the ANA plane. The fighter's right wing broke off, causing the plane to crash out of control, but the pilot ejected safely. Damage to the stabilizer caused a loss of control of the B727.

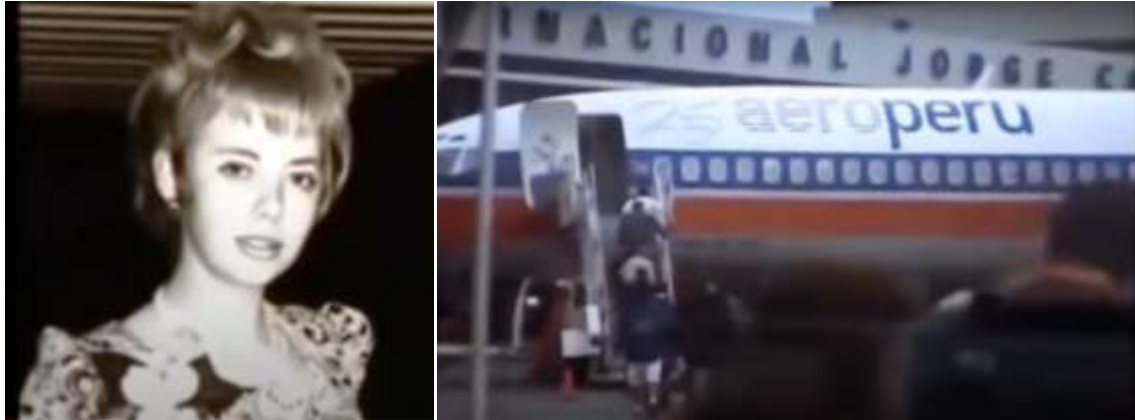
- 04/09/1971 Juneau, Alaska, 727-193, Alaska Airlines, Hit a mountain, 111
- 02/10/1971 Aarsele, Vanguard BEA, Structural Failure: bulkhead corrosion from leaky toilets, 63
- 21/11/1971 Penghu Islands, Caravelle, China Airlines, Mid-Air, Bomb, 25
- 24/12/1971 Puerto Inca, Lockheed Electra 188A, LANSА, Structural Failure due lightning, 91/92

About 40 minutes after takeoff, the aircraft entered a zone of strong turbulence and lightning. After flying for 20 minutes in this weather at FL210 lightning struck the aircraft, causing fire on the right wing which separated, along with part of the left wing. The aircraft crashed in flames into mountainous terrain. Structural failure occurred because of the loads imposed on the aircraft flying through a severe thunderstorm, but also because of stresses resulting from the maneuver to level out the aircraft.

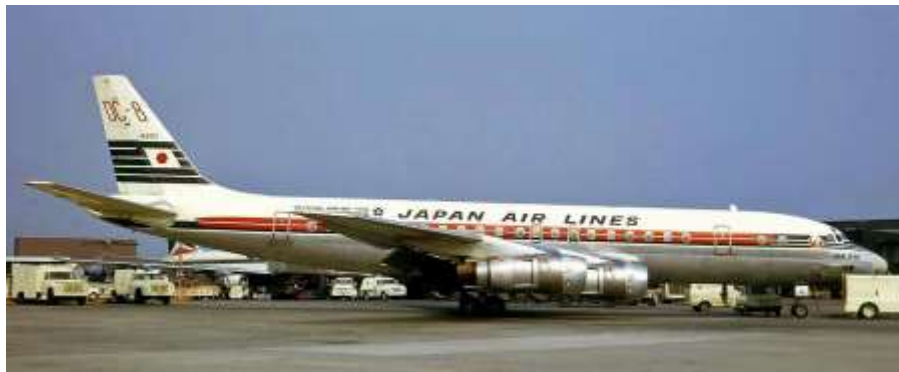
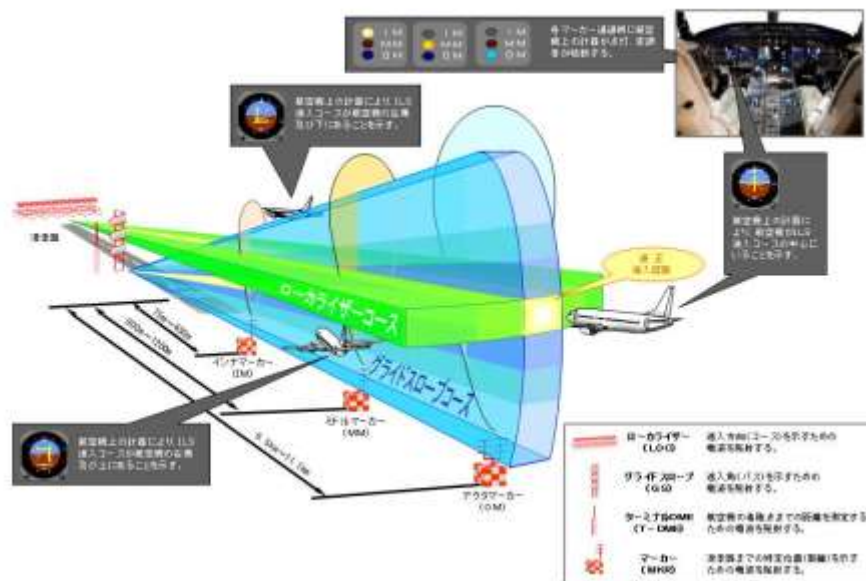
The DC-8 took off from Bangkok at 1121 UTC on a flight to Delhi, India. Clearance for a straight-in ILS approach to Delhi runway 28 was given at 14:43 UTC. Shortly after reporting 23DME, the aircraft struck the banks of River Yamuna. The first officer was Pilot Flying during the approach to Delhi.

PROBABLE CAUSE: Japanese investigators claimed a false glide path signal to be responsible for the descent into terrain. Indian investigators say the accident was caused by a total disregard of laid down procedures by the crew and abandoning all instrument indications without properly ensuring sighting of the runway.

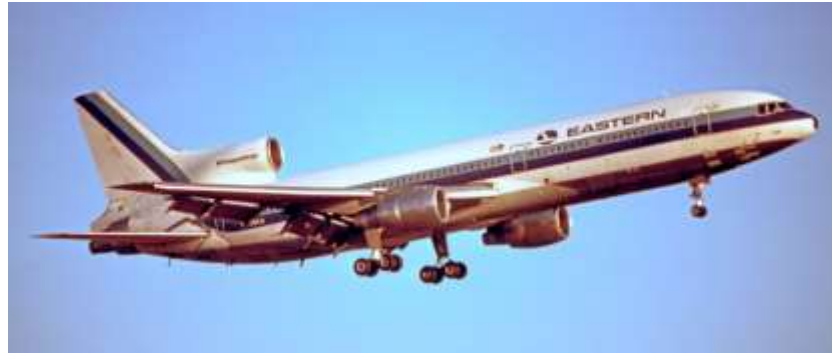
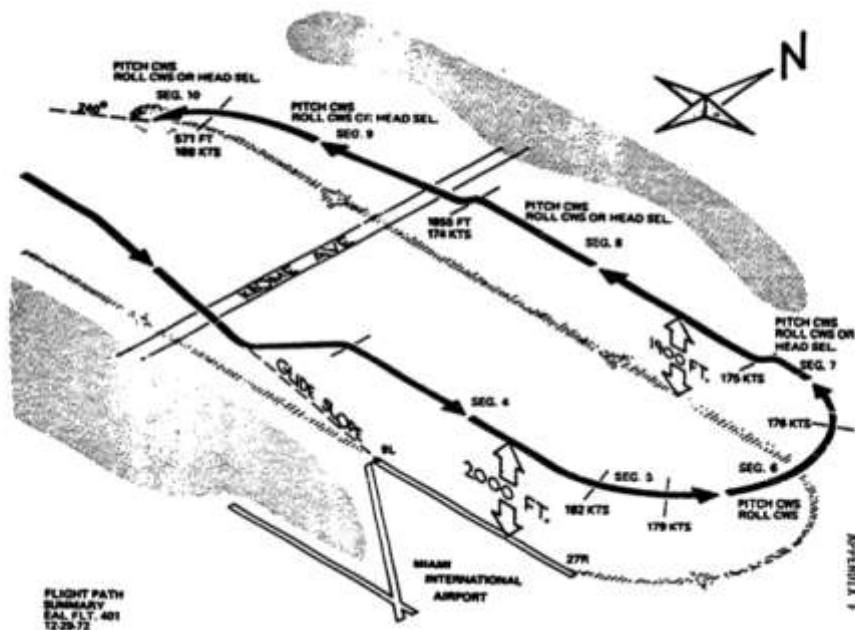
L-1011

EA401 departed New York-JFK at 21:20 EST for a flight to Miami. The flight was uneventful until the approach to Miami. After selecting gear down, the **nosegear light didn't indicate 'down and locked'**. Even after recycling the gear, the light still didn't illuminate. At 23:34 the crew called Miami Tower and were advised to climb to 2000 feet and hold. At 23:37 the captain instructed the second officer to enter the forward electronics bay, below the flight deck, to check visually the alignment of the nose gear indices. Meanwhile, the flight crew continued their attempts to free the nosegear position light lens from its retainer, without success. The second officer was directed to descend into the electronics bay again at 23:38 and the captain and first officer continued discussing the gear position light lens assembly and how it might have been reinserted incorrectly. At 23:40:38 a half-second C-chord sounded in the cockpit, indicating a +/-250 feet deviation from the selected altitude. None of the crewmembers commented on the warning and no action was taken. A little later the Eastern Airlines maintenance specialist, occupying the forward observer seat went into the electronics bay to assist the second officer with the operation of the nose wheel well light. At 23:41:40 Miami approach contacted the flight and granted the crew's request to turn around by clearing him for a left turn heading 180 degrees. At 23:42:05 the first officer suddenly realized that the altitude had dropped. Just seven seconds afterwards, while in a left bank of 28deg, the TriStar's no.1 engine struck the ground, followed by the left main gear. The aircraft disintegrated, scattering wreckage over an area of flat marshland, covering a 1600 ft x 300 ft area. **Five crew members and 94 passengers died in the accident.** Two passengers died more than seven days after the accident as a result of their injuries. **PROBABLE CAUSE:** "The failure of the flight crew to monitor the flight instruments during the final 4 minutes of flight, and to detect an unexpected descent soon enough to prevent impact with the ground. Preoccupation with a malfunction of the nose landing gear position indicating system distracted the crew's attention from the instruments and allowed the descent to go unnoticed."

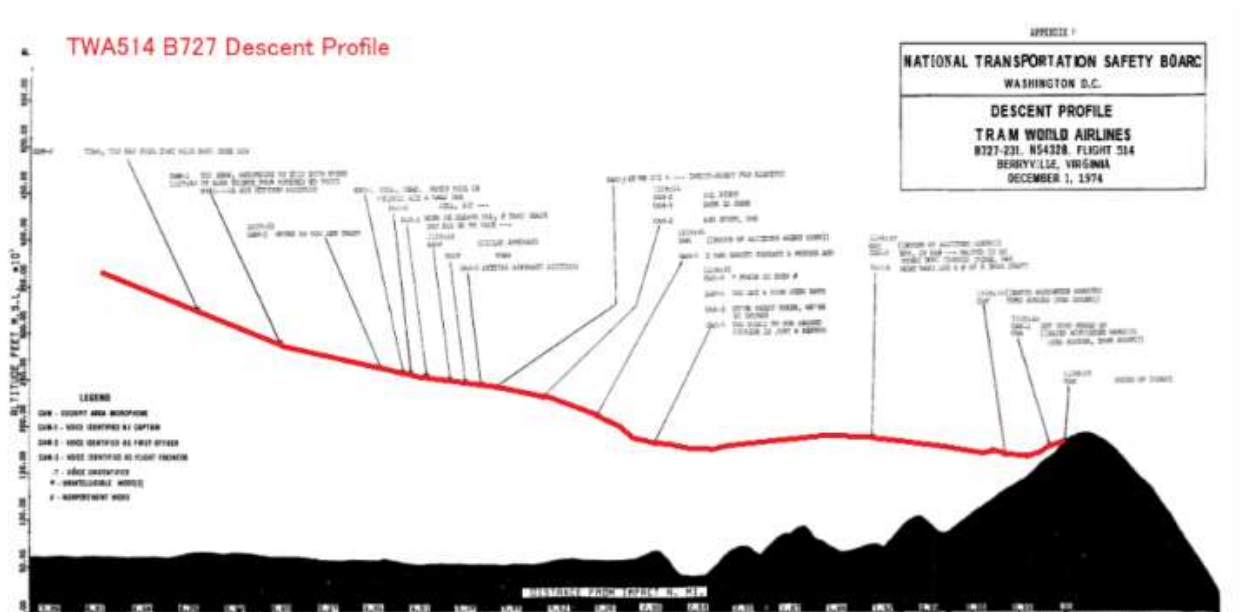
07/09/1974	Telukbetung, INA, F27, Garuda Indonesian Airlines, Crashed on landing, 31
08/09/1974	Ionian Sea, Greece, 707, TWA, Bomb, 88
11/09/1974	Charlotte, USA, DC-9-31, Eastern Airlines, Crashed during Approach, 72
15/09/1974	Phan Rang, 727, Air Vietnam, Hijacked, 76
20/11/1974	Nairobi, Kenya, 747, Lufthansa, Crashed at Take-off, 59
01/12/1974	Berryville, Virginia, USA, 727-231, Transworld Airlines, TW514 , While Landing in Bad Weather, CFTI , 92/92

PROBABLE CAUSE: "The crew's decision to descend to 1800ft before the aircraft had reached the approach segment where that minimum altitude applied. The crew's decision to descend was a result of inadequacies and lack of clarity in the air traffic control procedures which led to a misunderstanding on the part of the pilots and of the controllers regarding each other's responsibilities during operations in terminal areas under instrument meteorological conditions. Nevertheless, the examination of the plan view of the approach chart should have disclosed to the captain that a minimum altitude of 1800ft was not a safe altitude. Contributing factors were: 1) The failure of the FAA to take timely action to resolve the confusion and misinterpretation of air traffic terminology although the Agency had been aware of the problem for several years; 2) The issuance of the approach clearance when the flight was 44 miles from the airport on an unpublished route without clearly defined minimum altitudes; and 3) Inadequate depiction of altitude restrictions on the profile view of the approach chart for the VOR/DME approach to runway 12 at Dulles Int. Airport."

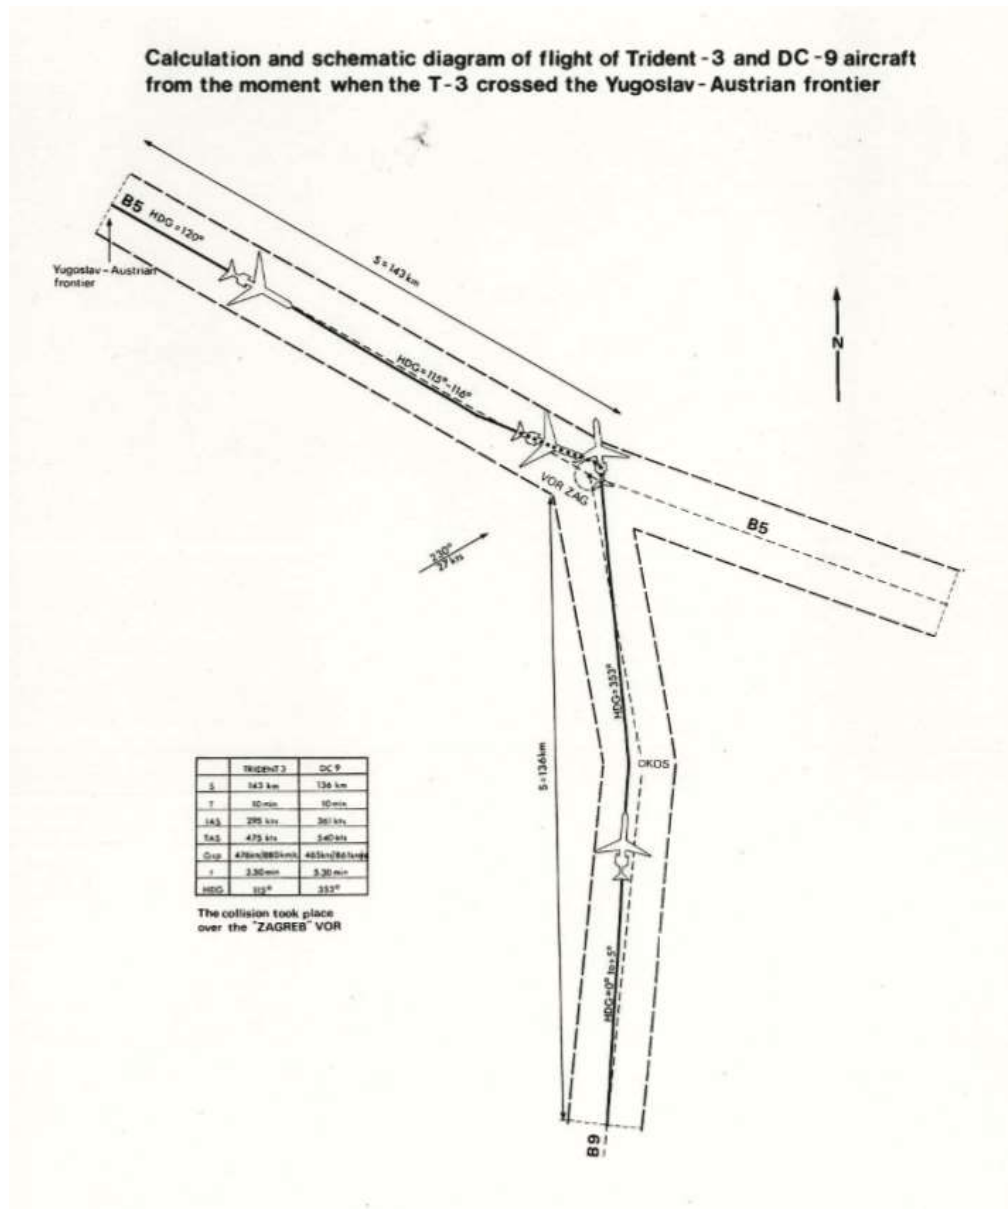
Hawker Siddeley HS-121 Trident 3B operated by British Airways as flight BE476 and a McDonnell Douglas DC-9-32, operated by Inex-Adria

Aviopromet, were destroyed when both aircraft crashed near Vrobec following a mid-air collision. The collision was the result of a **procedural error on the part of Zagreb air traffic controllers**. All 176 on board both aircraft were killed.

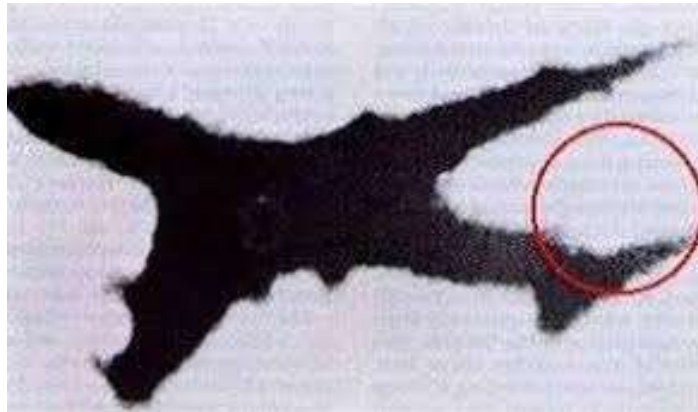
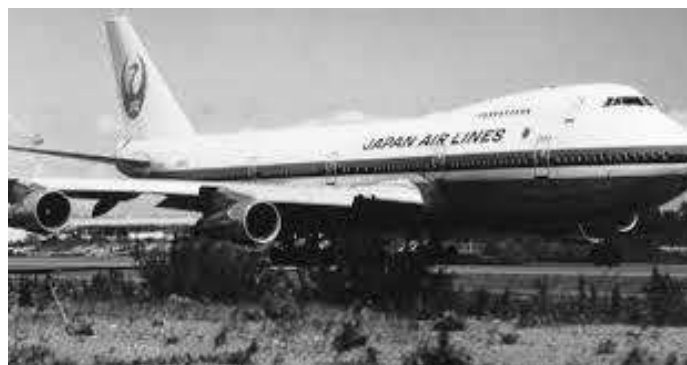
B747 SR

21/01/1985	Reno, USA, Lockheed Electra 188A, Galaxy Airlines, Crashed at Take-off, 64
19/02/1985	San Francisco, USA, 747-SP, China Airlines, Engine Failure, 2 Seriously Injured
19/02/1985	Bilbau, Spain, 727-256, Iberia, Hit high ground due to misunderstanding of Altitude Alert System , 148
05/03/1985	Ukraine, USSR, Tupolev 134A, Aeroflot, Mid Air Collision, 94
28/03/1985	Florencia, Colombia, F-28, Satena, Hit a mountain, 52
15/04/1985	Phuket, Thailand, 737-200, Thai Airways, Hit high ground, 11
28/04/1985	Maniheska, MD-83, Airtours, Structural Failure, 0
14/06/1985	Athens, Greece, 727, Trans World Airlines, Hijacking, 1
23/06/1985	Irish Coast, 747-200, Air India, Bomb, 329
10/07/1985	Uzbekistan, USSR, Tupolev 154B-2, Aeroflot, Uncontrolled descent, 200
02/08/1985	Dallas, USA, Lockheed TriStar, Delta Air Lines, 191 Wind shear on final, 135
12/08/1985	Mt. Osutaka, Japan, B747 SR, Japan Airlines, JL123, Structural Failure, 520/524

Probable Cause: It is estimated that this accident was caused by deterioration of flying quality and loss of primary flight control functions due to rupture of the aft pressure bulkhead of the aircraft, and the subsequent ruptures of a part of the fuselage tail, vertical fin and hydraulic flight control systems.

The reason why the aft pressure bulkhead was ruptured in flight is estimated to be that the strength of the said bulkhead was reduced due to fatigue cracks propagating at the spliced portion of the bulkhead's webs to the extent that it became unable to endure the cabin pressure in flight at that time.

The initiation and propagation of the fatigue cracks are attributable to the improper repairs of the said bulkhead conducted in 1978, and it is estimated that the fatigue cracks having not be found in the later maintenance inspection is contributive to their propagation leading to the rupture of the said bulkhead."

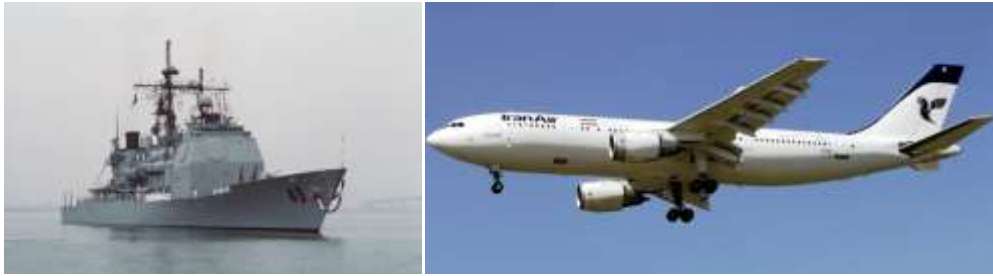
- 26/06/1988 Mulhouse, France, Airbus A-320, Chartered, Pilot Error, 4
- 03/07/1988 Straits of Hormuz, Airbus A-300, Iran Air, flt 655, **Shot Down by USS Vincennes, 290/290**
 Iran Air Flight 655, a scheduled passenger flight from Tehran to Dubai, was shot down by an SM-2MR surface-to-air missile fired from USS Vincennes, a guided missile cruiser of the United States Navy. The aircraft, an Airbus A300, was destroyed and all 290 people on board including 66 children were killed. The jet was hit while flying over Iran's territorial waters in the Persian Gulf along the flight's usual route. Vincennes had entered Iranian territorial waters after one of its helicopters drew warning fire from Iranian speedboats operating within Iranian territorial limits. In 1996, the United States and Iran reached a settlement at the International Court of Justice which included the statement "...the United States recognized the aerial incident of 3 July 1988 as a terrible human tragedy and expressed deep regret over the loss of lives caused by the incident...". As part of the settlement, even though the United States did not admit legal liability or formally apologize to Iran, they still agreed to pay US\$61.8 million on an ex gratia basis, amounting to \$213,103.45 per passenger, in compensation to the families of the Iranian victims.

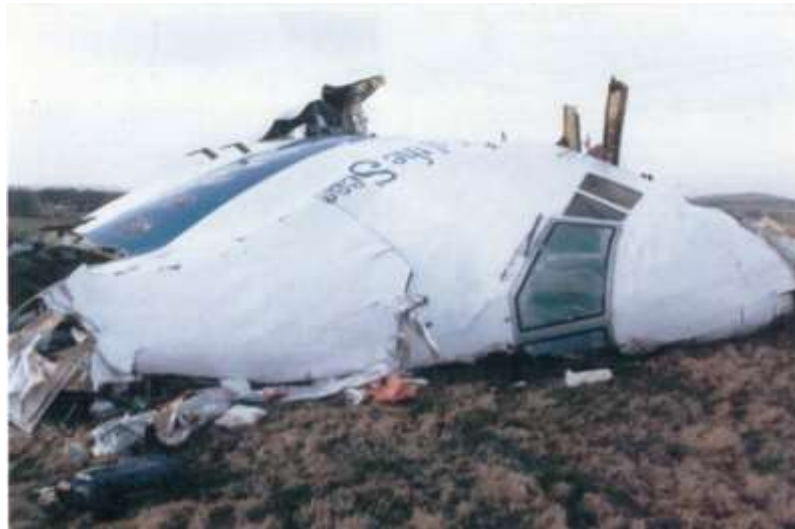
Pan Am Flight 103 was a regularly scheduled Pan Am transatlantic flight from Frankfurt to Detroit via London and New York. On 21 December 1988, N739PA, the aircraft operating the transatlantic leg of the route, was destroyed by a bomb, killing all 243 passengers and 16 crew in what became known as the Lockerbie bombing. Large sections of the aircraft crashed onto residential areas of Lockerbie, Scotland, killing 11 more people on the ground.

PROBABLE CAUSE: "The in-flight disintegration of the aircraft was caused by the detonation of an improvised explosive device located in a baggage container positioned on the left side of the forward cargo hold at aircraft station 700."

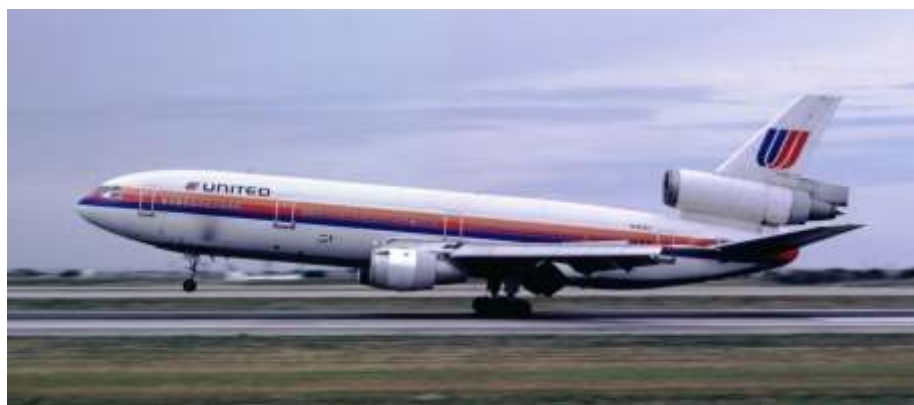
UAL232 departed Denver at 14:09 CDT for a flight to Philadelphia. Cruising altitude was FL370. About 1 hour and 7 minutes after takeoff the crew heard a loud bang, followed by vibration and a shuddering of the airframe; the no.2 engine had suffered an uncontained failure. It then appeared that the hydraulic pressure was zero. The DC-10 didn't respond anymore to flight control inputs and the descending right turn was arrested by using no. 1 engine power reduction. The air driven generator (ADG), which powers the no.1 auxiliary hydraulic pump, was deployed but hydraulic power couldn't be restored. An emergency was declared at 15:20, and vectors to Sioux City were given by Minneapolis ARTCC. An off-duty training check airman was travelling on Flight 232 and offered his assistance. He was asked to manipulate the throttles to control pitch and roll, which was difficult because the plane had a continuous tendency to turn to the right. The no.1 and 3 thrust levers couldn't be used symmetrically, so he used two hands to manipulate the throttles. Sioux City Airport was sighted at 9 miles out, but the aircraft was aligned with the closed runway 22 (6600 feet long) instead of the longer (8999 feet) runway 31. Given the position and the difficulty in making left turns, the approach to runway 22 was continued. The aircraft approached with a high sink rate (1620 feet/min for the last 20 seconds) at an airspeed of 215 knots. At about 100 feet above the ground the nose began to pitch downward and the right wing dropped. The plane touched down on the threshold slightly left of the center line, skidded to the right and rolled inverted. The DC-10 caught fire and cartwheeled.

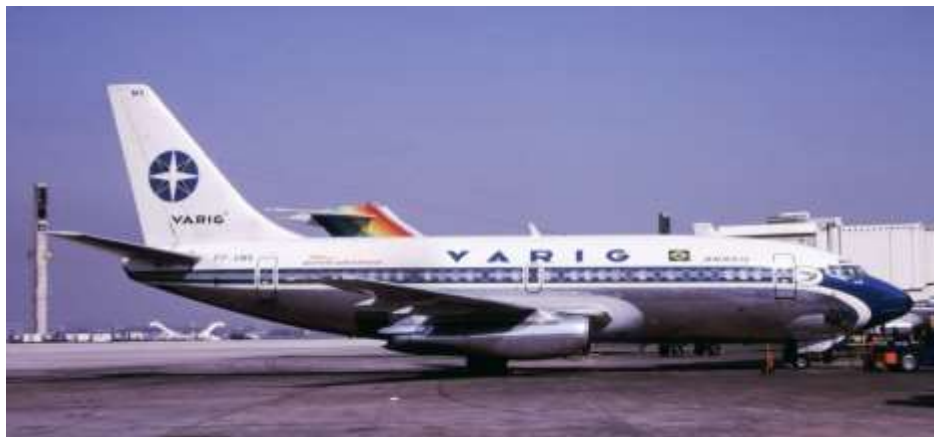
B737-200 aircraft that actually crashed

Upon investigation, it was concluded that the crash had been caused primarily by **negligence on the part of the flight crew**. Customary investigations showed that the aircraft was in perfect condition for the flight, and that its mandatory periodic inspections had been properly conducted. It was concluded that the main factor for the accident was an error in reading the correct heading from the flight plan by the commander, compounded by the co-pilot copying the setting from the commander's panel instead of checking the flight plan. The fact that plan course 0270 actually asked for 027.0 degrees was due to the Varig standardization of flight planning for all its fleet, but only aircraft equipped with an inertial navigation system actually used headings with decimals. Despite the pilots having been told about this peculiarity in the airline's training program, the value expressed in the flight plan 0270 was interpreted by the commander as 270° (he was on vacation during the change of standard). **This misinterpretation changed the general direction north-northeast (27.0°) to west (270°)**. The Boeing 737 was not equipped with INS, using only automatic direction finders (ADF) and VOR. Months after the accident, the flight plan VARIG 254 used was shown to 21 pilots of major airlines in the world during a test conducted by the International Federation of Air Line Pilots' Associations (IFALPA). No fewer than 15 pilots committed the same mistake that the VARIG flight 254 crew had made. After the flight 254 accident, VARIG would install Omega navigation systems in their aircraft.

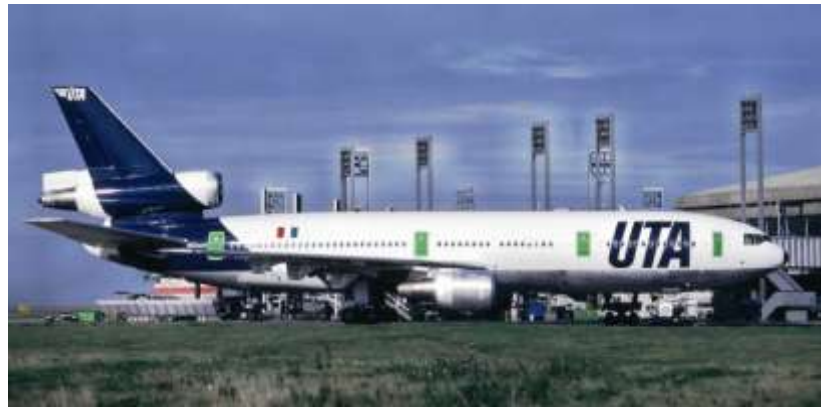
The DC-10 was operating as UTA Flight 772 on the Brazzaville-N'Djamena-Paris route. The aircraft took off from N'Djamena at 13:13 and climbed to a cruising altitude of FL350. At 13:59 **an explosion on board** caused the aircraft to crash into the desert. The explosive device was located at location 13R in the cargo hold. The device was most probably hidden in baggage, placed aboard at Brazzaville. **Possible groups responsible for the explosion are the Islamic Jihad group** (demanding the freedom of a Shi'ite Muslim in Israel) or the Secret Chadian Resistance. Co-incidental on March 10, 1984 another UTA aircraft was destroyed when a bomb exploded; in this case the bomb exploded during embarkation at N'Djamena.

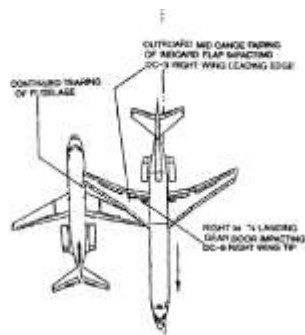
Figure 54.---Impact sequence.

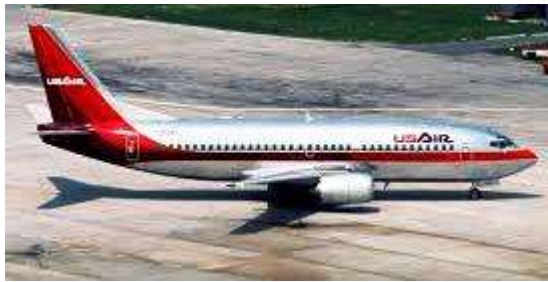
USAir B737 aircraft entered LAX airspace around 17:57 and was cleared for a CIVET Two Profile Descent and ILS runway 24R approach. At 17:59 this was changed to a runway 24L approach clearance. At about the same time a SkyWest Metro II (Flight **5569** to Palmdale) taxied out from Terminal 6, Gate 32 to runway 24L. At 18:03 the crew were advised to "**taxi up to and hold short of 24L**" because of other traffic. At 18:04:49 the flight was cleared to **taxi into position and hold**. Immediately thereafter the controller became preoccupied with instructing **WingsWest 5006** who had unintentionally departed the tower frequency. The **WingsWest 5072** reporting ready for takeoff caused some confusion because the controller didn't have a flight progress strip in front of her. The strip appeared to have been misfiled at the clearance delivery position. Meanwhile, Flight **5569** was still on the runway at the intersection with taxiway 45, awaiting takeoff clearance. At 18:07 Flight 1493 touched down. Simultaneous to the nose gear touchdown, the Boeing 737 collided with the SkyWest Metro. Both aircraft caught fire and slid to the left into an unoccupied fire station.

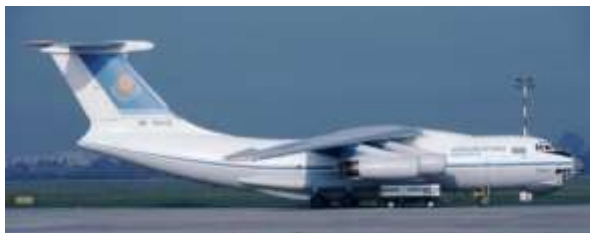
Kazakhstan IL-76

Apparently, the Kazakh aircraft had descended below its assigned altitude and was flying at 14500 feet. A few second later seconds later the Ilyushin had descended another 310 feet. Shortly afterwards both aircraft collided, plummeted down in flames and crashed in an arid farming area.

Probable Cause: "The root and approximate cause of the collision was the **unauthorized descending by the Kazak aircraft to FL140** and failure to maintain the assigned FL150".

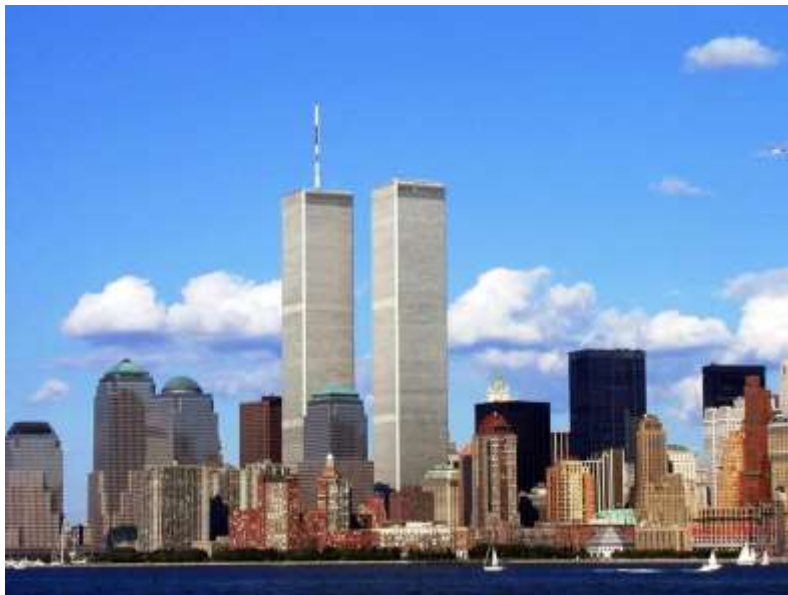
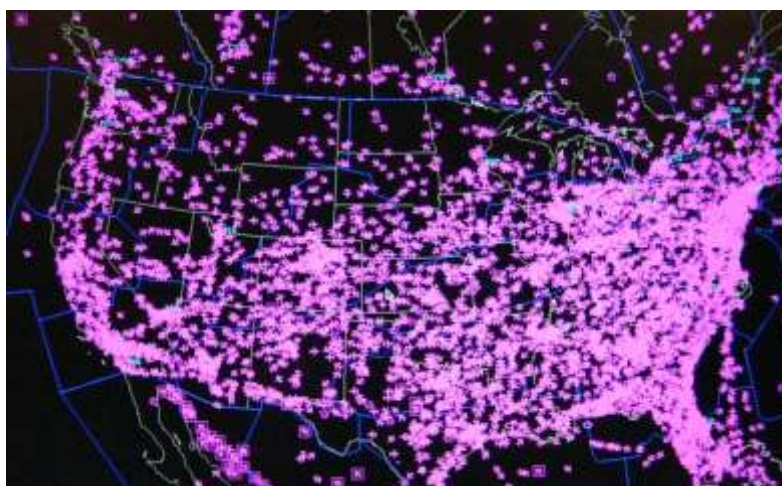
World Trade Center 9/11 Terror

- 11/09/2001 NYC, USA, AA11 BOS-LAX B767, hijacked and crashed into WTC, 81 pax + 11 crew
- 11/09/2001 NYC, USA, UA175 B767, hijacked and crashed into WTC, 56 pax + 9 crew
- 11/09/2001 Arlington VA, USA, AA77 B757, IRD-LAX, hijacked and crashed into Pentagon, 58 pax + 6 crew
- 11/09/2001 Nr Pittsburgh PA, UA93 EWR-SFO, hijacked and crashed into ground, 38 pax + 7 crew

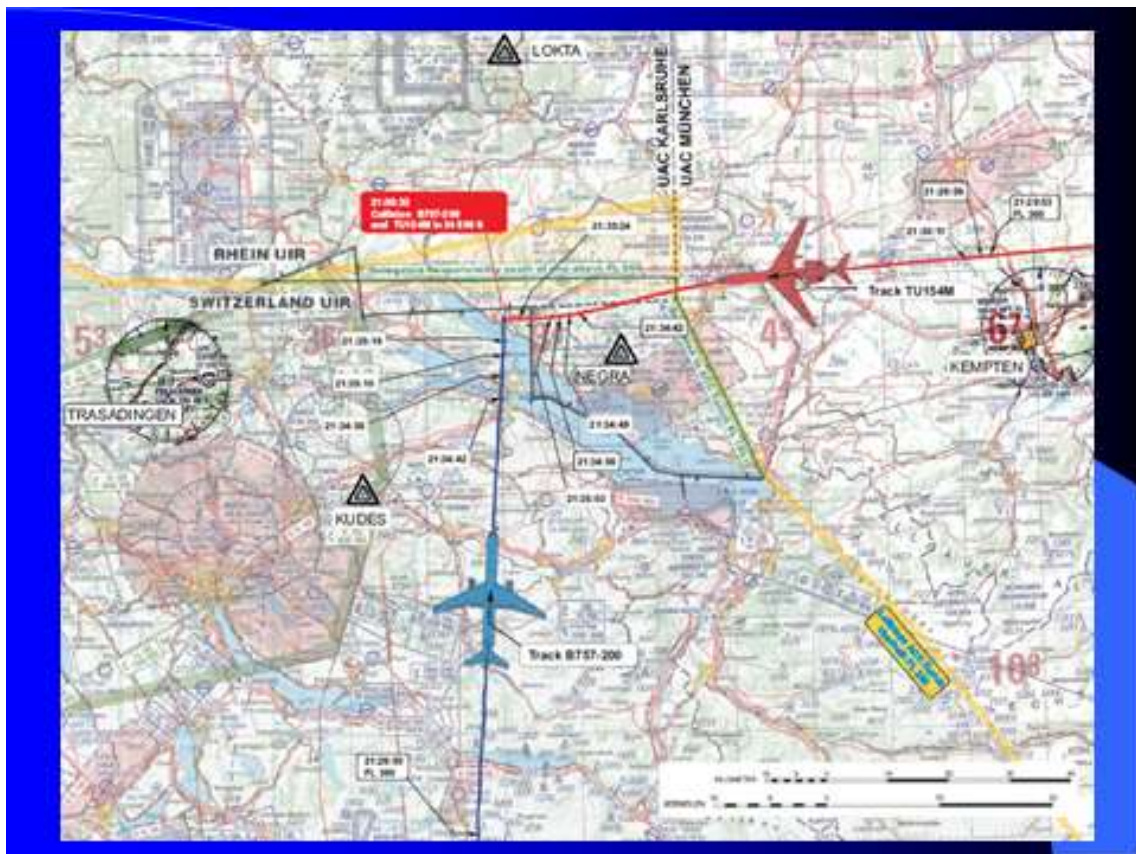
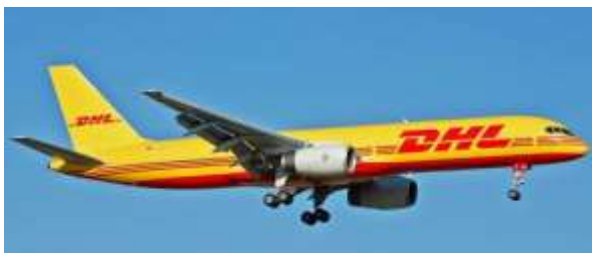
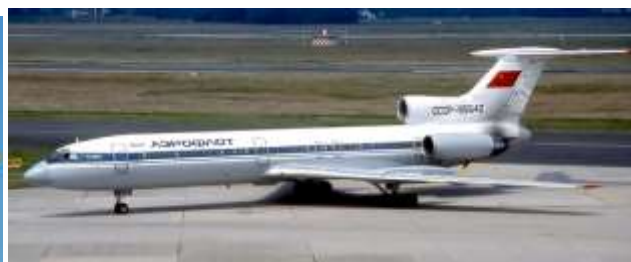
- 01/07/2002 Uberlingen, Switzerland, DHL B757 and Bashkirian Airlines (BTC) Tu-154, mid air collision, 69 BTC+2 DHL

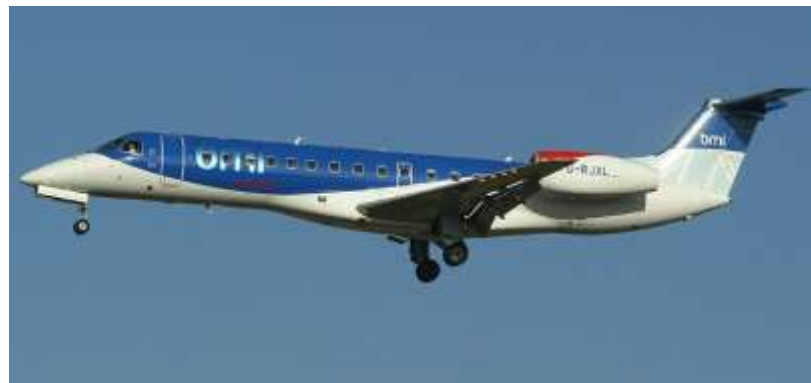
Embraer EMB-135BJ Legacy 600

Relatively to the crew of the N600XL, the following active failures were identified: lack of an adequate planning of the flight, and insufficient knowledge of the flight plan prepared by the Embraer operator; non-execution of a briefing prior to departure; unintentional change of the transponder setting, failure in prioritizing attention; failure in perceiving that the transponder was not transmitting; delay in recognizing the problem of communication with the air traffic control unit; and non-compliance with the procedures prescribed for communications failure.

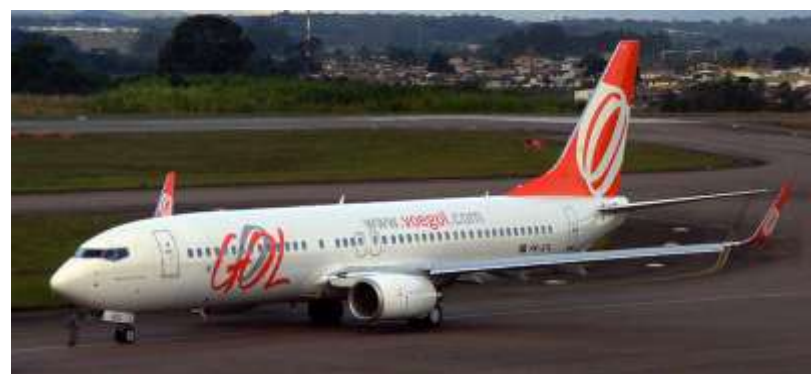
GOL B737-800

Neither active failures were identified in relation to the crew, nor latent failures in relation to the organizational system of the company.

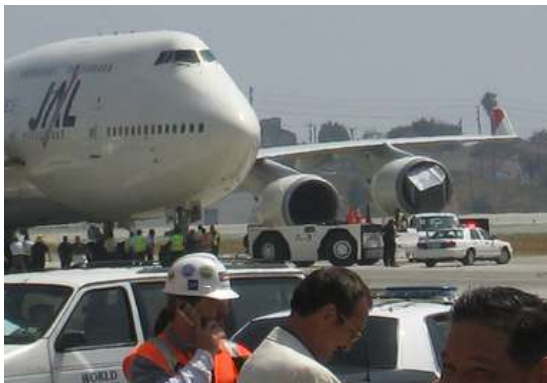
JAL B747 at Los Angeles

米ロサンゼルス国際空港 (Los Angeles International Airport) で離陸準備をしていた日本航空(JAL) のジェット旅客機が 11 日、エンジンに貨物用コンテナが吸い込まれていることが確認され、離陸を中止した。空港管理当局が明らかにした。

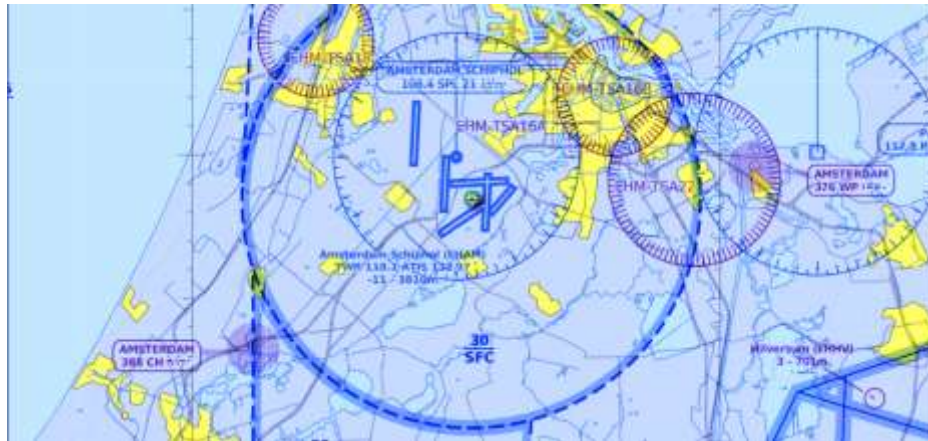
Amsterdam Schiphol Airport

- 28/01/2010 Wamena, Papua, INA, Manunggal Air, Antonov 26B cargo, from Jayapura, overrun rwy, 00/03 crew
- 10/02/2010 Schiphol, Amsterdam Netherland, KLM **took off from taxiway.**
 A KLM Boeing 737-300, registration PH-BDP performing flight KL-1369 from Amsterdam (Netherlands) to Warsaw (Poland), was cleared to take off runway 36C at about 20:36L (19:36Z), however actually took off along the parallel taxiway B. The airplane continued to Warsaw for a safe landing.

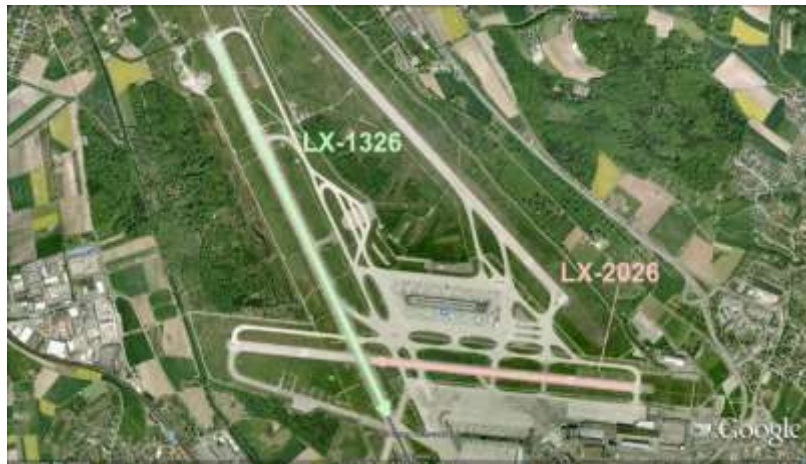
Zurich

The serious incident is attributable to the fact that the **air traffic control officer** concerned gave take-off clearance to an aircraft on runway 28 although another aircraft on runway 16, to which he had given take-off clearance shortly before, was still on its take-off roll. The result was that an **inadvertent convergence of these aircraft occurred**, involving a high risk of collision.

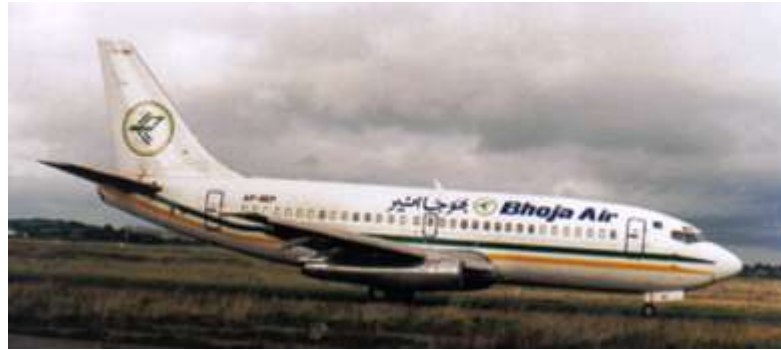
The ineffective automated flight deck management in extreme adverse weather conditions by cockpit crew caused the accident. The ineffective automated flight deck management was due to various factors including; incorrect selection of cockpit crew on account of their inadequate flying experience, training and competence level for B737-236A (advanced version of B737-200 series), absence of formal simulator training in respect of FO for handling an automated flight deck, non-existence of cockpit crew professional competence / skill level monitoring system at operator level (Bhoja Air). The cockpit crew incorrect decision to continue the flight for destination and non-adherence to Boeing recommended QRH and FCOM remedial actions / procedures due to non-availability of customized aircraft documents (at Bhoja Air) for B737-236A contributed towards the causation of accident. **The inability of CAA Pakistan** to ensure automated flight deck variance type training and monitoring requirements primarily due to incorrect information provided by the Bhoja Air Management was also a contributory factor in causation of the accident.
