民間航空機の主な航空事故一覧

Major Air Disasters Involving Commercial Airlines

1937-2025

作成者: 前川 博和(Hirokazu (Mike) Maekawa)

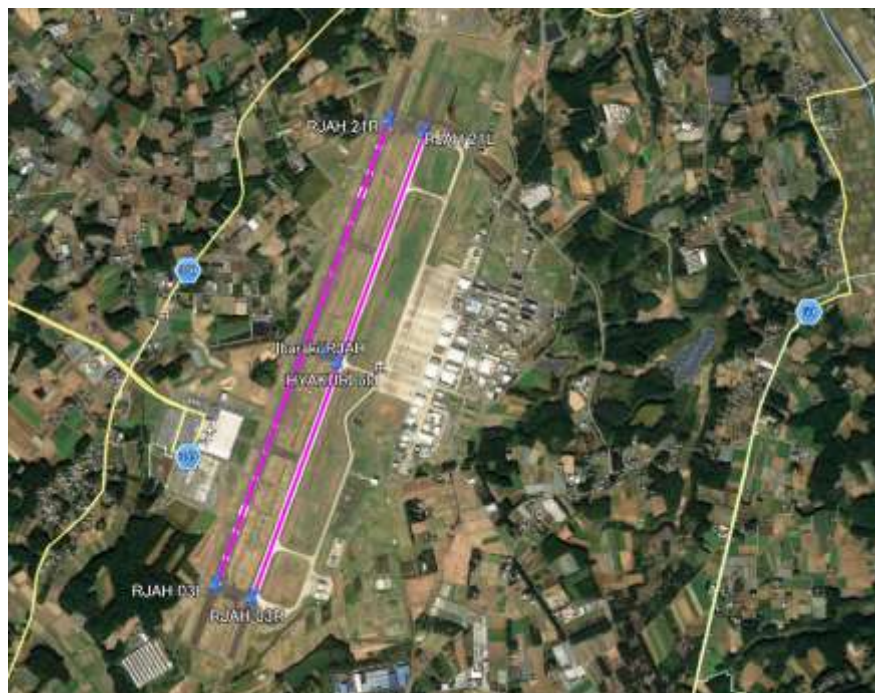
茨城空港(茨城県小美玉市)で今月22日、新千歳(北海道)発茨城行きのスカイマーク794便(乗員乗客142人)が、管制官の指示と異なる滑走路に誤って着陸していたことが28日、同社などへの取材で分かった。当時、滑走路に他の飛行機はなく、乗員、乗客にけがもなかった。同社や国土交通省東京航空局百里空港事務所によると、同便の機長は22日午後5時半頃、管制官が西側の滑走路への着陸を指示したのに、東側の滑走路に着陸した。茨城空港には、ほぼ南北に延びる2本の滑走路(2700メートル)が約210メートル間隔で並んでいる。機長は着陸後、誘導を受ける際に誤着陸に気づいたという。同社は、23日に国交省に誤着陸を報告。同省は事実関係や原因を調査した上で、改めて報告するよう同社に指示した。(2012年4月28日22時54分(読売新聞))

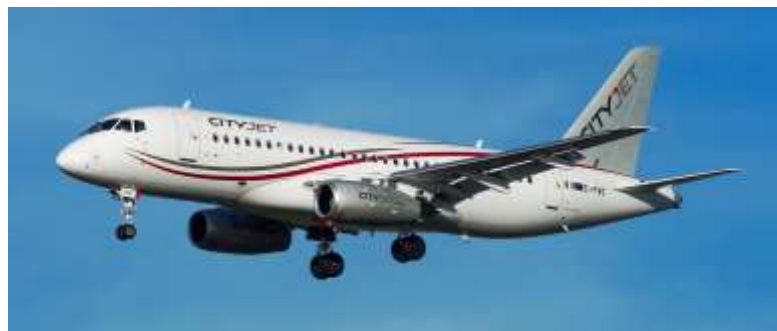
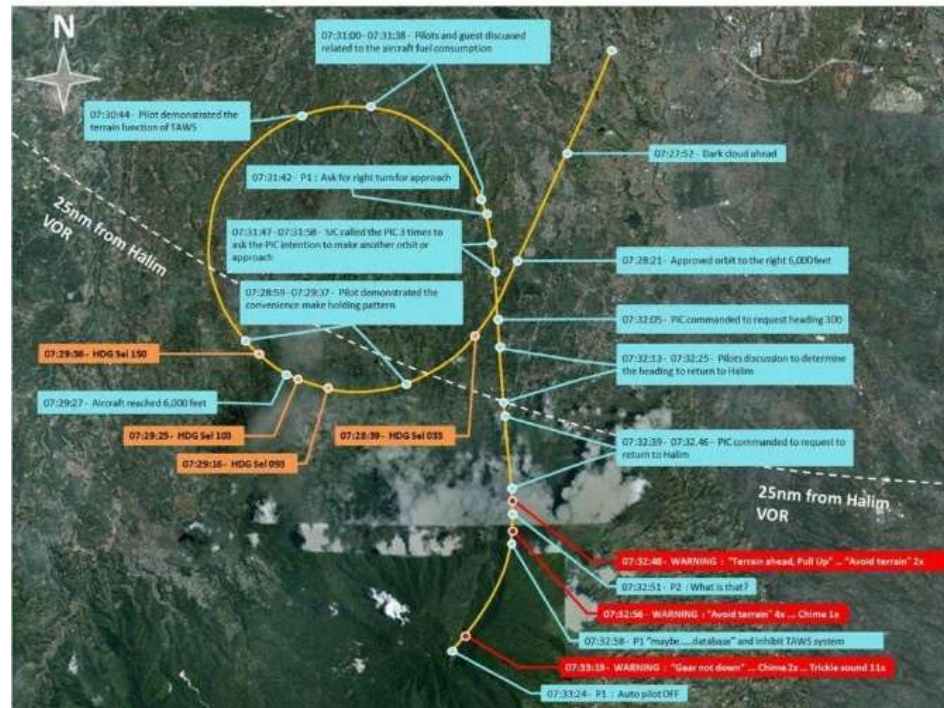
Crash: Sukhoi SU95 over Indonesia on May 9th 2012, aircraft impacted mountain

Sukhoi Superjet 100-95, registration RA-97004 performing a demonstration flight from Jakarta Halim Perdanakusuma Airport to Jakarta Halim Perdanakusuma Airport (Indonesia) with 37 passengers, 6 crew and 2 Sukhoi officials, was enroute near Mount Salak and Bogor about 36nm south of Jakarta about 30 minutes into the flight when the radio contact with the aircraft was lost between 14:21L and 14:33L (07:21Z to 07:33Z). The aircraft did not turn up at Jakarta or any other airport in the area. The aircraft wreckage was found by a helicopter the following morning (May 10th) at about 09:15L (02:15Z) on the slopes of Mount Salak at an elevation of about 5300 feet MSL. On May 11th around 14:00L (07:00Z) rescuers reached the crash site and so far recovered 27 bodies.

The Air Force said the aircraft impacted the edge of a cliff (top of the cliff at 6250 feet MSL) about 1.7 nm from Cijeruk. Approximate final position of the aircraft is S6.7102 E106.7447 (initially reported as S6.7045 E106.7373 but updated on May 11th taking the crash site from the western to the eastern cliff).

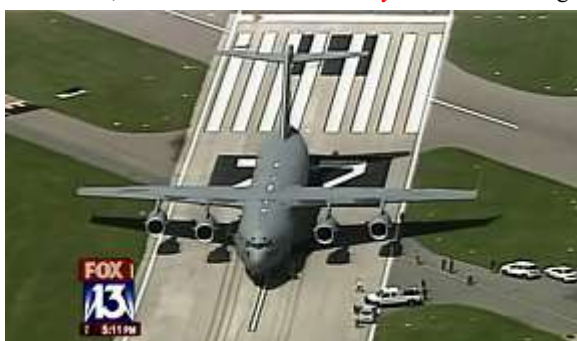
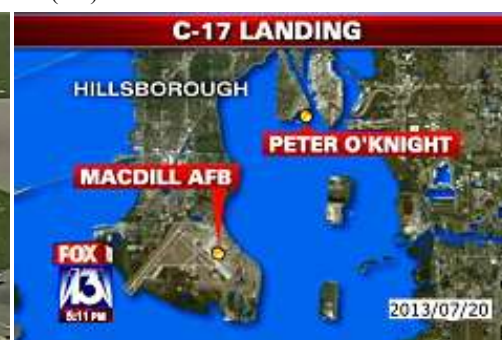
USAF C-17

20/07/2012 USAF C-17, bound for MacDill AFB mistakenly landed at Peter O'Knight Field (TPF)

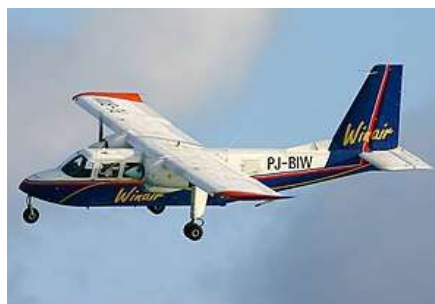
Fly Montserrat Britten-Norman BN2 A Islander, registration VP-MON performing flight 5M-107 from Antigua (Antigua and Barbuda) to Montserrat (Montserrat) with 1 crew and 3 passengers, took off V.C. Bird International Airport's runway 07 at 16:15L (20:15Z), but lost height immediately after becoming airborne and contacted ground nose first. 2 occupants died on the spot, a third initial survivor succumbed to the injuries in hospital, the fourth person is in hospital care in critical condition. The airline confirmed the aircraft crashed shortly after takeoff, one passenger survived with critical injuries, the pilot and 2 passengers died.

A preliminary report released by the East Caribbean Civil Aviation Authority on Oct 13th 2012 states, that the aircraft yawed to the right shortly after becoming airborne and stopped climbing while rolling to the right. The aircraft subsequently lost height and impacted ground right wing tip first at low forward speed and cart wheeled before coming to rest in an upright position. The fuselage section forward of the wing was destroyed, the rest of the aircraft sustained

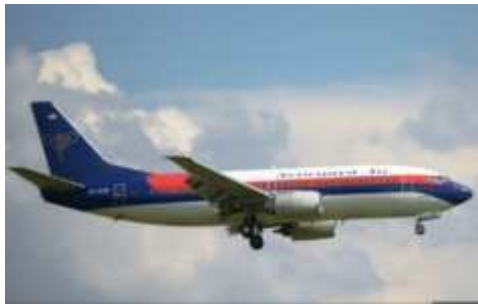
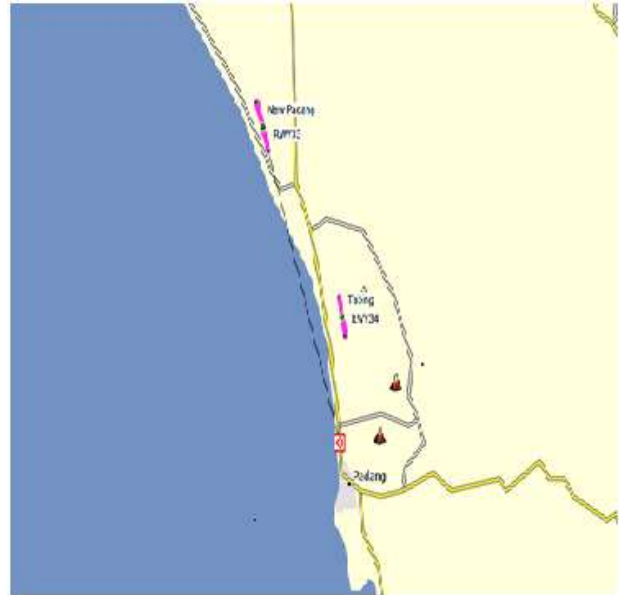
Sriwijaya Boeing 737-400

Sriwijaya Boeing 737-400, registration PK-CKD performing flight SJ-21 from Medan (WIMM) to Padang (WIPT) with 96 people on board, was supposed to land on Padang's new Minangkabau International Airport (WIPT), but landed on Padang's former civil, now only military Tabing Airport (WIMG) about 7nm south of Minangkabau International Airport. The landing at about 17:00L was safe.

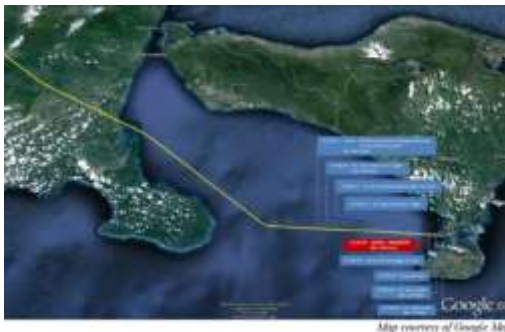
Figure 1: The sequence of events

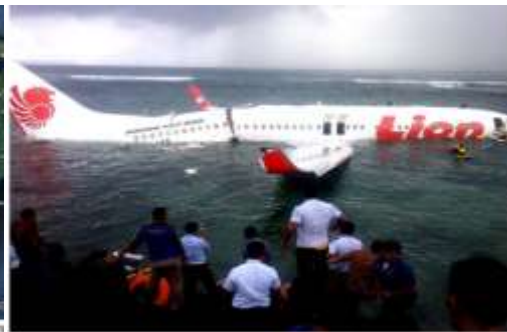
Figure 2: The aircraft after the accident

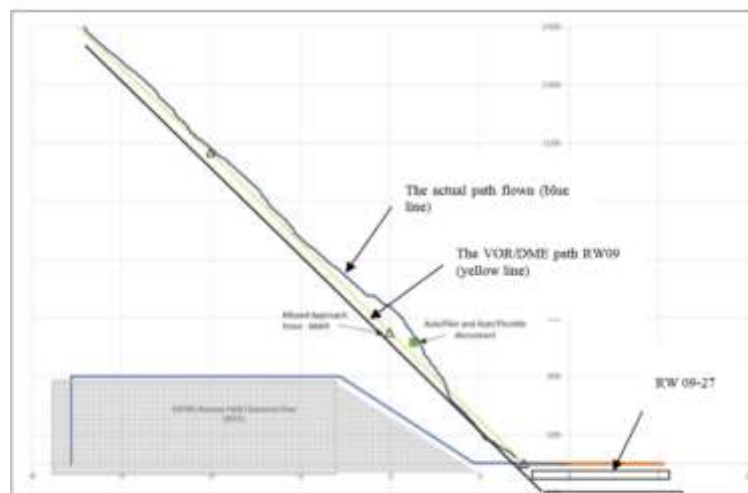
Figure 3: Aircraft flight path with respect to EGPWS envelope

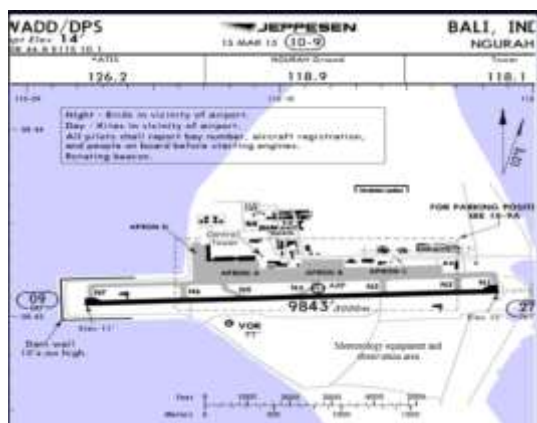
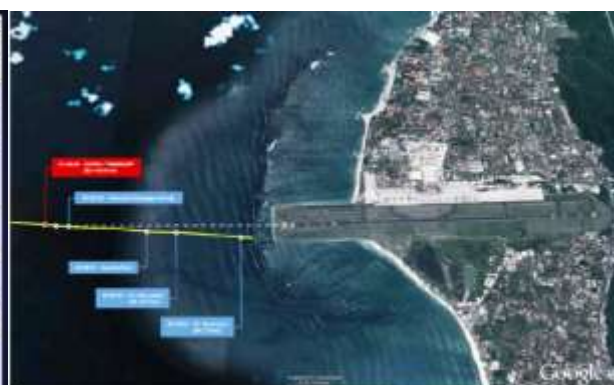
Figure 13: Aircraft flight path superimposed to Google Earth

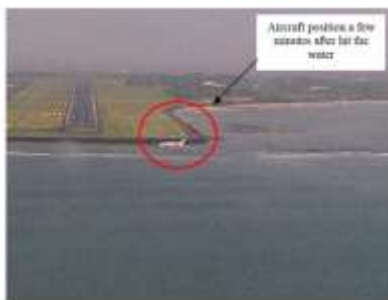
Figure 16: Final aircraft resting position

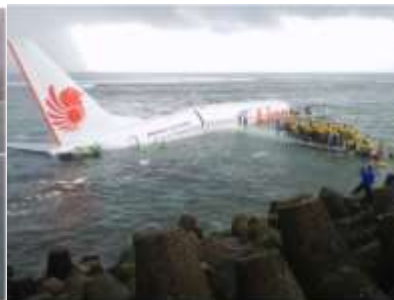
Figure 17: The evacuation process

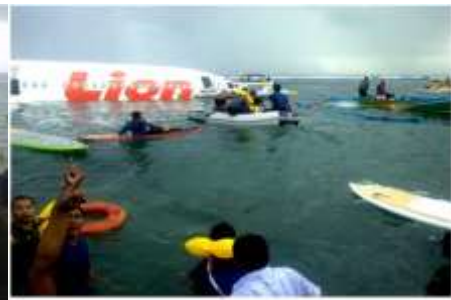
Figure 18: The situation during evacuation process

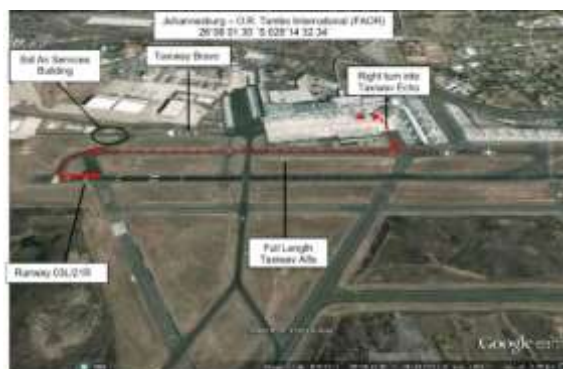
Contributory Factors: The crew did not conduct a briefing to discuss the cleared route, nor did they refer to the correct taxiway information in chart 10-6. In combination with the ground movement visual aids, this created confusion and loss of situational awareness when taxiing on taxiway Bravo.

Figure 1 The expected taxi route which the flight crew discussed during the taxi and take-off briefing session.

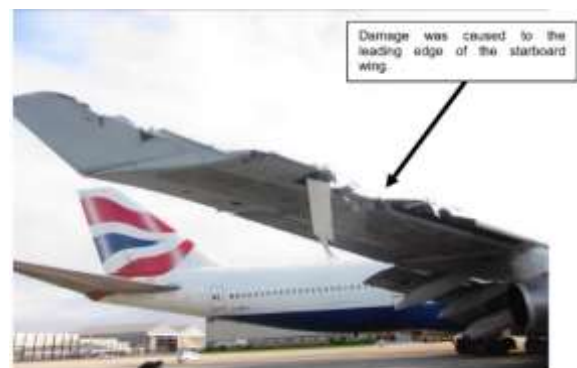
- 22/12/2013 BA B744 at Johannesburg took **wrong taxiway** and buried wing in building, 0/199
British Airways Boeing 747-400, registration G-BNLL performing flight BA-34 from Johannesburg (South Africa) to London Heathrow, EN(UK) with 182 passengers and 17 crew, was taxiing for departure and had been cleared to taxi to holding point runway 03L via taxiway B but missed the turn towards the holding point runway 03L (editorial note: watch the relevant caution on the taxi chart below) and continued on general aviation taxiway M until the right hand wing collided with and sliced an office building. 4 ground staff in the building received minor injuries, none of the aircraft occupants received injuries. The building and aircraft received substantial damage.
Cause: The loss of situational awareness caused the crew to taxi straight ahead on the wrong path, crossing the intersection/junction of Bravo and Mike instead of following Bravo where it turns off to the right and leads to the Category 2 holding point. Following aircraft stand taxilane Mike; they collided with a building on the righthand side of Mike.

Figure 4 Damage caused to the starboard wing of the BA034 aircraft

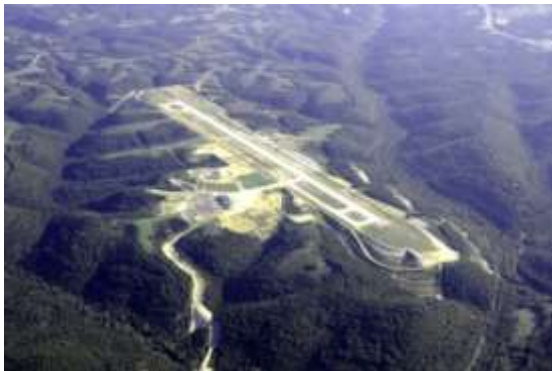
Rwy14/32 (7140ft) Hollister's Branson [KBBG]

Southwest Airlines B737-700, N272WN, WN4013 Chicago Midway, IL to Hollister Branson Airport, MO with 124 passengers and 5 crew, was on approach to Hollister's Branson Airport [KBBG] but managed to touch down on runway 12 of Hollister/Branson's Graham Clark Airport [KPLK] about 5.5nm north of Branson Airport at about 18:11L (00:11Z Jan 13th) and stopped just at the end of the short runway with the main gear on the "piano keys". On Jan 17th 2014 the NTSB reported that the aircraft was piloted by a captain with about 16,000 hours of flying experience and a first officer with about 25,000 hours of flying experience. The captain was on his first approach to Branson Airport, the first officer had flown into Branson one time before however in daylight. Air Traffic Control informed the crew they were 15nm from their destination, the crew advised they had the airfield in sight, and the air traffic controller cleared the flight for a visual approach to Branson's runway 14. The crew did not realize until after landing that they were at the wrong airport. The NTSB collected two hours of good recordings from the cockpit voice recorder and about 27 hours of data from the flight data recorder. In addition to the interviews with the two pilots the NTSB also talked to a Southwest Airlines dispatcher who was occupying the observer's seat. The crew reported they had programmed the approach into the flight management system, however then saw the airport beacon and runway lights that they identified as Branson Airport. They believed to be at Branson Airport until after touchdown when they applied heavy braking to stop the aircraft on the runway, then they radioed Branson Tower that they had landed at the wrong airport.

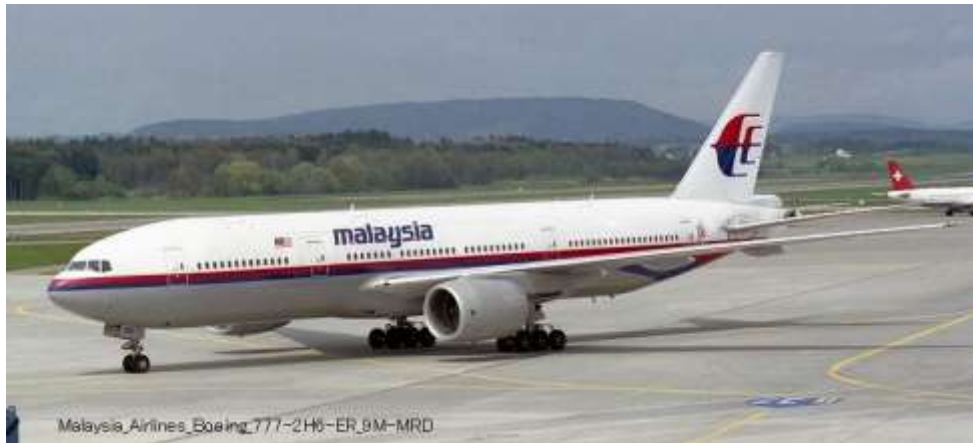
Aircraft destroyed by the incident

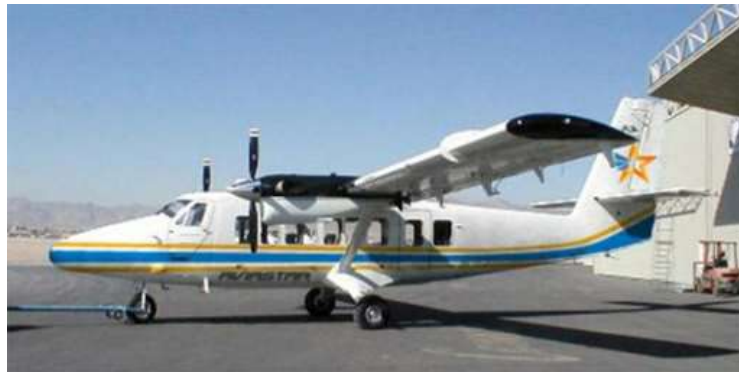
DHC-6

Aviastar Mandiri DHC-6-300 Twin Otter, PK-BRM from Masamba (WAWM) to Makassar with 10 passengers and 3 crew, was enroute at 8000 feet about 60nm before Makassar at about 15:15L (07:15z) when contact with the aircraft was lost.

At 06:50 UTC, the PIC told the SIC that he wanted to climb and the CVR stopped recording. The aircraft impacted treetops and crashed on the top of a mountain at an elevation of 7734 feet. The wreckage was located on Mount Latimojong on October 5. Mount Latimojong is a mountain range with several peaks. One of the peaks is the highest peak of Sulawesi at 3430 m above sea level.

On 5 October 2015, the wreckage was found by ground search team on top of Bajaja Mount, Gamaru, Ulusalu Village, Luwu District,

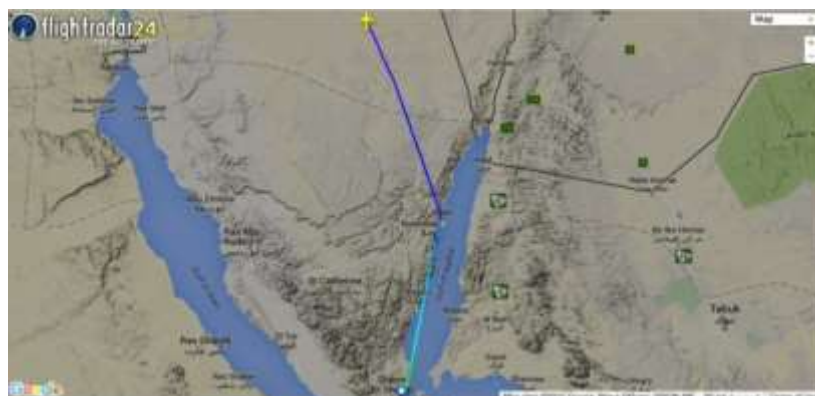
Metrojet (former Kogalym Avia, Kolavia) Airbus A321-200, EI-ETJ, 7K-9268 from Sharm el Sheikh (Egypt) to St. Petersburg (Russia) with 217 passengers and 7 crew, was climbing through FL307 out of Sharm el Sheikh over the Sinai Peninsula (Position N30.16 E34.17, 60nm south of Al-Arish) at 04:12Z when the aircraft disappeared from radar. Wreckage of the aircraft was later located in mountainous terrain about 20nm south of Al-Arish (Sinai, Egypt).

4:13:22z KGL9268 N30.183 E34.161 27925ft 62kts 351mag 6528ft (vertical) AP32000ft

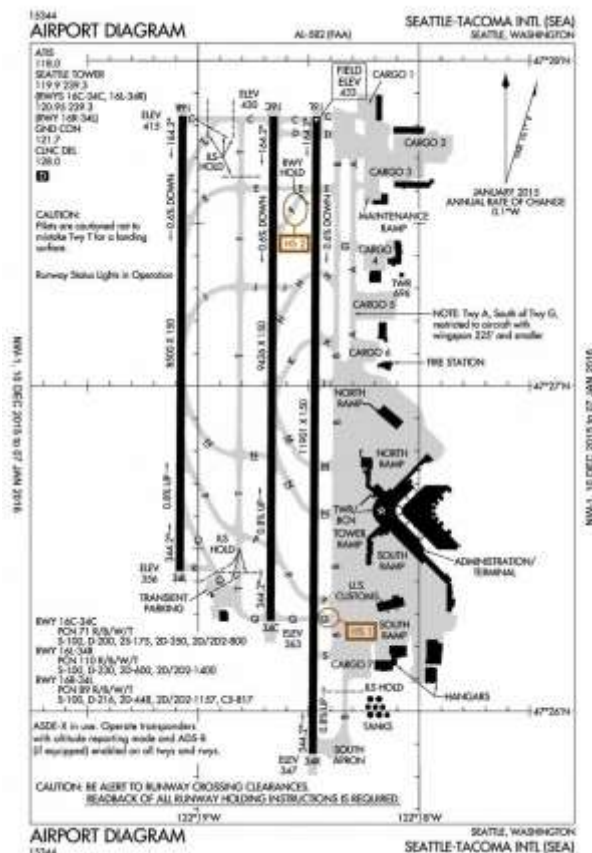
Alaska Airlines B737-900, N477AS, flight AS-27 from Chicago O'Hare, IL to Seattle, WA (USA) with 153 pax on board, was on an ILS approach to rwy 16R cleared to land on rwy 16R, when tower offered a visual swing over to rwy 16C, the crew opted to accept rwy 16C but aligned with taxiway T in between rwys 16R and 16C and continued for a safe landing on taxiway T at 08:31L (16:31Z), no other traffic was on taxiway T at that time. Tower, maintaining routine communication, cleared the aircraft to cross rwy 16L, the crew read that clearance back after a slight hesitation and maintained routine communication, too. On Feb 13th 2016 the NTSB announced that they have opened an investigation into the occurrence rated an incident. At the time of landing visual meteorologic conditions prevailed when the aircraft touched down on taxiway T instead of the intended rwy 16C.

A few points from the FO that was the non flying pilot for that flight... Light rain had just finished, making the rwys wet. With the type of overcast and light conditions, the rwys and T don't have markings at that angle/alt. 16L "hides" in the ramp/terminal view, and 16R, T, 16L look like the 3 rwys. So T looks like

16C. When one is the NFP, going heads down to retune the LOC and reprogram the FMC, ya kinda loose some situational awareness when coming heads up. Officially, there have been only a few landings on T. Unofficially, the FAA understands there have been almost 20 landing on T in half as many years. Opinion: In Toronto's airport, the highly landed taxiway now has obvious paint on it. The cost of painting clear markings on T clearly is too expensive to support safety.

The flight crew inadvertently landed on a taxiway that ran parallel to the intended landing rwy. About 5 miles from the rwy and having been cleared to land on rwy 16R, the tower controller asked if the flight would like to sidestep to rwy 16C which had recently opened. The flight crew accepted and visually lined up with taxiway T, instead of the intended landing rwy 16C. Although visual meteorological conditions were present, the sun was reflecting off taxiway T resulting in the flight crew visually focusing on it during landing. The flight crew and controller did not recognize the error until after landing.

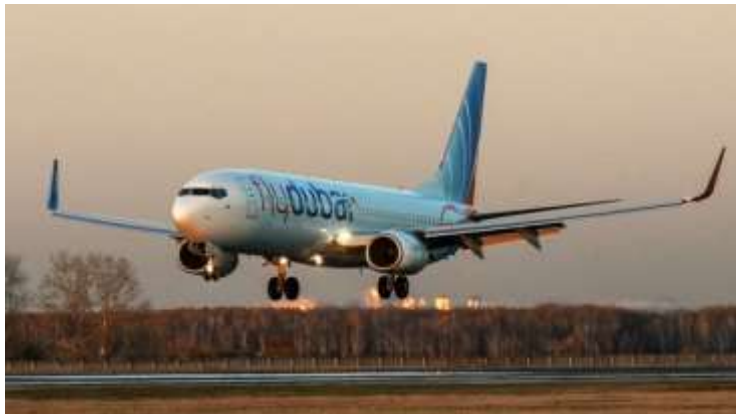
- 19/03/2016 Rostov-on-Don, Russia, Flydubai FZ981, B737, crashed on second apc, struck wing onto rwy after holding for 2 hrs, 62/55+7
 Flydubai B737-800, A6-FDN, FZ-981 from Dubai to Rostov on Don (Russia) with 55 pax and 7 crew, had aborted the approach to Rostov's rwy 22 at 01:41L (22:41Z) due to weather and entered a hold initially at 8000 feet, after 30 minutes at 8000 feet the aircraft climbed to FL150. After about 2 hours of holding the aircraft commenced another approach to Rostov's rwy 22, winds 240/27 knts (14 m/s) +42 knts (22 m/s), but struck a wing onto the rwy at about 3:43 (00:43Z), broke up, came to a rest near the end and to the right of the rwy and burst into flames.

Cause of accident: an incorrect aircraft configuration and crew piloting, the subsequent loss of PIC's situational awareness in nighttime in IMC. This resulted in a loss of control of the aircraft and its impact with the ground.

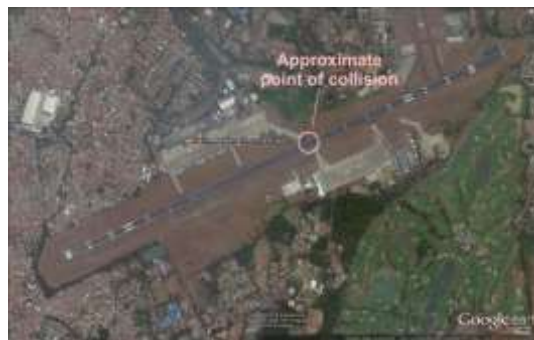
WIIH R/W 06/24

04/04/2016 Halim, INA, Batik B738 and Transnusa AT42, collision on rwy, both aircraft on fire. 0/56
 Batik Air B737-800, PK-LBS, ID-7703 from Jakarta Halim Perdanakusuma to Ujung Padang (INA) with 49 pax and 7 crew, was in the takeoff roll on rwy 24 at 19:55L (12:55Z) when its left wing tip entangled with the vertical tail and left wing of a Transnusa ATR ATR-42-600, PK-TNJ crossing the rwy under tow and separated the most of the vertical tail plane as well as the left wing from the ATR, the left wing tank ruptured open. Both aircraft caught fire. The B737 was evacuated via slides. Fire engines responded and were able to put the fires out in a matter of minutes. No injuries, both aircraft received substantial damage.

On Apr 14th 2016 the French BEA reported based on preliminary information from NTSC Indonesia, that the Batik B737-800 had been **cleared** to enter rwy 24 via taxiway C and backtrack the rwy. In the meantime the tug driver of the Transnusa ATR requested clearance to cross the rwy from the north to the south apron and **received clearance to taxi via taxiway C, rwy 06/24 and taxiway G**. While crossing the rwy the tug driver saw the B737 accelerate for takeoff and attempted to steer the tug and aircraft to the right rwy shoulder, however the left wing of the Boeing collided with the vertical stabilizer and left wing of the ATR. The Boeing rejected takeoff and came to a stop 400 meters past the point of collision.

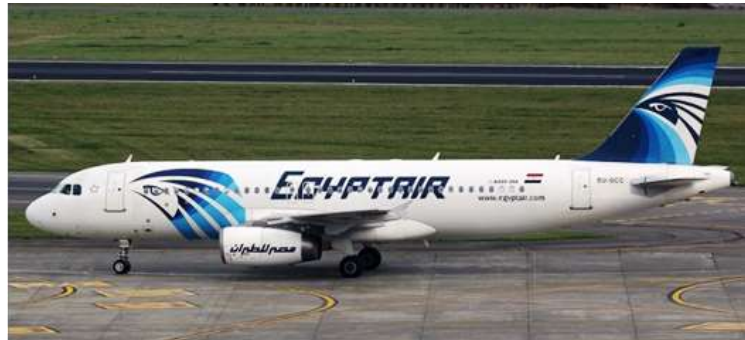
- 19/05/2016 Egypt, Mediterranean, MS804, AB320 LFPG-HECA found crashed, ACARS messages indicate **fire on board, 66/66**
Egyptair A320-200, SU-GCC, MS804 (dep May 18th) from Paris Charles de Gaulle (LFPG) to Cairo (HECA) with 56 pax and 10 crew, was enroute at FL370 over the Mediterranean Sea about 130nm north of Alexandria (Egypt) and about 210nm NNW of Cairo when the transponder signals of the aircraft ceased at 02:33L (00:33Z). The aircraft was located crashed in the Mediterranean Sea, there were no survivors.

2018/07/07 Investigation prolonged: The BEA considers (against Egypt) that the most likely hypothesis is that a fire broke out in the cockpit while the aeroplane was flying at its cruise altitude and that the fire spread rapidly resulting in the loss of control of the aeroplane, thus asking Egypt Investigation Team to expedited works. Later info leaked on 20220503 indicates FO's smoking ignited leaked Oxygen in flight deck might be the cause of fire.

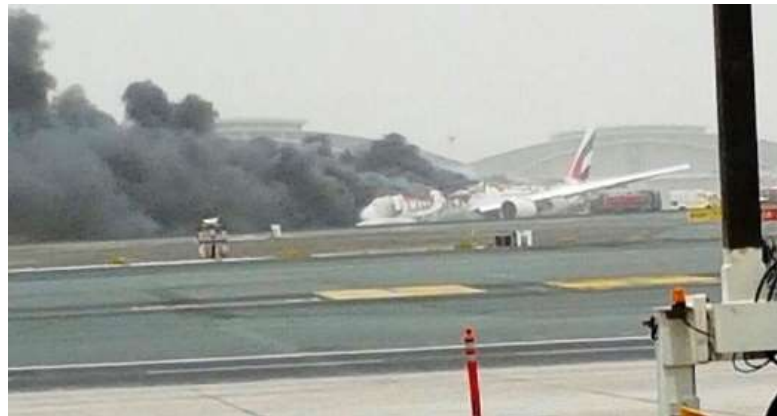
Emirates B773, EK521

gear touched down on the runway and burst into flames. All occupants evacuated via slides, 13 passengers received minor injuries, 10 were taken to hospitals, 3 treated at the airport. The aircraft burned down completely. **A firefighter attending to the aircraft lost his life.**

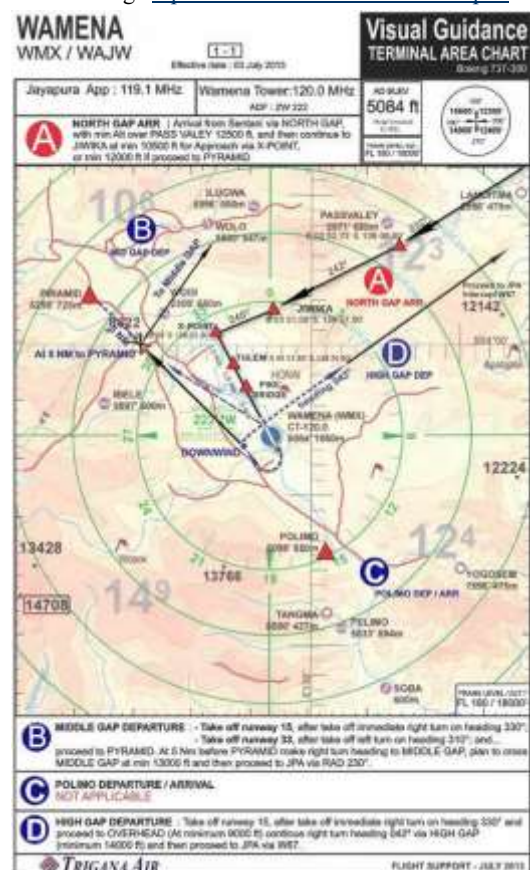
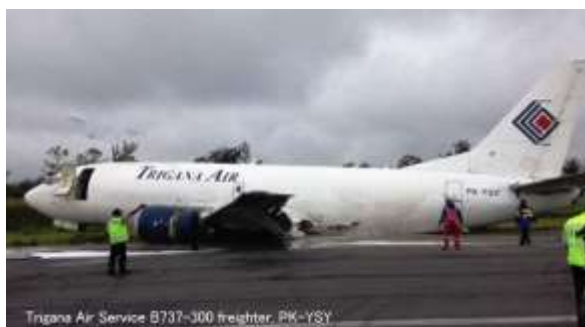
13/09/2016 Wamena, INA, Trigana B733 hard landing results in main gear collapse, 0/3

Trigana Air Service Boeing 737-300 freighter, registration PK-YSY performing flight IL-7321 from Jayapura to Wamena (Indonesia) with 3 crew and 15.3 tons of cargo (fuel, rice, sugar), landed on Wamena's rwy 15 at 07:35L (22:35Z Sep 12th) but touched down and both engines to a halt at and partly beyond the right hand edge of the rwy. There were no injuries, the aircraft sustained substantial damage. <http://avherald.com/h?article=49deac9a&opt=0>

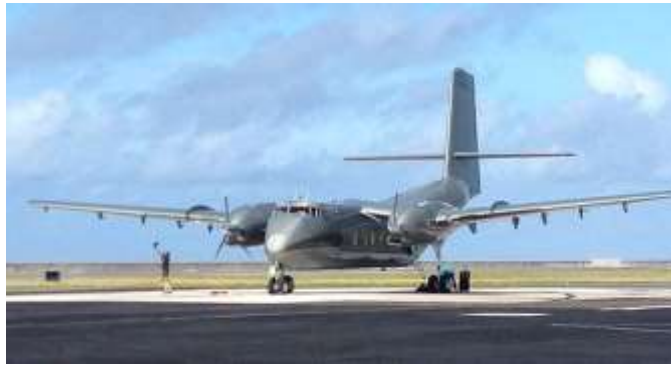
31/10/2016 Timika, INA, Trigana Air Service, de Havilland Canada DHC-4T Caribou cargo PK-SWW, 4/4

De Havilland Canada DHC-4T Caribou cargo plane is reported missing on a flight from Timika to Ilaga, Papua, Indonesia with four crew members on board. The aircraft, owned by the Puncak Regency, carried water-channel construction materials and a cement mixer, weighing 3,130 kilograms in total. The aircraft took off from Timika at 07:57. Last radio contact was at 08:23 when the flight reported at the Ilaga Pass. The aircraft failed to arrive and an ELT signal was detected 40-45 NM from the 060 radial of the TMK VOR. The wreckage of the aircraft was located the next day, scattered on a mountainside at an elevation of 3650 meters, 12 km south of Ilaga Airport. (WABP TIM Timika ICAO: WAYY old: WABP)

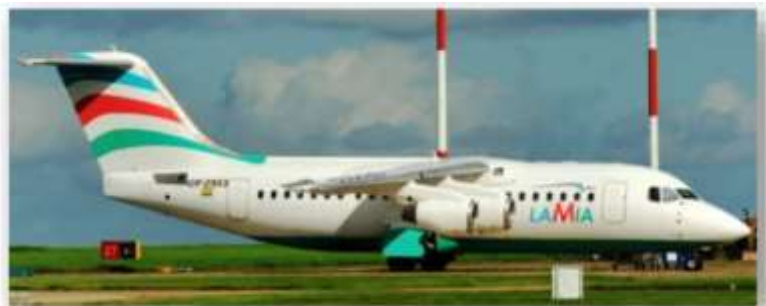
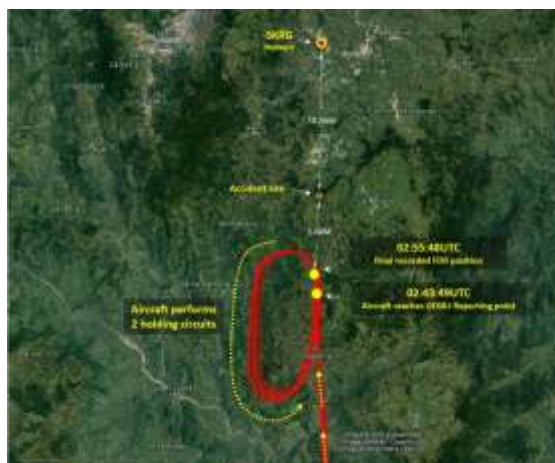
LAMIA Bolivia Avro RJ-85, registration CP-2933 performing flight LMI-2933 from Santa Cruz (Bolivia) to Medellin (Colombia) with 68 passengers and 9 crew, was descending towards Medellin about 15-20nm southeast of Medellin in the area of La Ceja (Colombia) at 21:56L (02:56Z Nov 29th) when the aircraft disappeared from radar screens. The Airport of Medellin reported a search was initiated and the crash site has been located in the municipality of La Ceja at the slopes of Cerro Gordo (main wreckage location N5.9789 W75.4189 190m southsouthwest of the VOR RNG on the north slope of a hilltop, point of first impact at N5.9779 W75.4183 on the southern edge of the hilltop about 290m south of the VOR RNG). Authorities confirmed 6 survivors (3 players, one flight attendant, one mechanics and one journalist) and 71 fatalities. The GRIAA located the main wreckage site at GPS coordinates "N05°58.725 W75°25.138" (N5.9787 W75.4190) about 140m from the point of first impact.

- The four engines shut down in sequence while the aircraft descended towards the holding pattern at GEMLI as result of depletion of fuel.
- Inadequate decision making within the operator's management resulting in lack of assurance of operational safety.

- Loss of situational awareness and inadequate decision making by the crew which maintained their fixation to complete the flight with an extremely limited amount of fuel. The crew was aware of the low level of remaining fuel, however, did not take corrective actions required, e.g. to land at an aerodrome and replenish the fuel.

- Latent deficiencies in the planning and execution of non-regular transportation flights by the operator, in particular insufficient supply of fuel.
- Specific deficiencies in the planning of the accident flight by the operator of the aircraft.

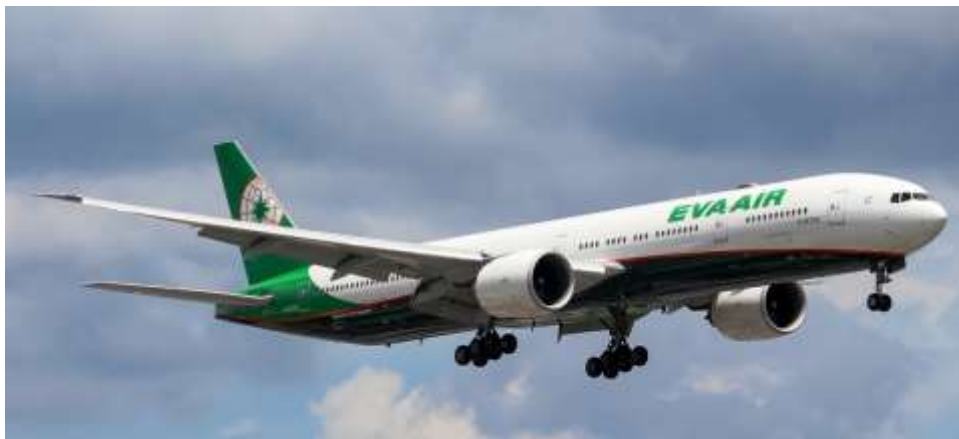
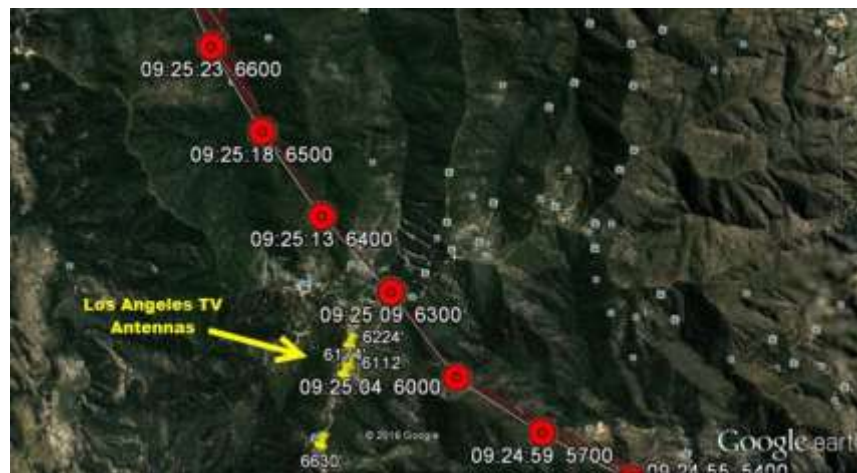
16/12/2016 Los Angeles, CA, Eva B773, ATC instructs turn **left instead of right**, loss of separation, confusion, **Near CFIT**

Eva Air B777-300, B-16726, flight BR-15 (scheduled Dec 15th, actual Dec 16th) from Los Angeles, CA (USA) to Taipei (Taiwan), departed LAX rwy 07R, contacted departure and was instructed to climb to 7000 feet, heading 090. The aircraft was subsequently instructed to climb to 7000 feet and turn left heading 180. The crew correctly acknowledged the instruction and turned left. Shortly after BR-15 an Air Canada Boeing 787-800, C-GHPX performing flight AC-788 (scheduled dep Dec 15th, actual dep 16th) from LAX to Toronto, ON (Canada), departed Los Angeles' rwy 06R, was instructed to climb to 7000 feet and join GABRE departure (which involves a left turn to the north). A conflict arose between AC-788 and BR-15, when BR-15 unexpectedly turned to the north, the controller instructed BR-15 to turn right heading 180. The crew acknowledged turn right heading 180, but continued to turn left. With raised voice the controller instructed BR-15 to stop climb. In an attempt to resolve the situation the controller now instructed **BR-15 to turn left** onto a heading

The incident was caused by the air traffic controller assigning the pilots a left turn instead of the required right turn after departure which placed the aircraft in an unsafe proximity with terrain and obstructions. Contributing to the incident was the air traffic controller's inadequate recovery technique during the development of the incident.

Due to weather in the area, LAX was operating in an east flow configuration with aircraft departing to the east. The B777-300 pilot contacted the SCT controller and was given an initial climb to 7,000 feet. A short time later, the SCT controller instructed the pilot to turn left to a heading of 180 degrees which required a left 270-degree turn. The turn resulted in the aircraft turning toward rising terrain and back toward the airport; normal procedures in an east flow would have been for a right turn to a heading of 180 degrees. While in the left turn, the pilot requested a high-speed climb which resulted in the aircraft accelerating beyond the 250 knot LAX class B speed restriction and required additional airspace in order to complete an assigned turn. After recognizing the aircraft was in a left turn, the SCT controller issued the crew a right turn to a heading of 180 degrees. As the aircraft began to turn right, the air traffic controller instructed the crew to expedite the turn due to recognizing a developing proximity issue with another aircraft that had departed from LAX. The air traffic controller stopped the climb of the B777-300 and issued a left turn to a heading of 270 degrees. These turns in quick succession, combined with the speed of the aircraft, resulted in the flight tracking northbound toward rising terrain. The closest lateral and vertical proximity between the airplane and terrain/obstructions was about 0.3 miles and 0 ft, respectively, which is less than the minimum separation requirements.

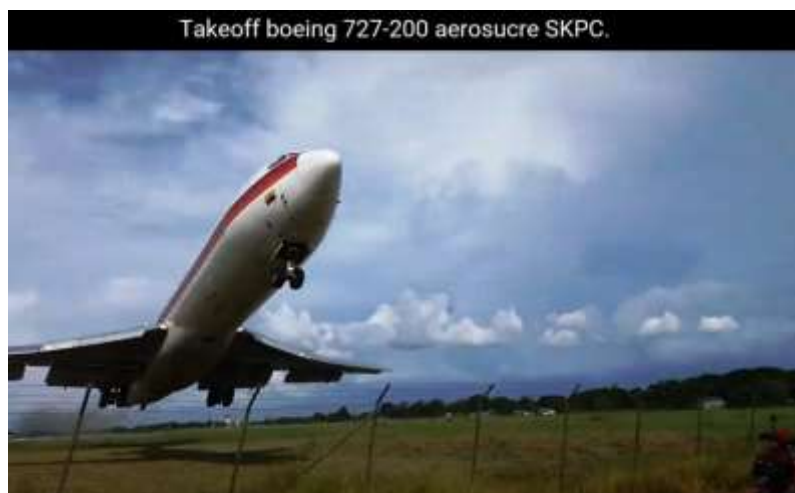
20/12/2016 B727 From Puerto Carreño-Germán Olano Airport (PCR/SKPC), Colombia, crashed after takeoff, 5/6

B727 cargo plane, operated by Aerosucre Colombia, was destroyed when it crashed shortly after takeoff from Puerto Carreño Airport in Colombia. One of the six crew members survived the accident. The aircraft took off from runway 24, a 1780 m long runway, about 17:20. Videos circulating online show the accident aircraft on takeoff. The airplane fails to lift off the runway and crosses the airport perimeter fence and road in a nose up attitude. The aircraft then became airborne and is seen in a right hand turn losing altitude until it impacted flat terrain, bursting into flames. Distance from the end of the runway to the perimeter road is 95 meters. Aerocivil reports the aircraft crashed 10 miles from the airport. A video posted on Youtube in October 2016 shows a takeoff of an Aerosucre Boeing 727 at Puerto Carreño Airport barely clearing the perimeter fence.

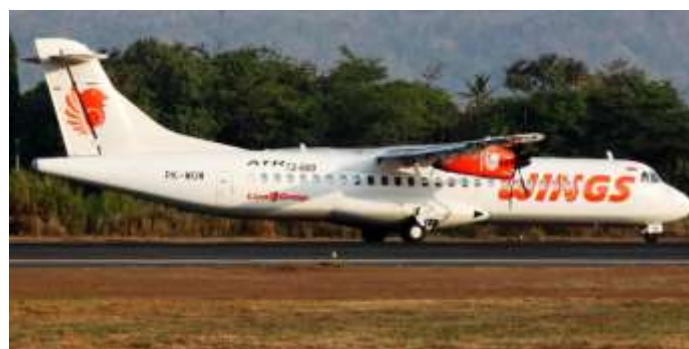
25/12/2016 Semarang, INA, runway excursion, main gear collapse. 0/68

Wings Abadi ATR-72-212A, PK-WGW, IW-1896 from Bandung to Semarang (Indonesia) with 64 passengers and 4 crew, landed on Semarang's runway 13 in rain at about 18:24L (11:24Z), but veered right off the runway and came to a stop with the right main gear collapsed. There were no injuries, the aircraft sustained substantial damage.

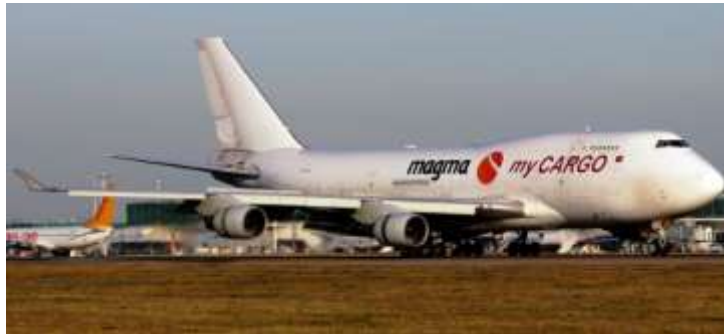
- 16/01/2017 Bishkek, Kyrgyzstan (UAFM), MyCargo B744 impacted terrain on go around, **4/4+35(on grd)=39**
MyCargo Airlines B747-400 freighter on behalf of Turkish Airlines, TC-MCL performing flight TK-6491 from Hong Kong (China) to Bishkek with 4 crew, was on final approach to Bishkek's rwy 26 at 07:18L (01:18z) when the aircraft went around from very low height but did not climb out to safety, impacted terrain about 1100 meters/3600 feet past the rwy end and went through a couple of houses of a village. All 4 crew on board the 747 as well as 35 people on the ground perished, 8 people on the ground received injuries and were taken to hospitals.

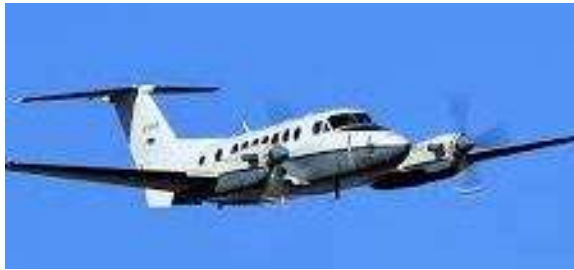
JGSDF LR2 (Super King Air 350)

- 15/05/2017 Hakodate, Japan, **JGSDF LR2** (Super King Air 350) **CFTI**, approx. 33km West of HWE at about 1147L, **4/4**
LR-2 reconnaissance aircraft of Northern Army Aviation Group, Japan Ground Self-Defense Force, carrying four persons, was en route to pick up a patient and is feared to have crashed. The accident airplane lost radar contact at 18 NM west of Hakodate Airport at 3000 feet. The wreckage and four bodies were

found in a forest the next day. Elevation of the accident site is 300 to 400 meters (1000-1300 ft), though the last ATC instruction was 'maintain 3500 feet'. The FDR of the accident plane had removed due to electrical malfunction, however, the CVR was operating at the time of the accident.

防衛省は、今年5月に北海道で自衛隊機が墜落し4人が死亡した事故について、**操縦士の操作ミス**が原因だとする調査結果を公表した。この事故は今年5月、陸上自衛隊のLR2連絡偵察機が北海道北斗市の山中に墜落し、搭乗していた4人の隊員が死亡したもの。調査結果によると、操縦士が誤って自動操縦機能を解除したうえ、それを知らせる警報や表示に気付かず、手動操縦に切り替わったことを認識していなかった。さらに、悪天候で視界が悪い中、機体が山に接近していることを知らせる警報にも気付かず、墜落を手動で回避しなかったという。機体に故障などはなかったとしている。防衛省は、操縦士の訓練などを徹底し再発防止に取り組むとしている。

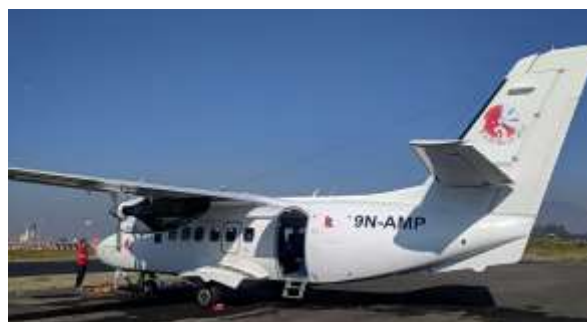
LET L-410

- 27/05/2017 Lukla, Nepal, Summit L410 contacted trees and impacted ground before runway, **2/3**
Summit Air (former Goma Air) Let L-410, 9N-AKY from Kathmandu to Lukla (Nepal) with 3 crew, was on final approach to Lukla's runway 06 at about 14:04L (08:19Z) when the aircraft contacted a tree short of the runway and contacted ground about 3 m/10 ft below the runway level. The aircraft slid down the slope before coming to a rest about 200 meters below the runway level. The captain and the first officer died as result of the accident, another crew member received injuries. Nepali Police reported the aircraft touched branches of a tree, suffered technical problems and impacted ground about 3 m below the runway level just before 14:00L (08:15Z).

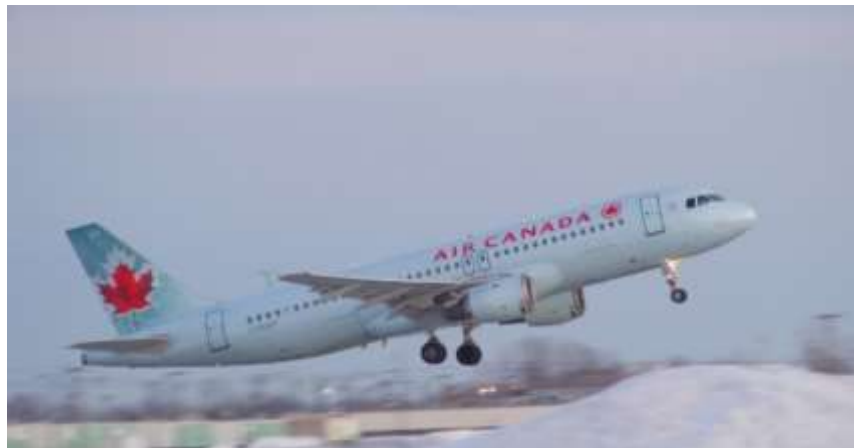
Air Canada A320-200

Air Canada A320-200, C-FKCK, AC-759 from Toronto, ON (Canada) to San Francisco, CA (USA) with 140 people on board, was on final approach to runway 28R in night conditions being cleared to land at about 23:56L (06:56Z Jul 8th), when a short time after reading back the landing clearance the crew queried tower to confirm they were cleared to land advising they were seeing lights on the runway, tower advised the runway was clear and they were cleared to land indeed. Another voice chimed in calling they were lined up with the taxiway, tower immediately instructed AC-759 to go around as result commenting it looked like they were lined up for taxiway C. The aircraft went around from below 100 feet AGL. Other flight crew taxiing their aircraft on taxiway C commented the A320 was flying straight over them. The A320 positioned for another approach and landed safely about 15 minutes later.

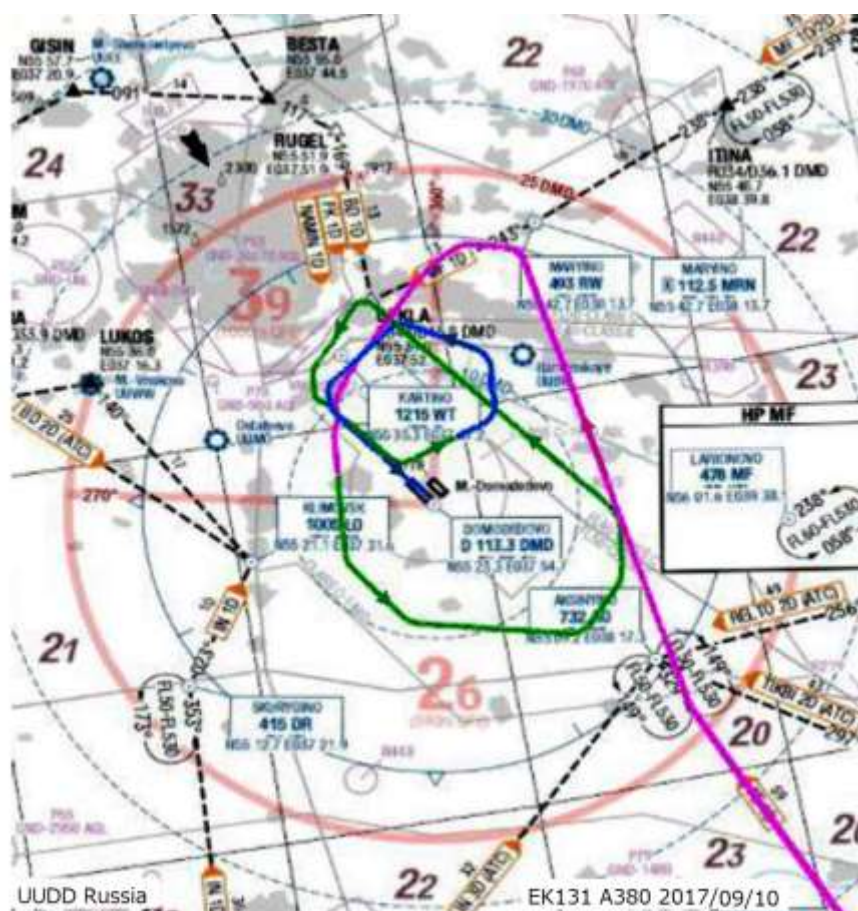
Incident Report: by UAE GCAA

UAE General Civil Aviation Authority (GCAA) reports: during approach to UDD, the aircraft was cleared for the rwy 14R ILS approach when it was on the base leg. The aircraft descended below its cleared altitude of 500m QFE prior to establishing on the localizer. The Radar Controller alerted EK131 to stop the descent. The flight crew then performed a go-around and requested vectors for a second approach. During the go-around, the minimum radio altitude reached was 395 ft above ground level, and EGPWS “Glideslope” and “Terrain Ahead - Pull Up” alerts were activated.

The flight crew flew one go-around and one discontinued approach and landed on runway 14R from the third approach. The go-around, discontinued and landing are shown in figure above. The trajectory in magenta depicts the first approach and go-around, the green line illustrates the second approach and discontinued approach, and the third approach and landing is shown by the blue line.

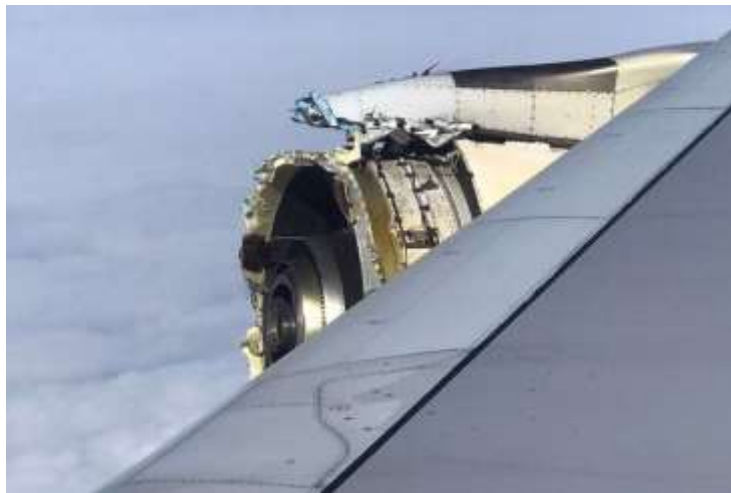
01/10/2017 AF66 CDG-LAX diverts - **uncontained engine failure** over Atlantic, no pax & crew injury.

A388 F-HPJE operating from Paris-CDG to LAX as AFR 066 diverted to YYR (Goose Bay) due to in-flight engine N°4 problem

uncontained engine failure

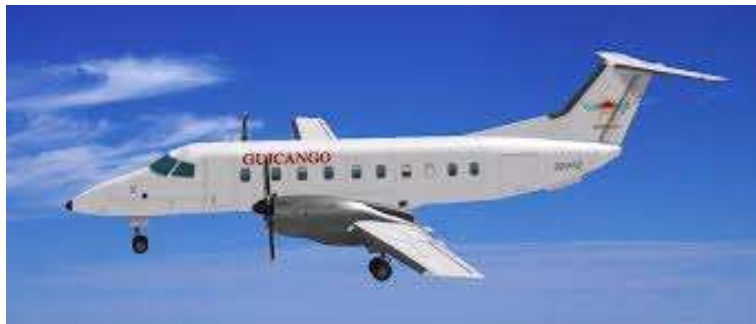
EMB-120

12/10/2017 Near Dundo (Angola), Air Guicango EMB-120, D2-FDO charter flight Dundo-Luanda (Angola) with 4 pax and 3 crew, was enroute about 15 minutes into the flight when the crew declared emergency reporting an engine (PW118) failure followed by fire. About 20 minutes after departure radio contact was lost, the aircraft was found the following day, there were no survivors. **77**

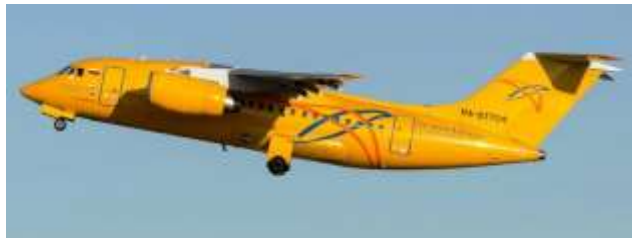
AN-148-100

- 11/02/2018 Moscow, Domodedovo (UUDD), Russia, Saratov AN148 lost height after departure, pitot heatings off, **71/65+6**
Saratov Airlines AN-148-100, RA-61704, 6W-703 from Moscow Domodedovo to Orsk (Russia) was climbing out of Moscow's rwy 14R when the aircraft reached an altitude of 6000 feet then descended and disappeared from radar at about 14:28L (11:28Z). The aircraft was subsequently found crashed at N55.3 E38.41.

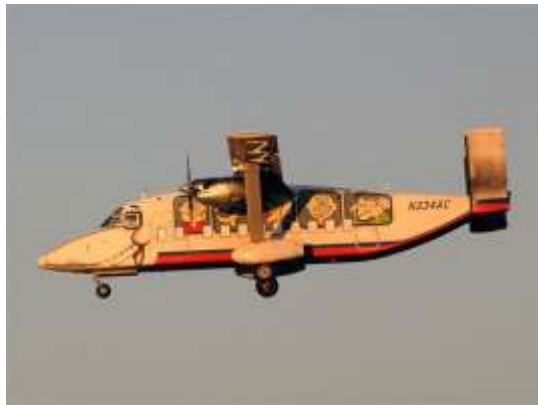
- 29/04/2018 Nha Trang, Vietnam, Vietnam A321, **landed on rwy under construction.**
- 05/05/2018 Charleston KCRW Short-33, wing tip strike on landing **2/2**
Air Cargo Carriers Short SD-330 on behalf of UPS, N334AC, flight 2Q-1260 from Louisville, KY to Charleston, WV (USA) with 2 crew, performed a VOR-A approach to and was on final approach to Charleston Chuck Yeager Airport's rwy 05 at 06:53L (10:53Z) when the aircraft impacted the rwy with its left wing and went down the hill to the left of the rwy located on top of the hill. The aircraft was destroyed. Both crew perished in the crash.
On May 7th 2017 Officials reported the male captain (47) and female first officer (31) have been identified. The families have been informed. (Johnathan Pablo Alvarado, 47, of Stamford, Texas and Anh K. Ho, 31, of Cross Lanes were killed Friday morning after their Short 330 twin-engine turbo plane crashed during landing at Yeager Airport, according to a news release from the airport.)

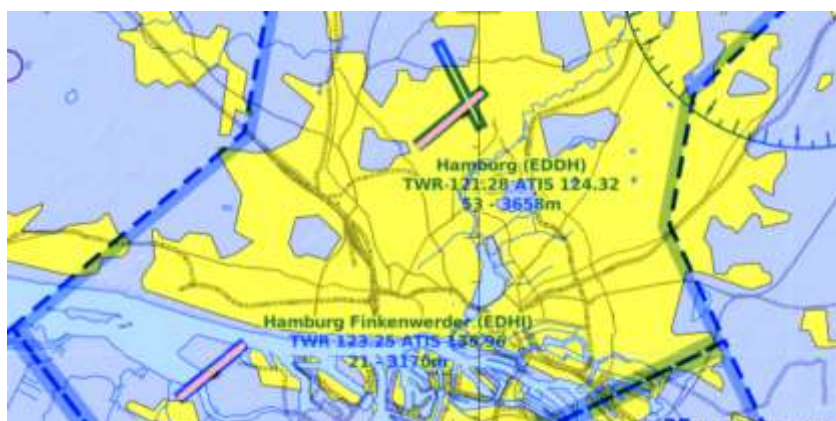
EDDH and EDHI airports in Frankfurt, Germany

- 11/05/2018 Vueling A320 at Hamburg ATC prevents landing on **wrong airport**
Spanish LCC Vueling A320-200, EC-KDG, VY-1820 Barcelona, SP (Spain) to Hamburg Fuhlsbüttel (フールスビュッテル), was on approach to Hamburg's International Airport **Fuhlsbüttel (EDDH)**. ILS for rwy 05 as well as NDB approach were out of service, the approach minima had been raised due to obstacles near the rwy 05. Aircraft were cleared for RNP approaches to rwy 05, the Vueling crew however performed a visual approach to rwy 05 and lined up with **Finkenwerder (フインケンヴェルダー: EDHI)** rwy 05 (about 15km away).
ATC intervened, instructed the crew to turn left and not to descend. The crew shifted their flight path slightly to the left, climbed 200 feet, **now aligned with the rwy 05 of Fuhlsbüttel** and continued for a safe landing on the correct rwy.

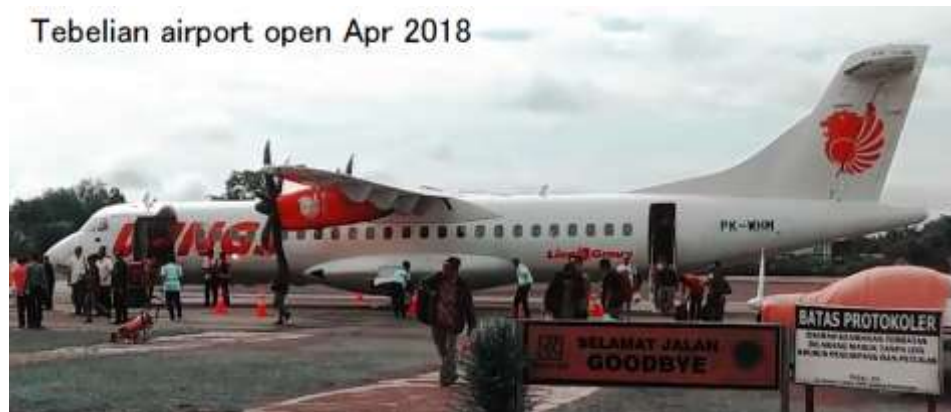
Wings Air ATR-72-212A

- 19/06/2018 Sintang, Kalimantan, INA, Wings AT72 at Sintang on Jun 19th 2018, landed at wrong airport
Wings Air ATR-72-212A, PK-WHF, IW-1370 from Pontianak to Sintang Tebelian (WOS Indonesia), landed safely on Sintang's former Susilo Airport. Susilo Airport had been in use until April 26th 2018. On April 26th 2018 00:00Z (07:00L) the new Tebelian Airport (rwy 09/27 length 1660 meters) located about 11km south replaced Susilo Airport (rwy 08/26 length 1300 meters) maintaining the ICAO and IATA identifiers of Susilo Airport, Susilo Airport was shut down. (Old Sintang Sisulo: N0.063619E111.473428)
