民間航空機の主な航空事故一覧

Major Air Disasters Involving Commercial Airlines

1937-2025

作成者: 前川 博和(Hirokazu (Mike) Maekawa)

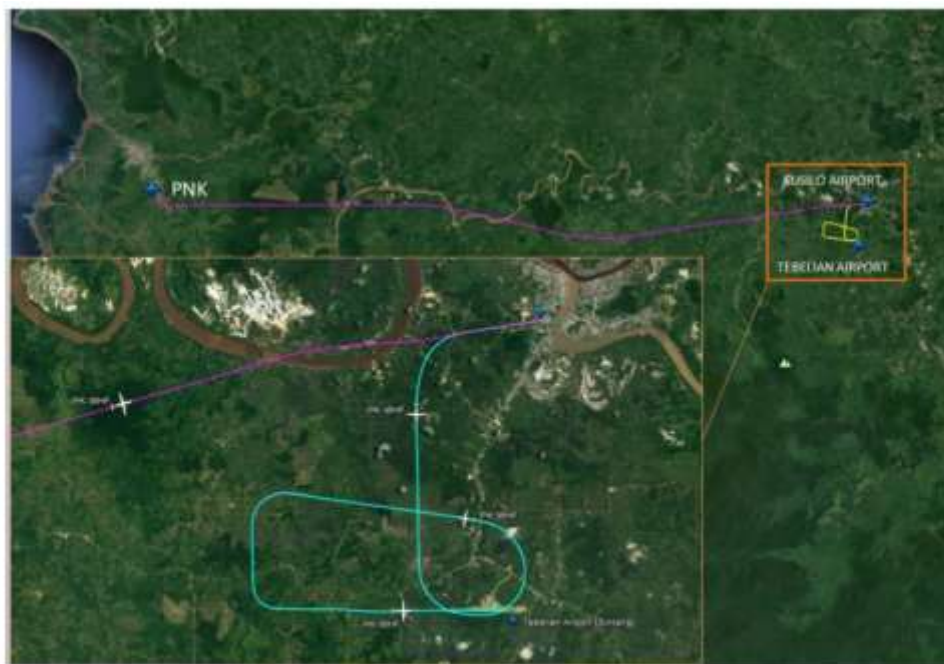
- 19/06/2018 Sintang, Kalimantan, INA, Wings AT72 at Sintang on Jun 19th 2018, landed at wrong airport
Wings Air ATR-72-212A, PK-WHF, IW-1370 from Pontianak to Sintang Tebelian (WOS Indonesia), landed safely on Sintang's former Susilo Airport. Susilo Airport had been in use until April 26th 2018. On April 26th 2018 00:00Z (07:00L) the new Tebelian Airport (rwy 09/27 length 1660 meters) located about 11km south replaced Susilo Airport (rwy 08/26 length 1300 meters) maintaining the ICAO and IATA identifiers of Susilo Airport, Susilo Airport was shut down. (Old Sintang Sisulo: N0.063619E111.473428)

Figure 2: The flight track as recorded on the FDR. Purple line indicated the flight from Pontianak to Susilo Airport, and the blue line indicated the flight from Susilo Airport to Tebelian Airport.

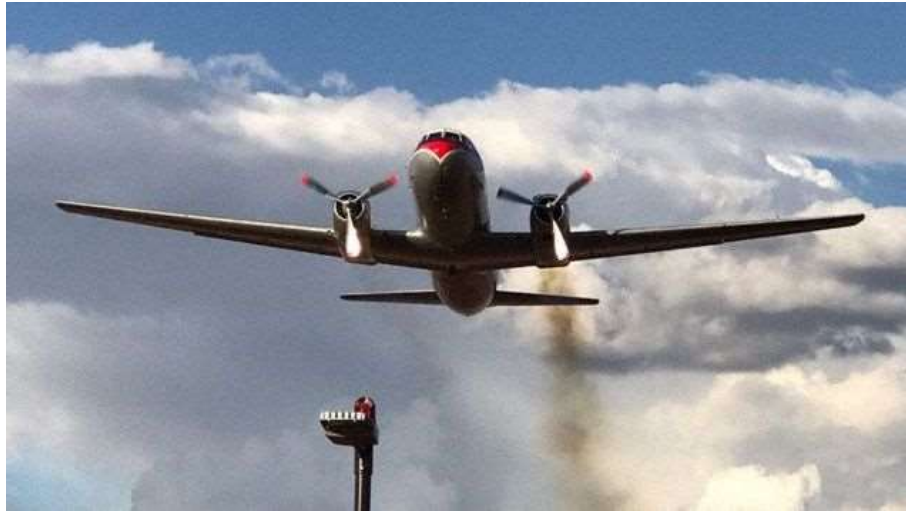
Convair CV-340

- 10/07/2018 Pretoria, South Africa, Rovos Rail CVLP, engine problem, **1/19+1 on gnd**
Rovos Rail Tours Convair **CV-340** in MAC Martin's Air Charter colours, registration ZS-BRV performing a test flight from Pretoria Wonderboom to Pilanesberg (South Africa) with 4 crew and 15 passengers, was climbing out of Wonderboom's rwy 29 when ground observers observed smoke from the left-hand engine, the aircraft appeared to not climb anymore, estimated height was about 300 feet. The aircraft appeared to maneuver to join a right downwind and turn for final when it lost height, impacted and broke through an industrial building and came to rest about 5.7km/3.1nm east of the airport at position

S25.6711 E28.2838. About 20 people on the aircraft and on the ground received injuries, the flight engineer received critical injuries and subsequently died, three other people - reportedly including the pilots - received serious injuries.

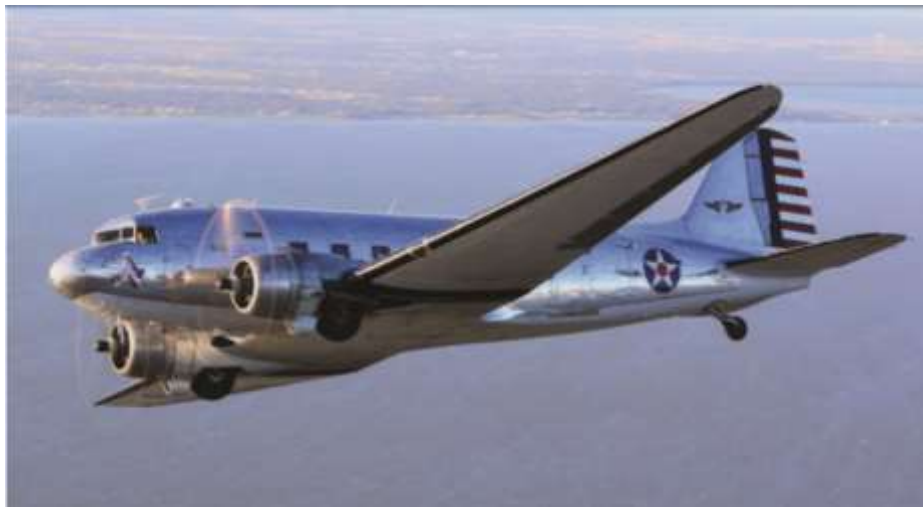
Commemorative Air Force, Highland Lakes Squadron C-47B (DC-3)

21/07/2018 Burnet Municipal Airport, Texas, USA. Douglas C-47, named "Bluebonnet Belle", was involved in an accident during takeoff. The aircraft came to rest in the grass next to the runway and burst into flames. The captain, crew chief, and 4 passengers sustained serious injuries, 1 passenger sustained minor injuries, and the co-pilot and 5 passengers were not injured. The destroyed aircraft was to be flown to a fly-in at Oshkosh, Wisconsin.

Examination of the accident site revealed that the airplane came to rest upright on a heading of about 113° magnetic, about 145 ft east of the left side, and 2,638 ft from the approach end of runway 19. The postimpact fire consumed the fuselage from the nose cone aft to about 3 ft forward of the left side cargo door along with a majority of the wing center section.

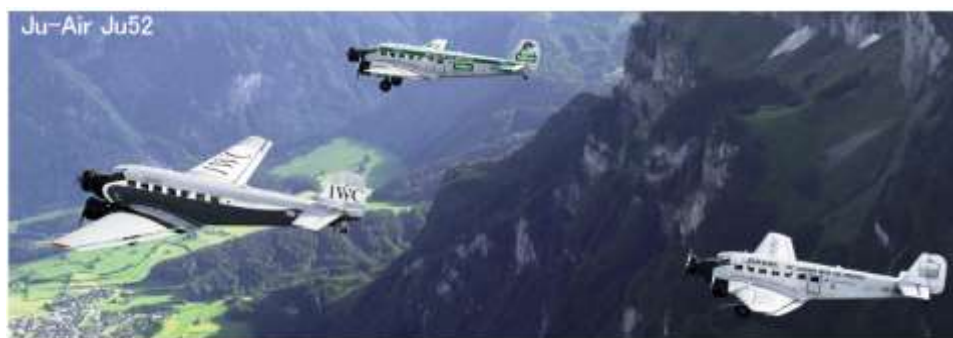
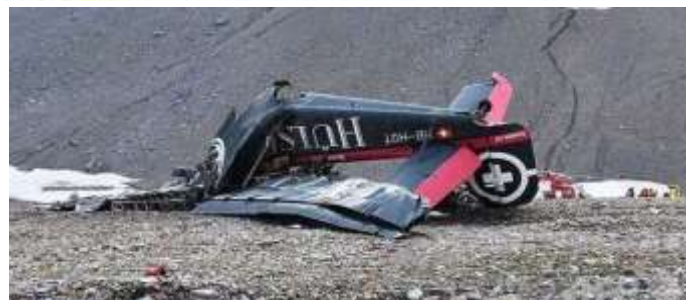
HB-HOT crashed

Ju-Air Junkers JU-52 ("Tante Ju", "Auntie Ju"), HB-HOT performing a flight from Locarno to Dubendorf (Switzerland) with 17 pax and 3 crew, impacted terrain near N46.9022 E9.2247 and came to rest at an elevation of about 2540m/8330ft near Martinsloch/Piz Segnas (Switzerland) at about 16:50L (14:50Z). No survivors have been located.

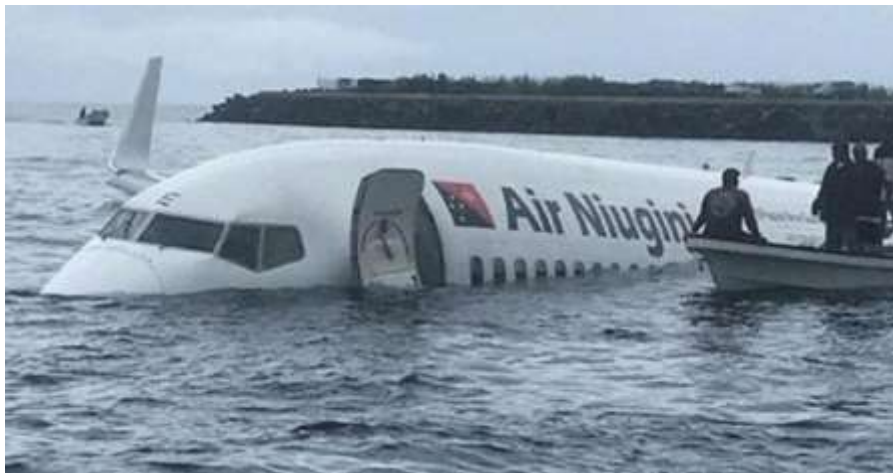
- 28/09/2018 Chuuk, (カキツのトラック諸島) Federated States of Micronesia, Niugini B738 touched down in **sea** short of runway, 1/35+12

Air Niugini B737-800, P2-PXE PX-73 Pohnpei to Chuuk (Micronesia) with 35 pax and 12 crew, was on final approach to Chuuk's runway 04 in poor weather when the aircraft came too low and touched down into the sea and came to a stop about 150 meters left abeam of runway threshold.

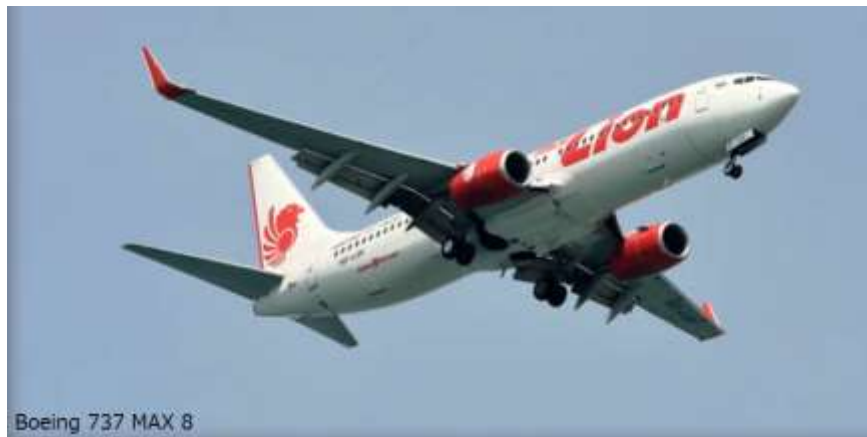
On Monday 29 October 2018 at 0631z a Lion Air B737 MAX 8, PK-LQP, lost height and crashed into Java Sea, 15 km (9.4 mls) N off Tanjung Bungin, Indonesia. The flight departed Jakarta-Soekarno-Hatta International Airport (CGK/WIII), to Pangkal Pinang Airport (PGK/WIKK), Indonesia. The aircraft is commanded by Captain. Bhavye Suneja and co-pilot Harvino with six cabin crew Shintia Melina, Citra Noivita Anggelia, Alviani Hidayatul Solikha, Damayanti Simamata, Mery Yulianda, and Dery Maula. The captain (Indian national) has 6,000 flight hours and the co-pilot (Indonesian) has more than 5,000 flight hours.

The Aircraft Flight Maintenance Log (AFML) recorded that since October 26, 2018 until the occurrence date several problems occurred related to airspeed and altitude flags that appeared on the captain's (left) Primary Flight Display (PFD) on three occasions, SPEED TRIM FAIL light illumination and MACH TRIM FAIL light illumination that occurred twice.

Several attempts were made by engineers to rectify these issues. The day before the accident the Angle of Attack (AoA) sensor was replaced by engineers at Denpasar Airport. During takeoff from Jakarta, the DFDR recorded a difference between left and right Angle of Attack of about 20° which continued until the end of the recording. During rotation of the aircraft, the left control column stick shaker activated and continued for most of the flight. After the flaps were retracted, the FDR recorded automatic aircraft nose down (AND) trim for 10 seconds followed by flight crew commanded aircraft nose up (ANU) trim.

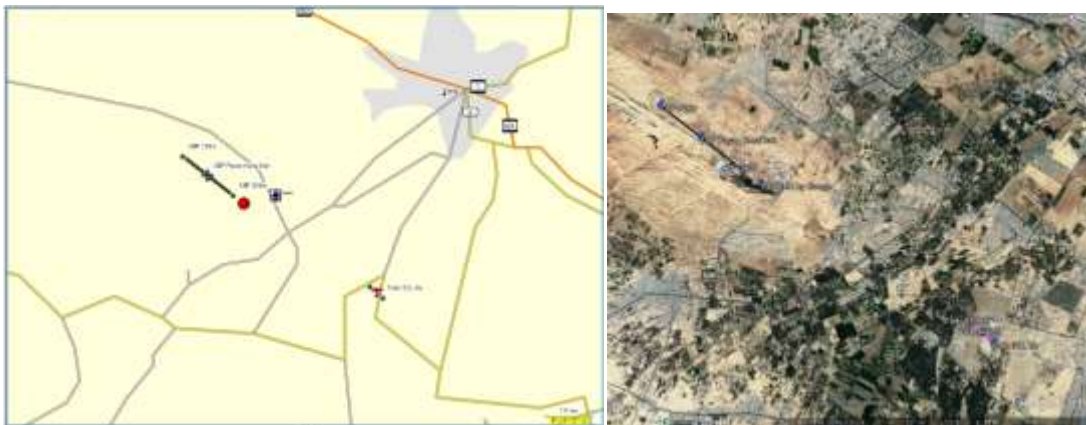
16/11/2018 Taban MD88 at Karaj on Nov 16th 2018, went around from very low height (3ft agl) at **wrong airport**

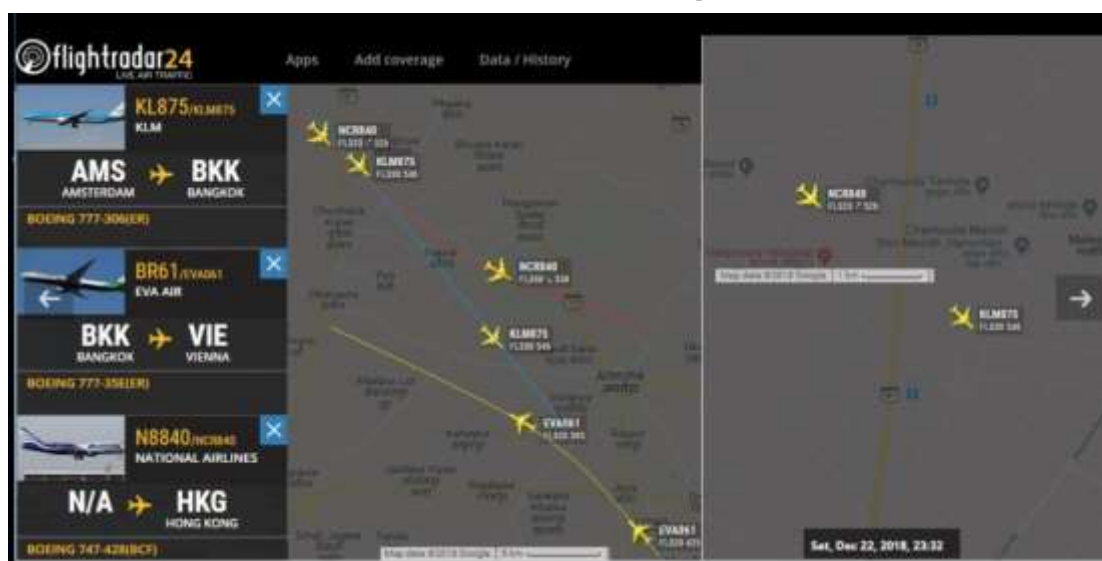
Location: N28 59 35.3 E78 18 57.3 at Dec 23 in India (but Dec 22 2332Z)

23/12/2018 BOBCAT L509 near New Delhi NAC B744 climbed without ATC clearance, loss of separation with KLM875 and BR61

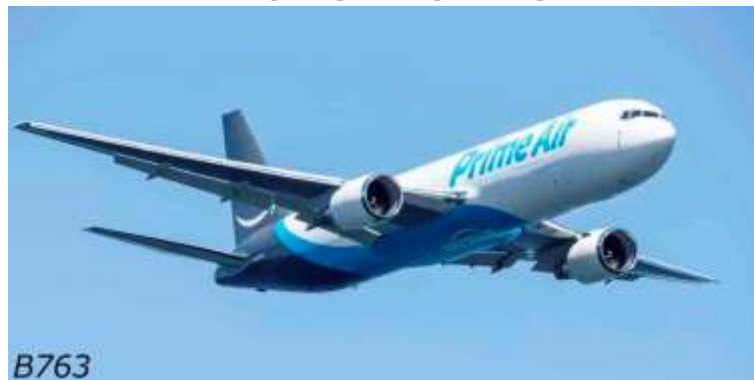
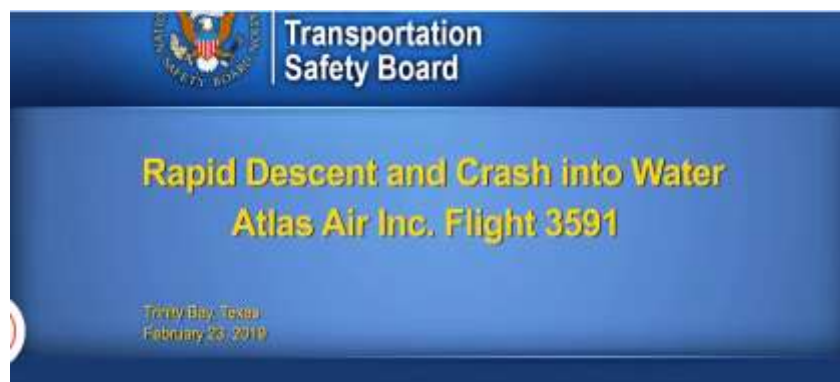
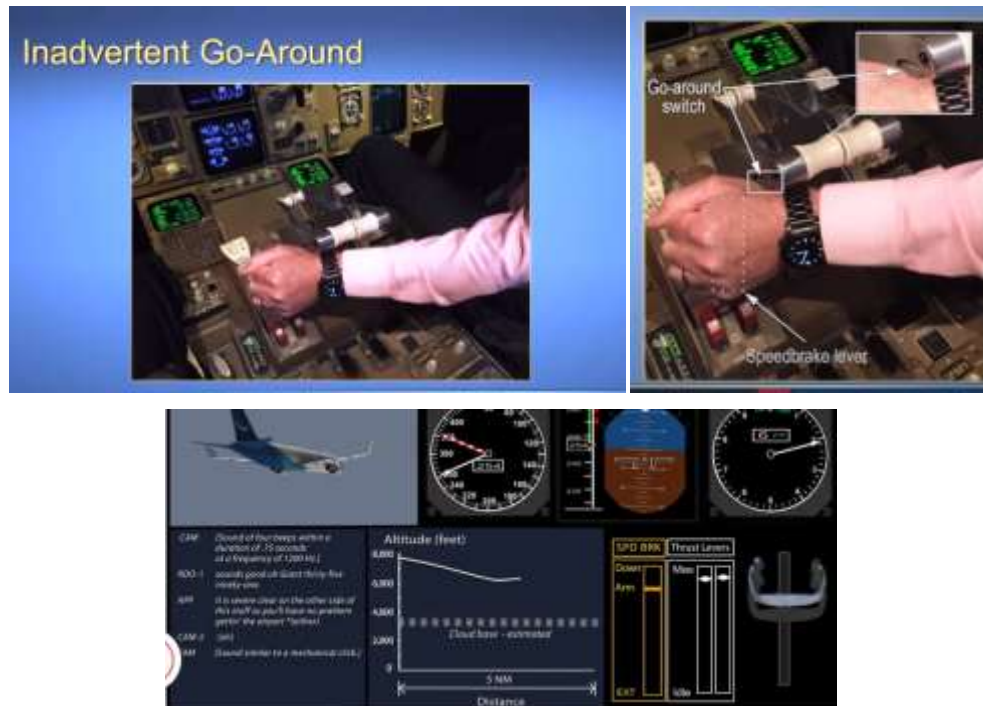
- 23/02/2019 Houston, TX, USA, Atlas B763 carrying Amazo Cargo lost height on approach. 3/3, Human Error (Somatogravic illusion)
B763 cargo aircraft with 3 crew, was on approach to Houston in contact with Houston Approach, routine communication, when radio and radar contact with the aircraft was lost about 30nm southeast of Houston Intercontinental Airport at about 12:40L (18:40Z). The aircraft was found near position N29.7636 W94.7145 having impacted the waters of Trinity Bay about 1.5nm northwest of Anahuac's Bayside Community Hospital. NTSB determines that the probable cause of this accident was the **inappropriate response by the first officer** as the pilot flying to an **inadvertent activation of the go-around mode**, which led to his spatial disorientation and nose-down control inputs that placed the airplane in a steep descent from which the crew did not recover.

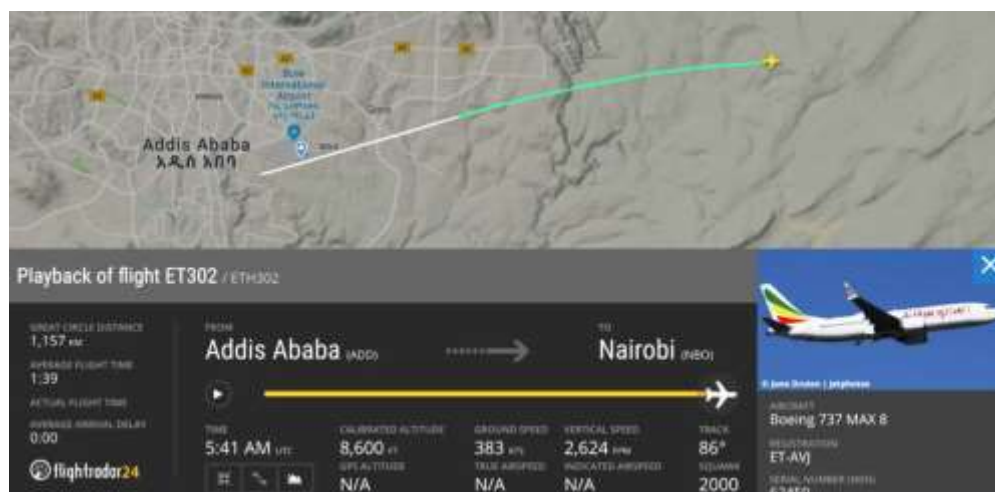
10/03/2019 Addis Ababa, Ethiopia, Ethiopian B38M near Bishoftu impacted terrain after departure, **157/149+8crew**.

Ethiopian **B737-8 MAX**, ET-AVJ flight ET-302 from Addis Ababa (Ethiopia) to Nairobi (Kenya) with 149 passengers and 8 crew, departed Addis Ababa's rwy 07R and was climbing out of Addis Ababa when the aircraft levelled off at about 9000 feet MSL, radar contact was lost shortly after at 08:44L (05:44Z). No survivors. Senior captain Yared Getachew, who had more than 8,000 flight hrs, was in command of the plane. First officer, Ahmed Nur Mohammad Nur, had 200 hours of flight time.

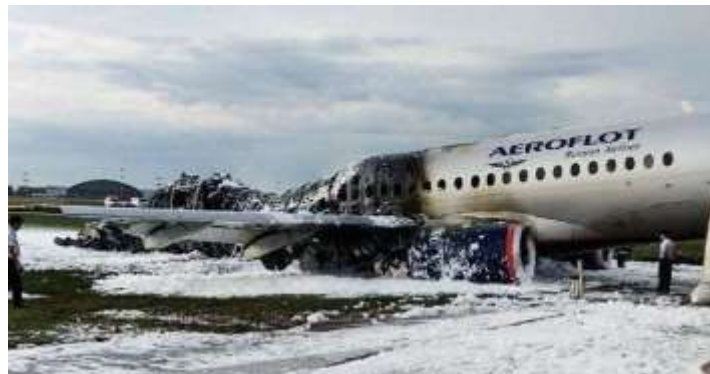
- 05/05/2019 Sheremetyevo, Moscow, Russia, Aeroflot SU95 bursts into flames during rollout and burns down, 41/73+5
Aeroflot Sukhoi Superjet 100-95, RA-89098, SU-1492 from Moscow Sheremetyevo to Murmansk (Russia) with 73 pax and 5 crew, departed Sheremetyevo's rwy 24C at 18:04L (15:04Z) but stopped the climb at about FL100 following a lightning strike, declared loss of radio communication first, later emergency via transponder codes and returned to Sheremetyevo for a landing on rwy 24L at 18:31L (15:31Z). During the roll out the aircraft burst into flames, veered left off the rwy and came to a stop on the grass adjacent to the rwy, the aircraft burned down. 41 occupants perished in the accident, 35 occupants were able to evacuate the aircraft via both front door emergency slides, the 2 flight crew escaped via the escape ropes through the cockpit windows, there were 11 injuries. The aircraft's tail section completely burned down and was destroyed.

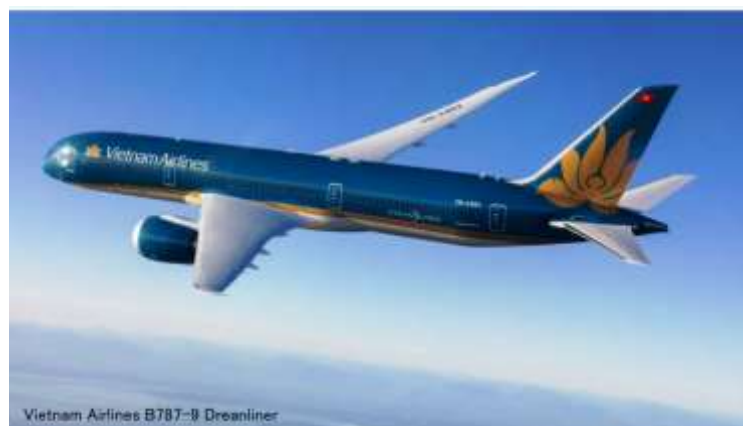
19/09/2019 Incorrect configuration involving Boeing 787, VN-A870 near Melbourne, Victoria

Vietnam Airlines flight was within one minute of landing at Melbourne Airport on Thursday morning when air traffic controllers were shocked to discover the Boeing 787 Dreamliner's landing gear was still up. Air safety officials have launched an investigation into the incident, regarded as extremely serious because the plane came so close to the ground without landing gear having been put down.

"During approach to land, Melbourne ATC advised the crew that the aircraft's landing gear was observed not to be extended. The crew initiated a missed approach," the Australian Transport Safety Bureau said in a statement on Thursday. FlightRadar24 shows the service approaching Melbourne Airport just after 8am on Thursday morning. The flight dropped as low as 675 feet, the website indicated, and then rapidly ascended to 5000 ft after aborting the landing. The flight then circled the airport and landed safely just before 8.30am.

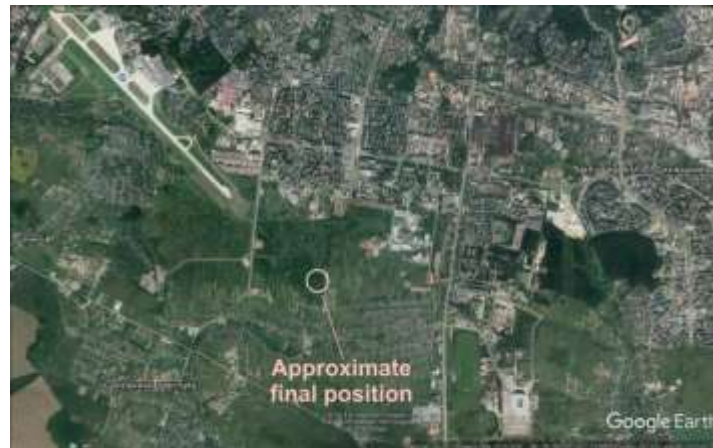
04/10/2019 UAA AN12 at Lviv crashed short of runway, **ran out of fuel**, 5/8

UAA Ukraine Air Alliance AN-12 freighter, UR-CAH, flight UKL-4050 from Vigo (Spain) to Lviv (Ukraine) リヴィウ (ウクライナ語) with 7 crew and one passenger, was on approach to Lviv about 7.4 nm before the airport when the aircraft disappeared from radar. The aircraft was subsequently found on the ground about 0.8 nm before Rwy31 in soil and vegetation, near a soccer stadium and a cemetery, where the crew had attempted an emergency landing due to running out of fuel. Five occupants were killed, three occupants were taken to hospitals with injuries. The flight plan was filed at FL260 ETE 05+45, 1580nm, 272KTS, alternate UKBB. Crew reached FL210 after 140nm and climbed to the final FL250 above Switzerland (800nm).

Oct 8th 2021 the NBBAAI released their **final report** concluding the probable causes of the accident was *the crew's failure to perform the flight in the instrument conditions due to the probable physical excessive fatigue.*

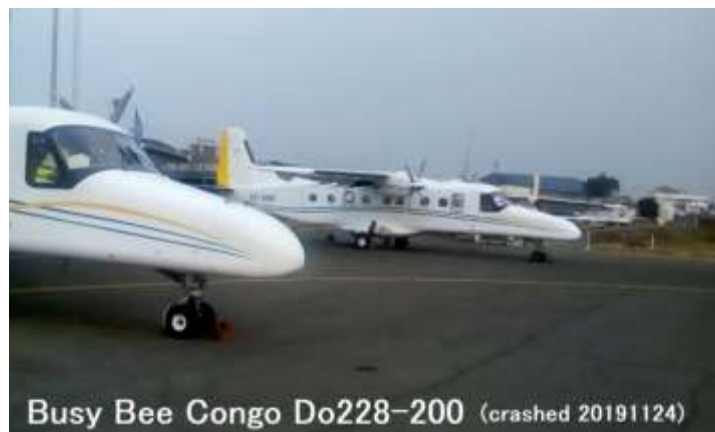
24/11/2019 Goma, Congo, Busy Bee D228 9S-GNH impacted populated area past departure runway, **19/19+7 on grd.**

Busy Bee Congo Domier 228-200, 9S-GNH, a scheduled flight from Goma to Beni (DR Congo) with 17 pax + 2 crew, departing Goma's runway 17 at 09:10L (07:10Z) either did not manage to become airborne or lost height after becoming airborne, impacted houses in the densely populated area of Birere just south of the runway. All occupants perished in the crash, a number of injuries and fatalities occurred on the ground.

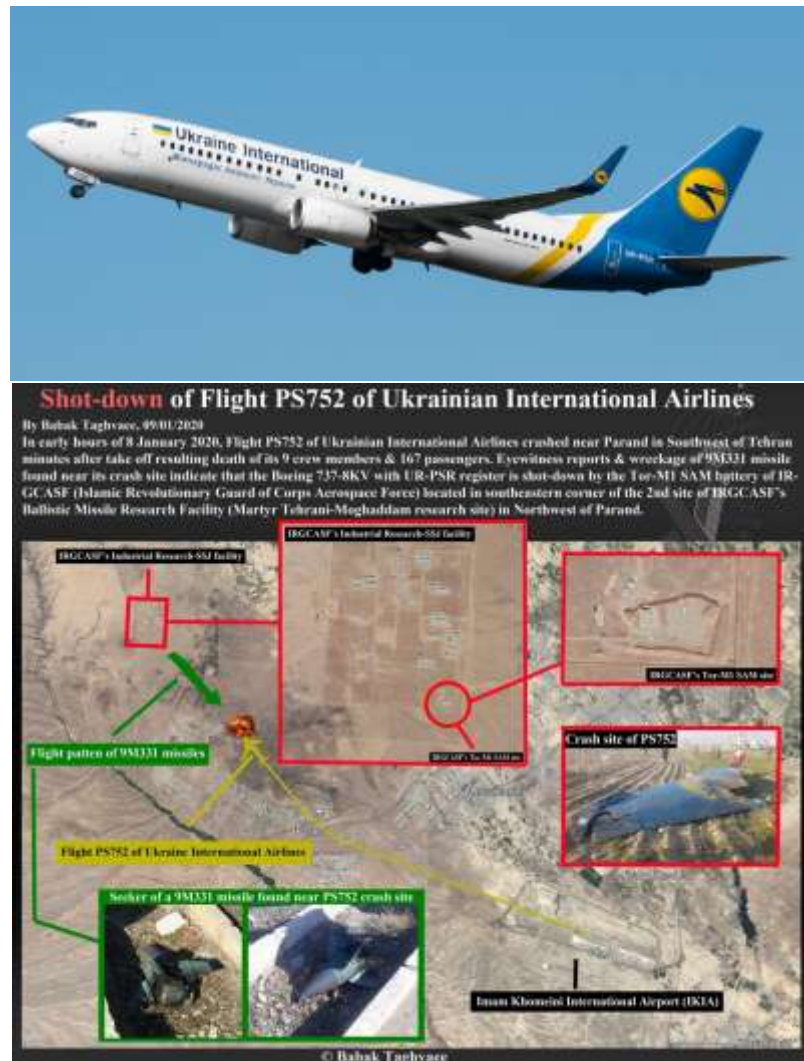
- 08/01/2020 Teheran, Iran, UIA B738 lost height after departure, aircraft **shot down** by Iran's armed forces **176/167+9(crew)**
- UIA Ukraine International Airlines B737-800, UR-PSR flight PS-752 from Tehran Imam Khomeini (Iran) to Kiev (Ukraine) with 167 pax and 9 crew, was climbing through 8000 feet MSL out of Tehran's rwy 29R about 12nm northwest of the airport at about 06:18L (02:48Z), when the aircraft's transponder signals ceased. The aircraft was found in an open field near Parand, a suburb of Tehran, at position N35.5529 E51.1121 about 10nm east of the last transponder position (N35.52 E50.91). All occupants perished in the crash.

Jan 11th 2020 Iran's Civil Aviation Organisation confirmed the aircraft was unintentionally and accidentally shot down. The CAO wrote quoting Iran's armed forces: "A Ukrainian passenger plane was hit unintentionally by human error, which unfortunately killed a number of dear compatriots and killed a number of foreign nationals."

Mar 17th 2021 Iran's CAO released their **final report**, concluding the probable causes of the crash were: **The air defense's launching two surface-to-air missiles at the flight PS752, UR-PSR aircraft**, the detonation of the first missile warhead in proximity of the aircraft caused damage to the aircraft systems, and the intensification of damage led the aircraft to crash into the ground and explode instantly. Other Contributing Factors- The mitigating measures and defense layers in risk management proved to be ineffective due to the occurrence of an unanticipated error in threat identifications, and ultimately failed to protect the flight safety against the threats caused by the alertness of defense forces.

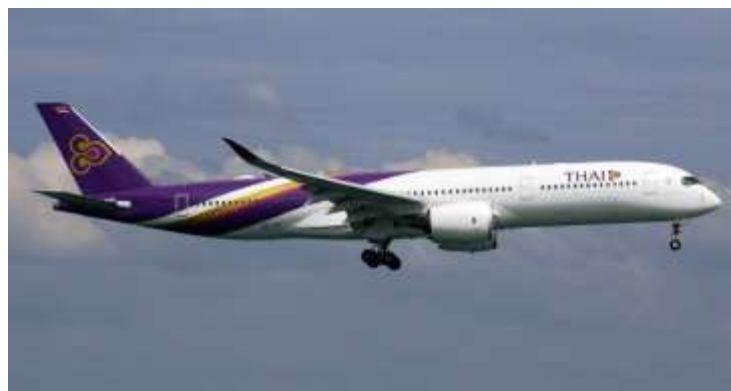
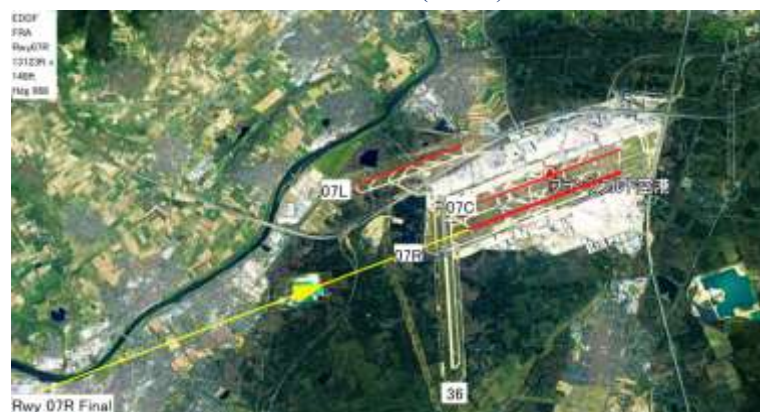
Airbus A350-900 (HS-THF)

01/01/2020 Frankfurt, Germany, Thai A359, descended to about 800 feet AGL about 7nm from touch down, **Near CFIT**
 Thai Airways A350-900, HS-THF, TG-926 from Phuket (Thailand) to Frankfurt/Main (Germany), was on final approach to Frankfurt's rwy 07R when the aircraft descended to about 800 feet AGL (about 1150 feet MSL) before initiating a go around. The aircraft climbed to 5000 feet MSL, positioned for another approach and landed safely on rwy 07R about 15 minutes later.

Mar 27 2020 the BFU reported in the January bulletin, that the first officer (36, ATPL, about 4000 hrs total, about 1500 hrs on type) was PF, the captain (43, ATPL, about 8000 hrs total, about 400 hrs on type) was PM. Two more first officers (all with ATPL) were on board. Descending through 7600 ft, Frankfurt App (feeder) instructed the crew to increase the descent to 3000 ft, turn to heading 040 and cleared the flight for ILS rwy 07R. Approach, the crew was instructed to maintain 170 KIAS or more. The crew extended flaps to position 1 at about 6000 ft MSL, 18 sec (later?) to position 2, the gear was lowered at 5100 ft, sink rate was about 2000 ft per min at that time. The aircraft intercepted the localizer and was following the LOC with increasing sink rate. The automated call "two thousand five hundred" occurred, the autopilot was disengaged. The GPWS sounded 9 sec later "Sink Rate" two times. 5 sec later the automated call "one thousand" occurred and the GPWS sounded "Glideslope". 34 sec after the 2500 ft call the PF called a go-around, the PM informed Tower. At that point the aircraft was at 668 ft AGL/936 ft MSL 6.43nm before the rwy threshold. The aircraft performed a second approach, passed the point 6.43nm before the threshold at 2238 ft MSL and landed safely.

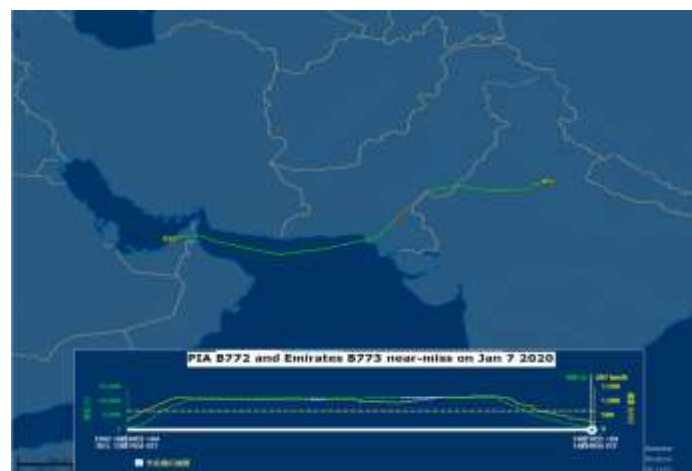
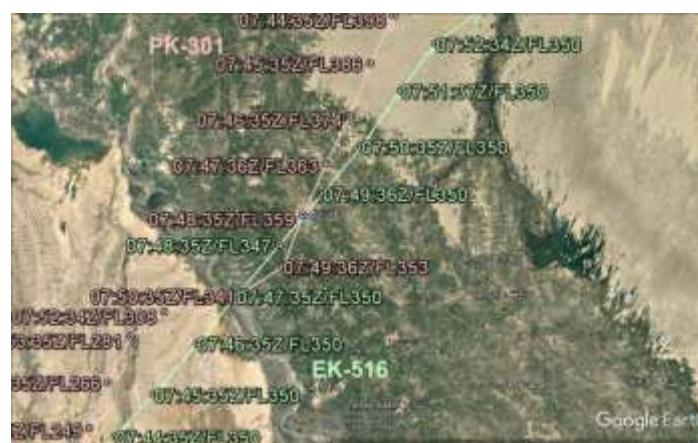
07/01/2020 PIA B772 and Emirates B773 near Karachi on Jan 7th 2020, loss of separation, **near-miss**

PIA Pakistan International Airlines B777-200, AP-BGY, flight PK-301 from Islamabad to Karachi (Pakistan), at FL400, reached the top of descent into Karachi about 140nm northeast of Karachi and was in the initial descent.

Emirates B777-300ER, A6-EPS, flight EK-516 from Dubai (United Arab Emirates) to Delhi (India), at FL350 about 50nm northeast of Karachi tracking into a northeasterly heading. About 90nm northeast of Karachi the Emirates Boeing received a TCAS resolution advisory to descend due to the PIA Boeing descending at high sink rate, the Emirates crew complied with the advisory, the PIA Boeing received a TCAS resolution advisory to reduce rate of descent about 110nm northeast of Karachi. The PIA Boeing continued to descend, descended to below FL360 about 106nm northeast of Karachi. According to ADS-B data the horizontal separation reduced to about 1nm at about 07:48:50Z while due to TCAS activations and compliance with the resolution advisories the vertical separation was kept at about 1000 feet. About 106m northeast of Karachi, about 45 seconds after point of closest approximation, the Emirates had returned to FL350, the PIA Boeing was descending through FL353, the horizontal separation between the aircraft had increased to 13nm again. Pakistan's CAA reported a near collision occurred and suspended three air traffic controllers involved into the occurrence.

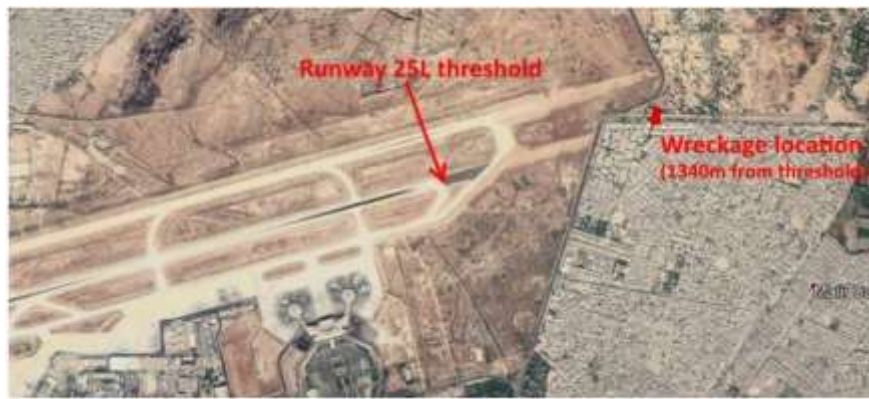
Fig 1: Google Earth crash site location (direction of flight from right to left)

- 20/05/2020 Karachi, Pakistan, PIA A320-214, AP-BLD, Lahore (OPLA) to Karachi (OPKC), PK8303, 97/99, 8 crew (Capt, F/O, 6 FA)+91 pax. At 14:35 the aircraft performed an ILS approach for rwy 25L and touched down **without landing gears**, resting on the engines. Both engines scrubbed the runway at high speed. Flight crew initiated a go-around and informed "Karachi Approach" that they intend to make a second approach. About 4 minutes later, during downwind leg, at an altitude of around 2,000 ft, flight crew declared an emergency and stated that both engines had failed. The aircraft started losing altitude. It crashed in a populated area, short of rwy 25L by about 1,340 meters. An immediate subsequent post impact fire initiated. Out of 99 souls on-board, **97 were fatally injured** and 2 pax survived. On ground 4 persons were injured however 1 out of these reportedly expired later at a hospital. **One on ground killed.**

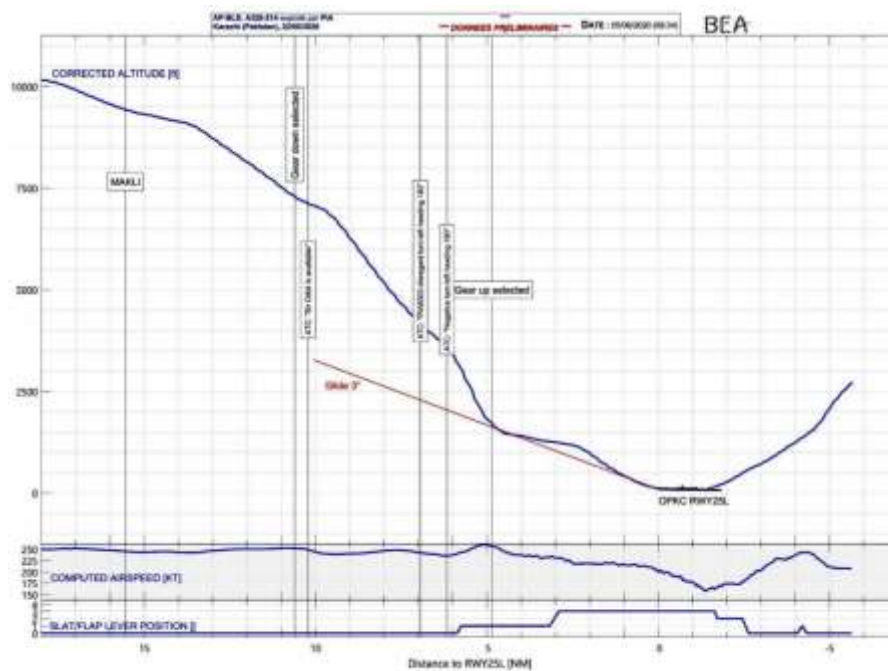
Fig 21 : Selected FDR parameters during last part of the first approach

The aircraft crashed on the second approach

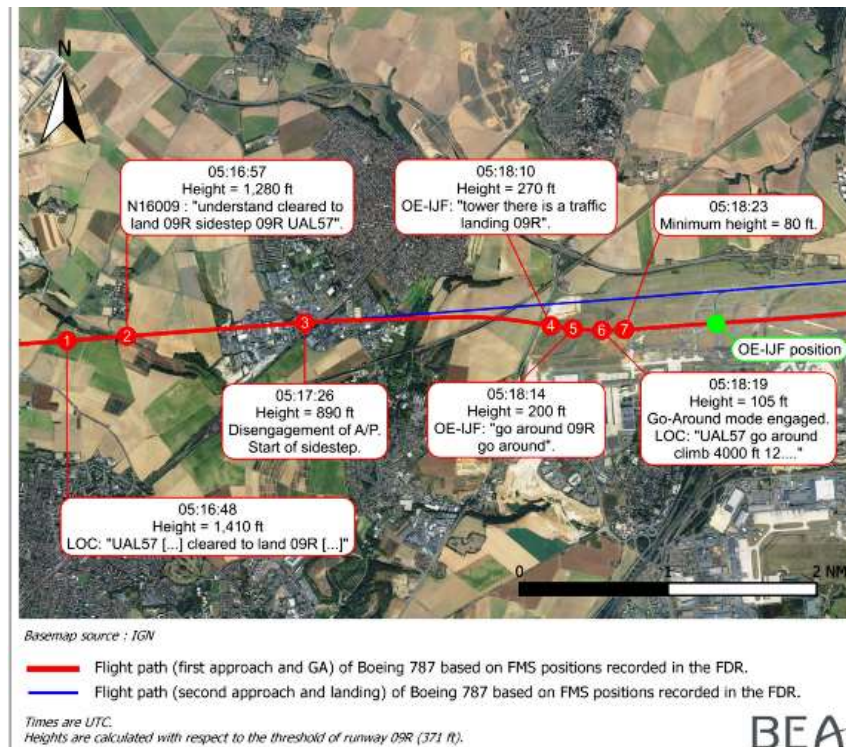
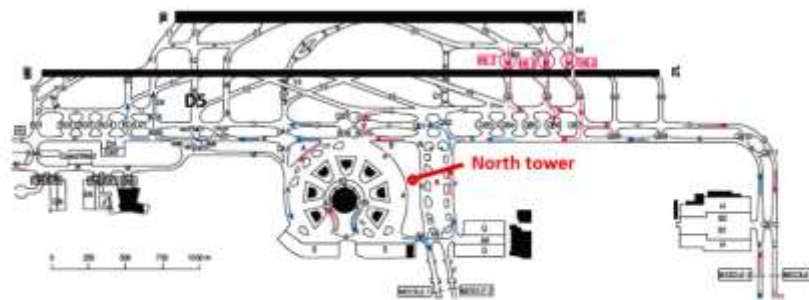
Figure 2: Excerpt from airport chart

20/07/2020 Paris, CDG, France, UAL B78X 2020, cleared to land on wrong runway, **ATC error** saved by Easyjet
 UAL B787-10, N16009 UA-57 from Newark, NJ (USA) to Paris Charles de Gaulle (France), was on final approach to Paris' rwy 09L when tower cleared the aircraft to land on rwy 09R. The crew read back the clearance and performed a swing over to rwy 09R.
 An Easyjet Europe A320-200, OE-LJF U2-3955 from Paris CDG (France) to Malaga, SP (Spain), had been cleared to line up rwy 09R and wait, recognized the developing situation and reported the conflict on radio.
 B78X initiated a go around from about 260 ft AGL (500 ft transponder altitude corrected to QNH 1018 and 367 ft ground elevation) resolving the conflict.
 AAR by BEA: https://bea.aero/fileadmin/user_upload/BEA2020-0289.en.pdf

Lapsus by a controller when giving a landing clearance, read back not checked, missed approach on short final on request from aeroplane lining up on runway

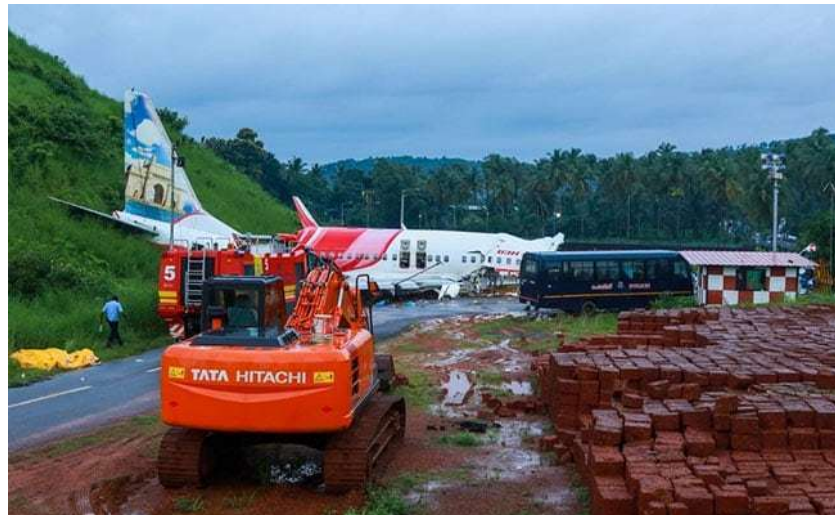
07/08/2020 Calicut airport, Kozhikode (コジコー ド) India **overran** runway and fell into valley, 21/184+6

Air India Express B737-800, VT-AXH flight IX-1344 from Dubai (UAE) to Kozhikode (VOCL) with 184 pax and 6 crew, landed on Kozhikode's rwy 10 in bad WX with tail winds but went past the end of the rwy, went past the rwy end safety area (150m/500 ft) and fell into a valley at 19:41L (14:11Z) coming to a stop about 100 ft below the rwy and about 245 m/800 ft past the rwy end. 21 people including both pilots died in the accident, Kozhikode's rwy 10/28 is 2845 m/9330 ft long and features ILS approaches for both rwy 10 and 28 as well as VOR approaches to both rwys. The runway sits on a flattened hilltop, a drop off of 35 m/114 ft exists past the runway 10 end.

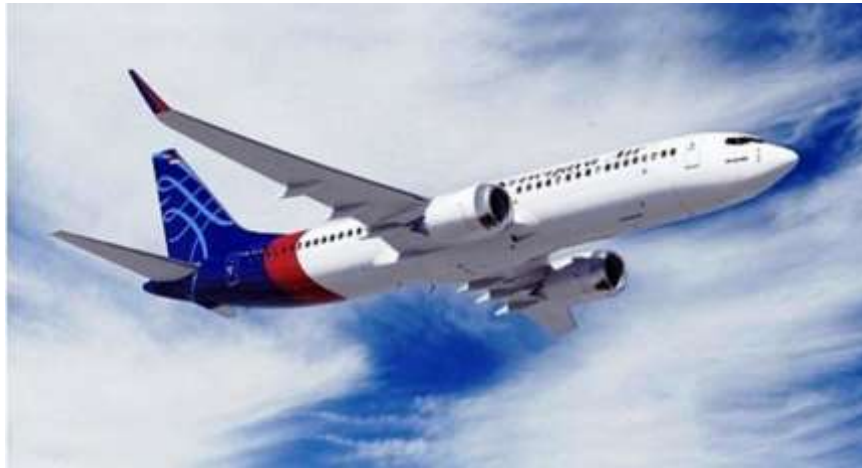
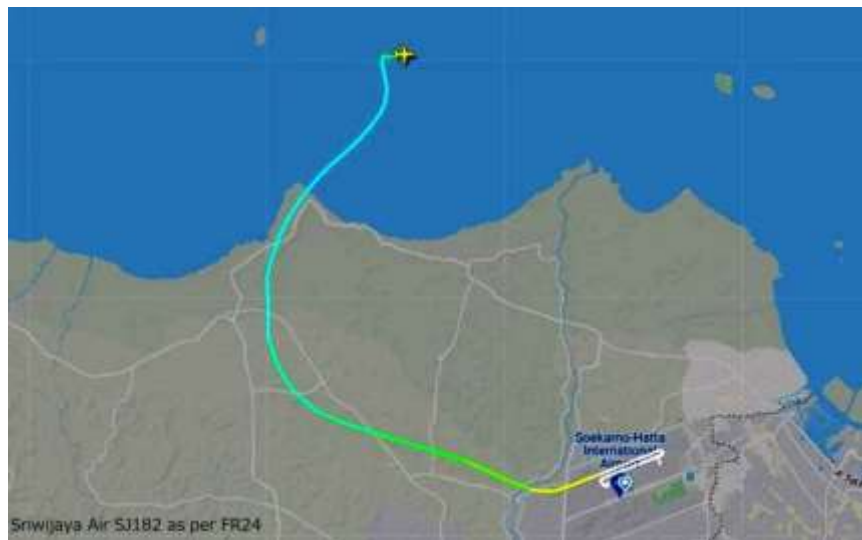
09/01/2021 Off Jakarta, Indonesia, Sriwijaya B735 lost height and impacted Java Sea, **62/56+6**

Sriwijaya B737-500, PK-CLC, SJ-182 from Jakarta to Pontianak (Indonesia) with 56 pax and 6 crew, was climbing out of Jakarta about 11 nm north of Jakarta's Soekarno International Airport (WIII) over the Java Sea when radar and radio contact was lost with the aircraft at 14:40L (07:40Z).

The KNKT informed the minister, that the wreckage field of the aircraft is about 110m long and 80m wide at the sea floor at a depth between 16 and 23m. All parts of the aircraft, from the nose cone to the tail, were found in this area. There is **no evidence of an explosion** of the aircraft prior to impact with the water, there is also no evidence the aircraft broke up before impact with water. Impact damage indicates the engines were still operating upon impact with water. At the time of the actual departure there were CB clouds over Jakarta which were dispersing, visibility improved, rain intensity decreased. There were no lightning strikes around the area while SJ-182 was in flight. Lightning and turbulence conditions did occur south of Jakarta, **the weather along the flight path of SJ-182 north of Jakarta was rather good** however. The aircraft had reported with Jakarta Departure while climbing through 1700 feet and was cleared to climb to FL290 following the standard departure route. While climbing through 7900 feet the crew requested to deviate around weather at a heading of 075 degrees, ATC cleared them for a heading of 075 degrees but restricted their climb at FL110 due to conflicting traffic, later clearing the flight to climb to FL130. The crew acknowledged these instructions including the clearance to climb to FL130 normally. Less than a minute later the controller noticed the aircraft was turning left instead of turning right to 075 degrees and queried the crew, but did not receive a reply anymore. The aircraft disappeared from radar shortly afterwards. ATC called SJ-182 11 times without a reply, other aircraft attempted to call SJ-182 as well also remaining without reply.

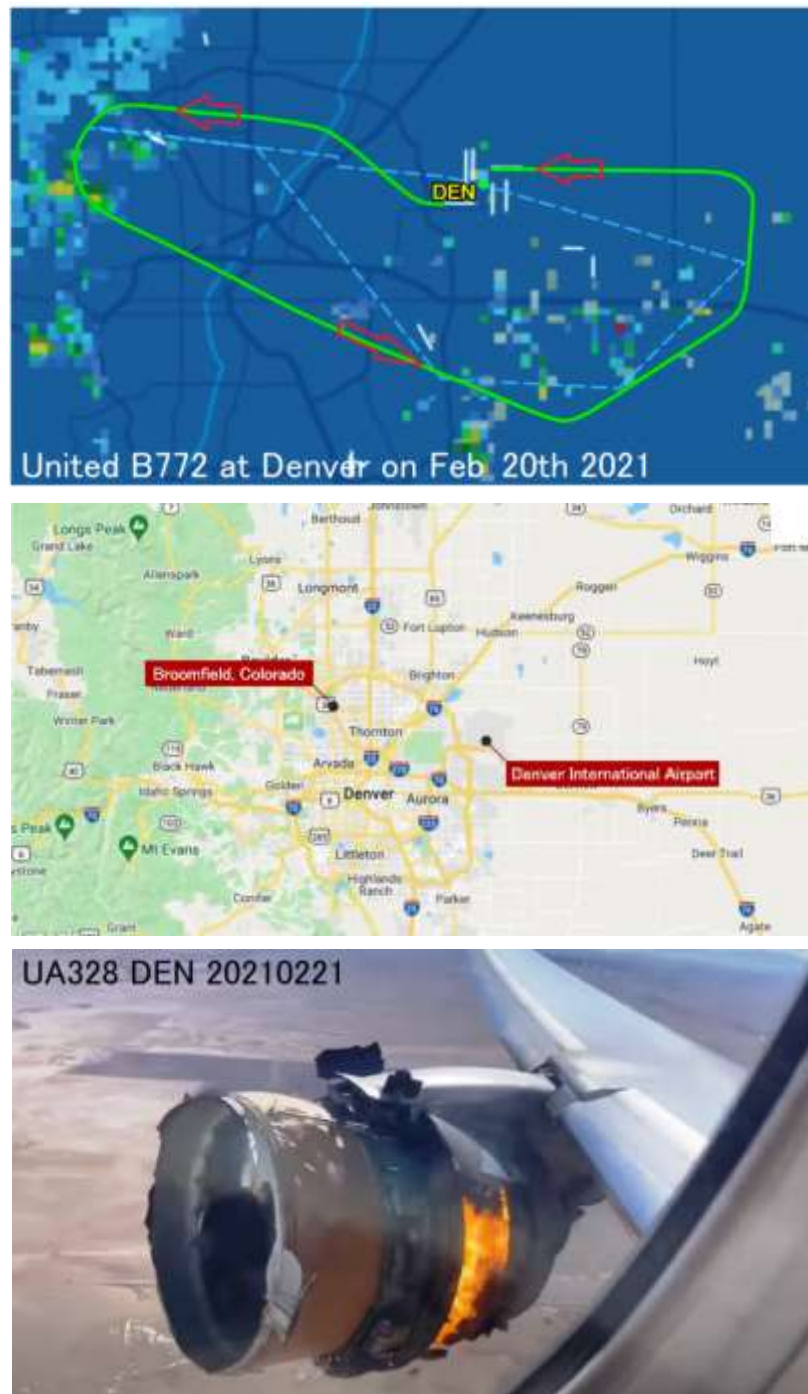
21/02/2021 Denver, USA, UAL B777-200, engine inlet separates from engine, engine fire, 0229+10
 UAL B777-200, N772UA flight UA-328 from Denver, CO to Honolulu, HI (USA) with 229 pax and 10 crew, was in the initial climb out of Denver's rwy 25 when the righthand engine's (PW4077) inlet separated associated with the failure of the engine. The crew declared Mayday reporting an engine failure. The aircraft stopped the climb at about 13000 feet, the crew requested to return to Denver after running the checklists. ATC offered any runway, they would make it happen. The aircraft returned to Denver for a safe landing on rwy 26 **about 23 minutes after departure**. The aircraft stopped on the runway for a check by emergency services. Emergency services advised of an active fire within the righthand engine and extinguished the fire a few minutes later. The aircraft was subsequently towed off the runway to a remote parking stand, where passengers disembarked and were bussed to the terminal. There were no injuries.

Contained Engine Failure

On Feb 21st 2021 United, Japan Airlines and All Nippon Airways grounded their active B777 aircraft equipped with PW-40xx engines.

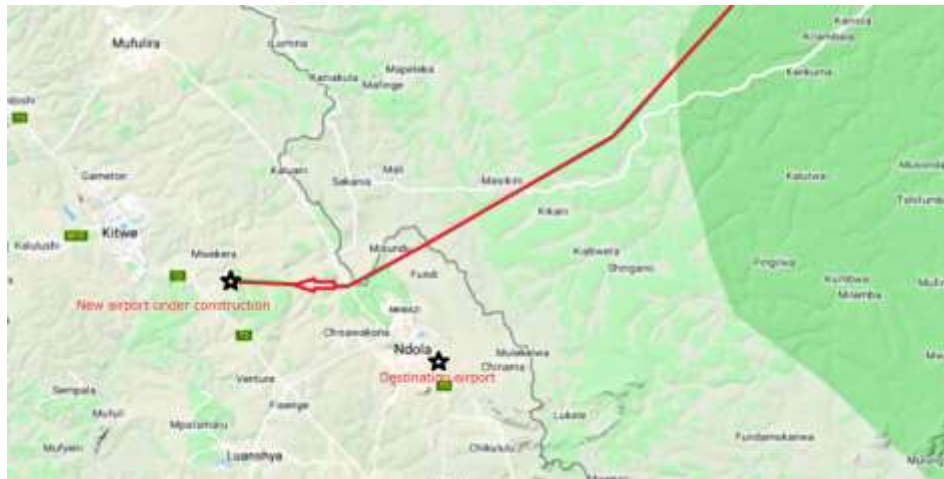
04/04/2021 Ndola, Zambia, Ethiopian B738 landed at **wrong airport** under construction

Ethiopian Airlines B737-800 freighter, ET-AYL freight flight ET-3891 from Addis Ababa (Ethiopia) to Ndola (FLSK, Zambia), was expected to land at Ndola's current (and old) Simon Mwansa Kapwepwe International Airport (S12.9977 E28.6634) but landed on Ndola's new Copperbelt International Airport (S12.9624 E28.5141), about 9nm westnorthwest of the current airport and is still under construction. The aircraft taxied to the apron, where airport construction workers signalled to the crew they were not expected at that airport. The **crew thus continued taxi across the apron, entered the runway via the next taxiway and departed again.**

Simon Mwansa Kapwepwe Intl Airport with parallel rwy, 10L/28R, 2515m/8250 ft + 10R/28L 1215m/3980 ft. New Airport; rwy ca 09/27, 3500m.

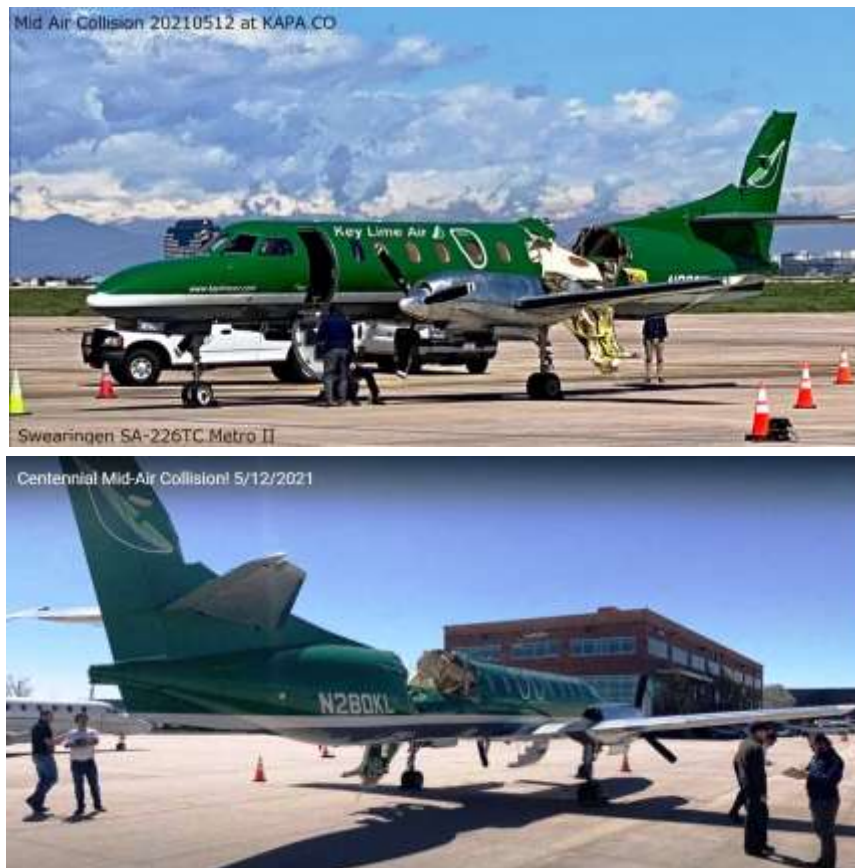
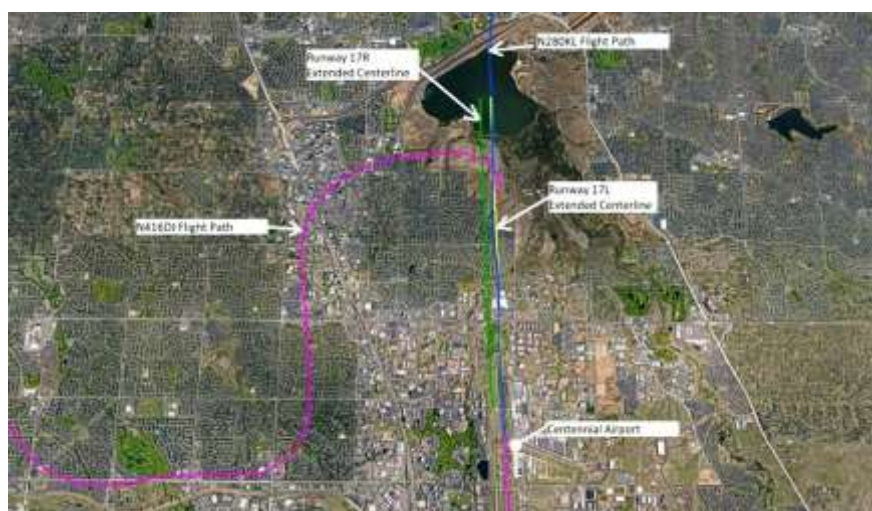
- 12/05/2021 Key Lime SW4 and private Cirrus aircraft at Denver on May 12th 2021, **midair collision**, 0/1+2
SR22 N416DJ and Key Lime Air Flight 970, Swearingen SA-226-TC Metro II N280KL cargo flight, collided on approach to Centennial Airport in Colorado. (El:5884.9 ft / 1793.7 m. Var 08E (2015):15 miles SE of DENVER, CO.) The Cirrus made a safe off-airport parachute-assisted landing, while the Key Lime pilot landed safely at Centennial despite the loss of a section of the cabin roof, damage to the empennage, and failure of one engine. There were no injuries.
Cirrus apparently struck across through the fuselage of the Metroliner just above the wings taking out the whole cabin section at that point. The Metro crew declared emergency on tower frequency reporting their righthand engine had failed. After landing the crew advised, it had definitely been a mid air collision.

NTSB report : (20230404)

The Cirrus pilot's failure to maintain the final approach course for the assigned runway, which resulted in a collision with the Swearingen which was on final approach to the parallel runway.

Contributing to the accident was the failure of the controller to issue a traffic advisory to the Swearingen pilot regarding the location of Cirrus, and the Cirrus pilot's decision to fly higher than recommended approach speed which resulted in a larger turn radius and contributed to his overshoot of the final approach course.

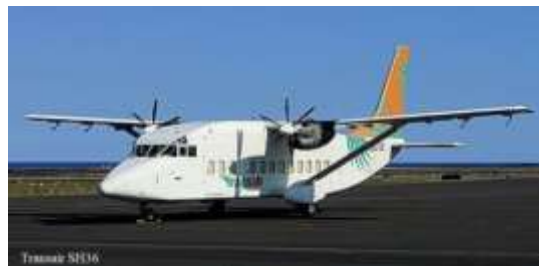
20/08/2021 Honolulu, Hawaii, USA, Transair SH36, gear up landing

Transair Shorts 360, N4476F, flight P6-7 from Kahului, HI to Honolulu, HI (USA) with 2 crew, landed on runway 04R at 04:02L (14:02Z) when tower queried: "did the gear collapse or did you land gear up?" There were no injuries, the aircraft sustained substantial damage. The **FAA reported the aircraft landed gear up.**

Tower queried: "did the gear collapse or did you land gear up?"
