民間航空機の主な航空事故一覧

Major Air Disasters Involving Commercial Airlines

1937-2025

作成者: 前川 博和(Hirokazu (Mike) Maekawa)

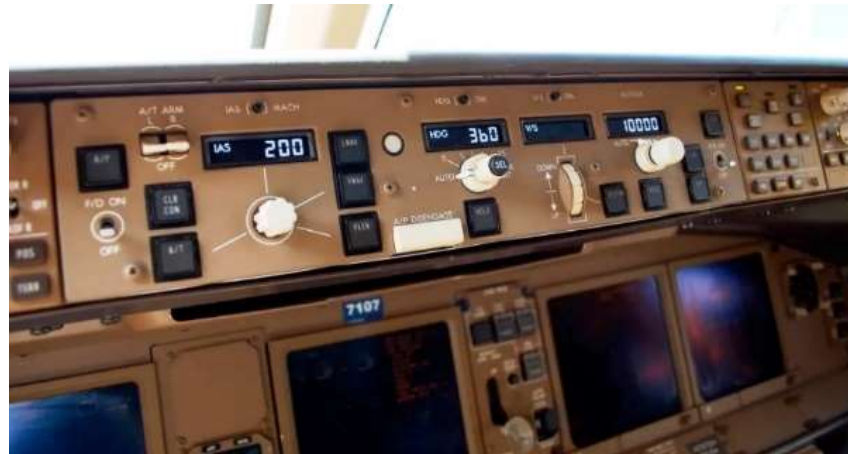
B777-300-mode-control-panel

20/12/2021 Dubai, UAE, Emirates B773, overran runway on departure, **Near CFIT**

Emirates B777-300, registration A6-EQL, EK-231 from Dubai (UAE) to Washington Dulles, DC (USA), was accelerating for takeoff from Dubai's rwy 30R when the aircraft rotated for takeoff past the end of the rwy and became airborne just at the end of the rwy end safety area. The aircraft continued to Washington for a landing without further incident. The aircraft performed the return flight EK-232 on schedule, then was grounded in Dubai and remained on the ground in Dubai for 4 days

On Dec 27th 2021 Emirates Airlines released a crew alert to their pilots following the occurrence suggesting the crew had not picked up **the previous flight crew had left the altitude setting at the Master Control Panel at airport elevation/00000 ft causing the flight director to not indicate takeoff rotation and climb out but instead indicate to maintain that altitude (ALT mode).**

```
CREW ALERT
*****
CO1408/21 COMPANY NOTAM - B777 MCP POWER UP DEFAULTS AND AFTER
LANDING/ SHUT DOWN MCP CHANGES
CREWS ARE REMINDED THAT THERE ARE NO FCOM NORMAL PROCEDURE (NP)
REQUIREMENTS TO CHANGE THE MCP AFTER LANDING OR SHUTDOWN.
THERE HAVE BEEN TIMES WHEN THE MCP "ALTITUDE WINDOW" HAS BEEN SET
TO THE AIRPORT ELEVATION WHICH MAY CAUSE ISSUES ON THE SUBSEQUENT
DEPARTURE. THE FCOM 4.10.2 STATES THAT THE AFDS WILL ENGAGE IN
"ALT" WHEN THE FIRST FLIGHT DIRECTOR SWITCH IS TURNED ON, IF THE
MCP SELECTED ALTITUDE IS WITHIN 20 FEET OF THE DISPLAYED BARO
ALTITUDE. CREWS SHALL NOT SET AIRPORT ELEVATION ON THE MCP AFTER
LANDING OR SHUT DOWN.
- FTPB 27DEC21
```

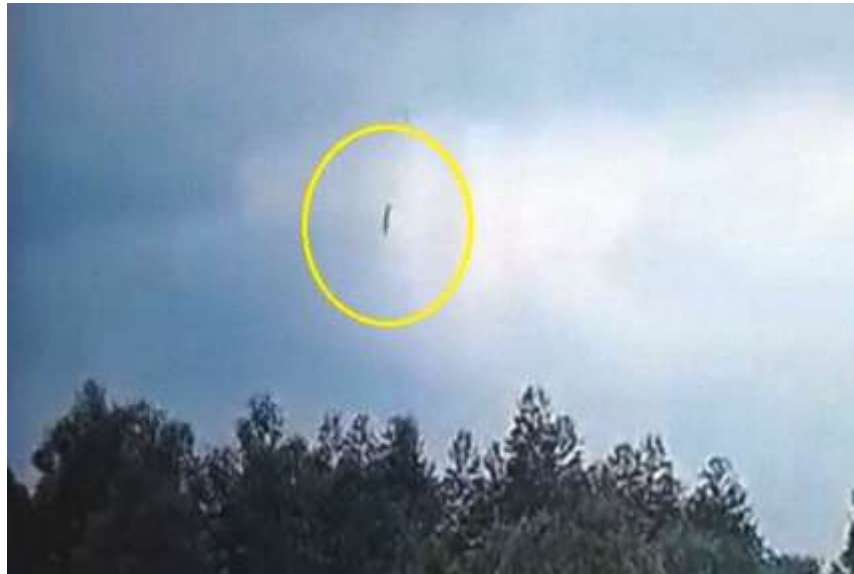
China Eastern B737-800, B-1791 (6.8yo) MU-5735 from Kunming to Guangzhou (China) with 123 pax and 9 crew on board, was enroute at 8900 meters/FL291 about 130nm west of Guangzhou nearing the top of descent when the aircraft suddenly lost altitude and impacted ground about 119nm west of Guangzhou (N23 20.251 E111 06.335) in mountainous terrain.

The CAAC report on April 20 2022, shows that the B737-800 aircraft, Flight MU5735, departed Kunming, capital of southwest China's Yunnan Province, for Guangzhou, capital of Guangdong Province, on March 21, and entered the Guangzhou control area at 2:17 p.m. The area control radar warned of a deviation at 2:20:55 p.m., and the aircraft left the cruising altitude of 8,900 meters. The controller called the crew immediately, but received no reply. At 2:21:40 p.m. on March 21 2022, the last aircraft information recorded by the radar was: standard pressure altitude at 3,380 meters, ground speed at 1,010 kph, with the aircraft on a heading of 117 degrees. Subsequently, the radar signal disappeared, the report shows.

The plane finally crashed into an area near Molang Village under Langnan Township of Tengxian County in the city of Wuzhou, south China's Guangxi Zhuang Autonomous Region, killing all 123 passengers and nine crew members on board. The crash site is located in a valley near the Molang Village. A crater with an area of about 45 square meters and a depth of 2.7 meters has been determined as the main impact point, the report shows. Before the plane deviated from the cruising altitude, the radio communications between the crew and the air traffic control department did not show any abnormality.

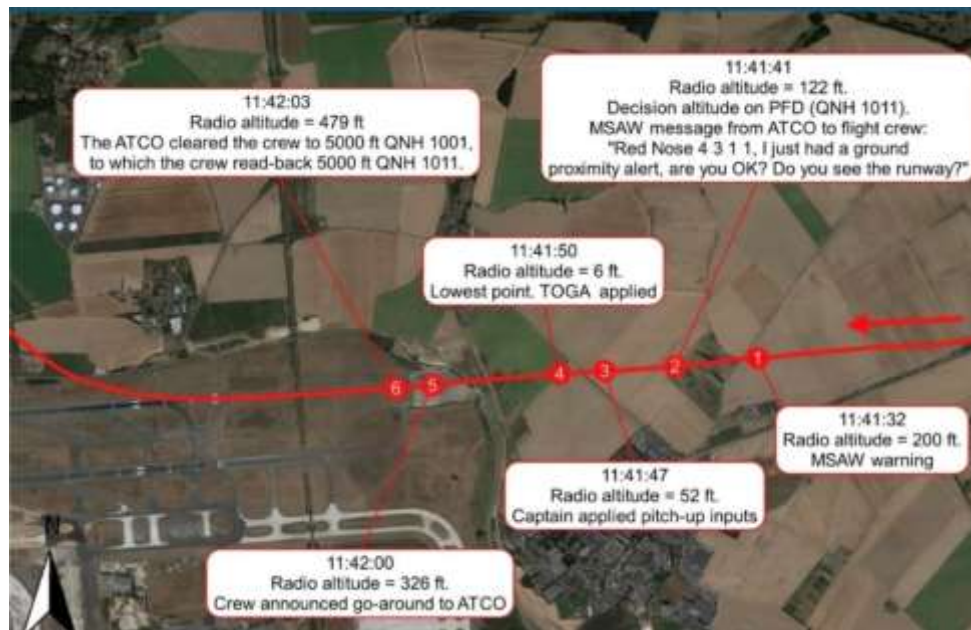
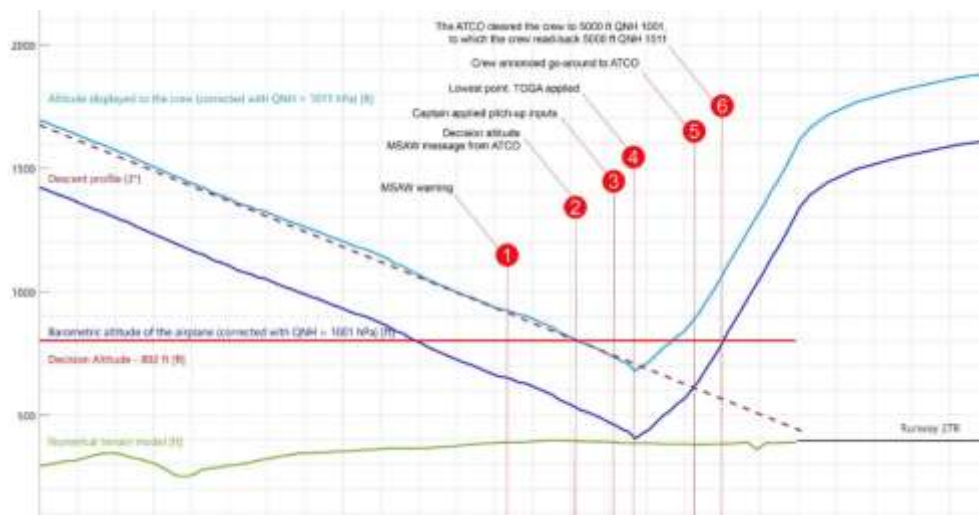
AvHerald reports: Getjet Airlines Malta Airbus A320-200 on behalf of Norwegian, registration 9H-EMU performing flight D8-4311 from Stockholm (Sweden) to Paris Charles de Gaulle (France), was on an RNP approach to CDG's runway 27R, however, with an erroneous Altimeter setting, instead of QNH 1001 hPa the crew had selected 1011 hPa. The approach was thus performed below the glide path and eventually triggered a Minimum Safe Altitude Warning (MSAW) at the controller's desk. In response the crew initiated a go around at low height, without having acquired visual contact with the ground, and positioned for another approach. The second approach was also performed below the glideslope, the crew however acquired visual contact, corrected their trajectory and landed without further incident about 16 minutes after the go around.

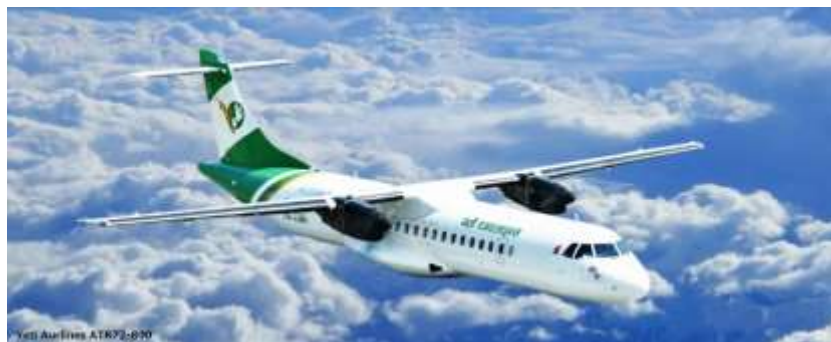
Yeti Airlines AT-72

Yeti AT72 crashed on Jan 15th 2023, **found**, lost height on final approach, both propellers went into feather by **human error**.

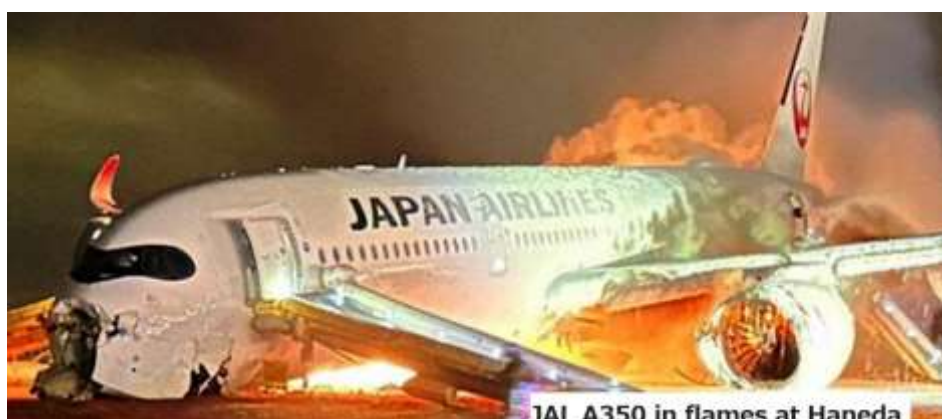
A350 was carrying 367 pax (incl 8 children) and 12 crew, all of them evacuated from the aircraft. The JAL516 crew had received and read back landing clearance. After the collision and coming to a stand still three emergency slides were used to evacuate the occupants of the aircraft. **The cause may have been a misunderstanding of ATC instructions by the JCG flight crew.**

Haneda Airport Runway Layout (Red star indicates collision point)

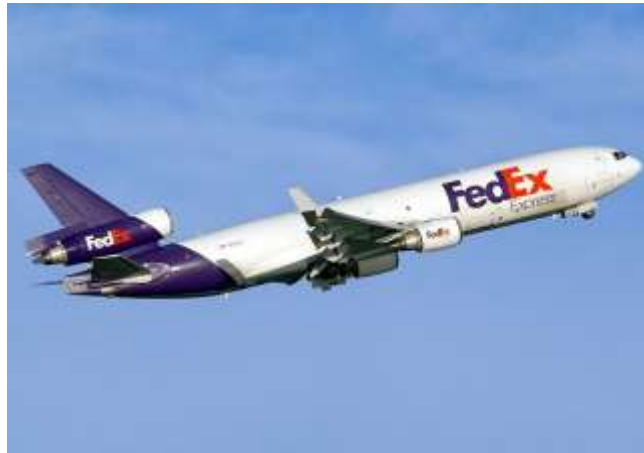
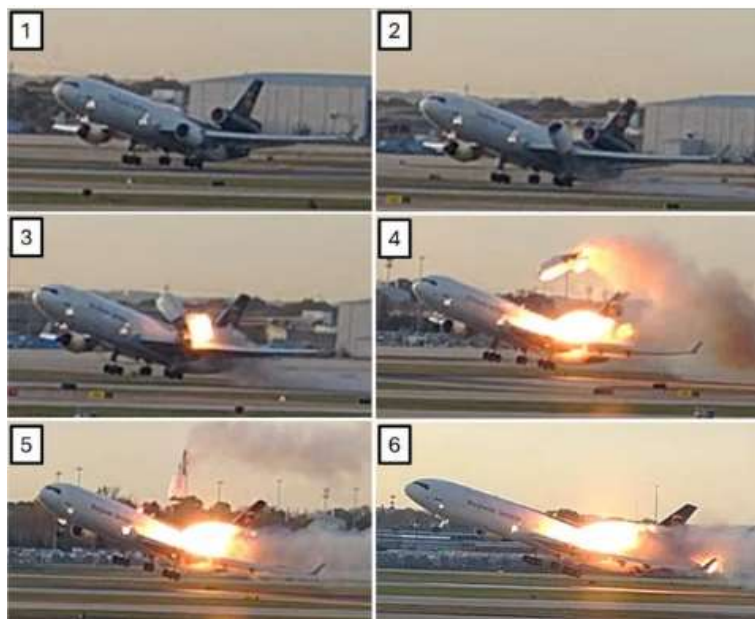
According to pictorial evidence engine #1 (left hand engine, CF6) separated the airframe during rotation for takeoff, the departure of that engine may also have failed the center engine #2.

Ground observers reported the aircraft had been delayed for about two hours for work on the left hand engine (engine #1), the engine #1 separated during the takeoff run, the center engine emitted streaks of flames, the aircraft impacted a UPS warehouse and ploughed through other facilities before coming to rest in a large plume of fire and smoke.
