# 民間航空機の主な航空事故一覧

## Major Air Disasters Involving Commercial Airlines

1937-2025

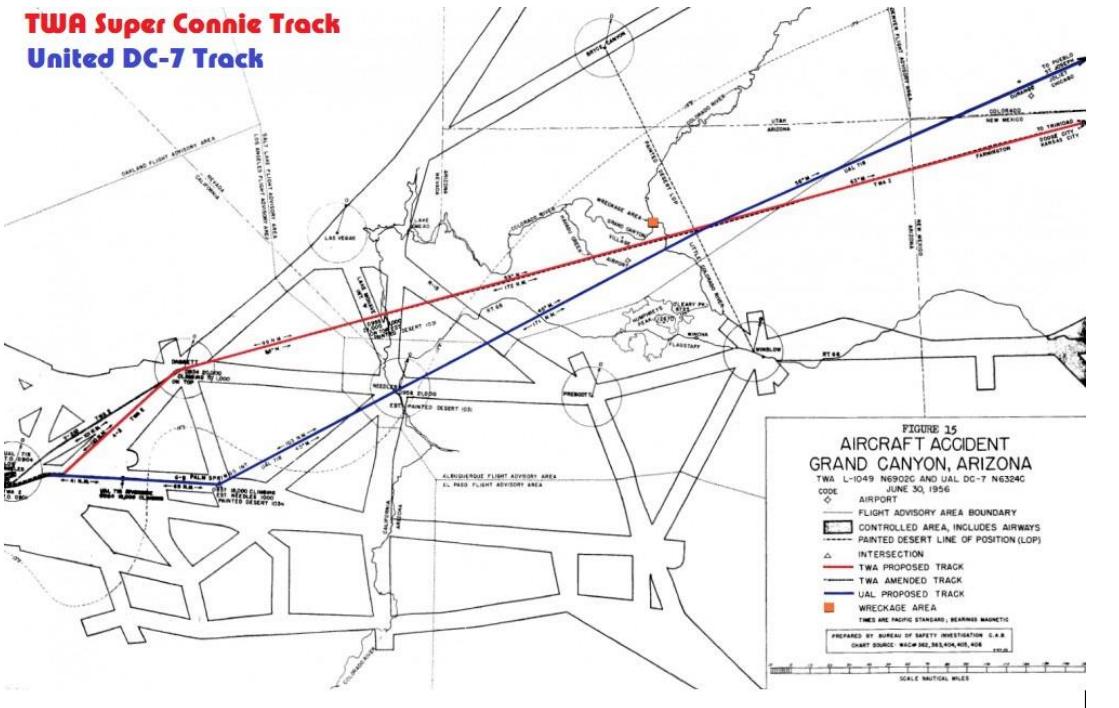
Routes of flight of UAL DC-7 and TWA L-1049

06/10/1955 Medicine Bow Peak, Laramie, USA, DC-4, United Airlines, Crashed into Mountain, 66  
 01/11/1955 Denver, USA, DC-6B, United Airlines, Mid-Air Bomb, 44  
 30/06/1956 Grand Canyon, USA, Super Constellation, TWA, Mid-air collision, [TWA pilot's failure to comply VFR on Top rules](#), 70/70  
 30/06/1956 Grand Canyon, USA, DC-7, United Airlines, Mid-air collision w/TWA, 58/58

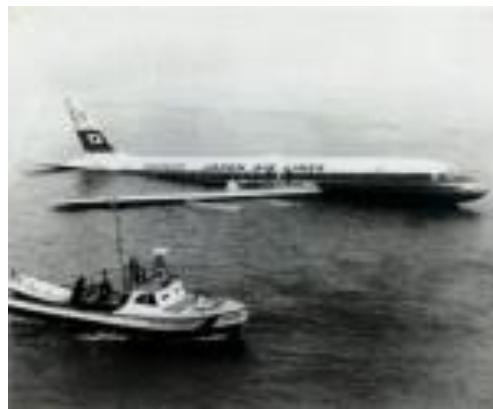
JAL DC8 JA8032 ditched short final RWY28L

22/11/1968 San Francisco, CA, USA, **JAL DC-8 JA8032 "Shiga"** Capt. Kohei Aso (麻生幸平機長、元航空管制官 4期生、1922.11 生れ), arrived in the San Francisco area after an uneventful flight from Tokyo Haneda. Normal communications were established, and the crew was radar vectored to the Woodside VOR and thence to intercept the ILS for runway 28L at San Francisco. The flight crossed the Woodside VOR at 17:16 at approximately 4,000 feet and, at 17:18:30, was cleared to descend to 2,000 feet. The flight descended in a constant, uninterrupted rate of descent from this time until about 6 seconds before water impact at 17:24:25. The aircraft was on the localizer and contacted the water about 2.5 miles from the end of runway 28L. There were no injuries to any of the passengers or crew during the accident and ensuing evacuation. The aircraft was recovered from the waters of San Francisco Bay about 55 hours after the accident. Repairs were carried out by United Air Lines and the plane was delivered back to JAL on March 31, 1969. This will a **CFIT, 0/107**

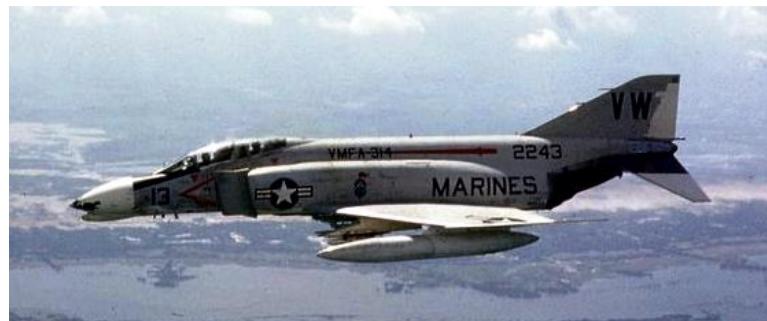
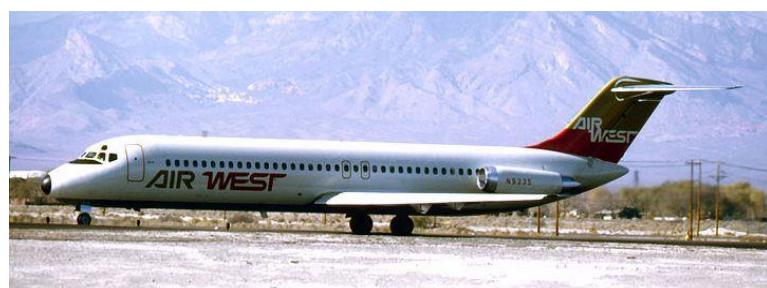
F4B (top) and DC-9 (bottom)

level-off was 420 knots. The F-4B collided with the Airwest DC-9 about 1 minute and 20sec after the roll, at 15150 feet. After the collision, the F-4 began to tumble violently about the lateral axis. The RIO waited about 5 seconds, and, after seeing numerous warning lights in the cockpit, he ejected from the aircraft. The ejection was successful, and he parachuted to the ground without injury. The other F-4 crewmember did not survive the accident.

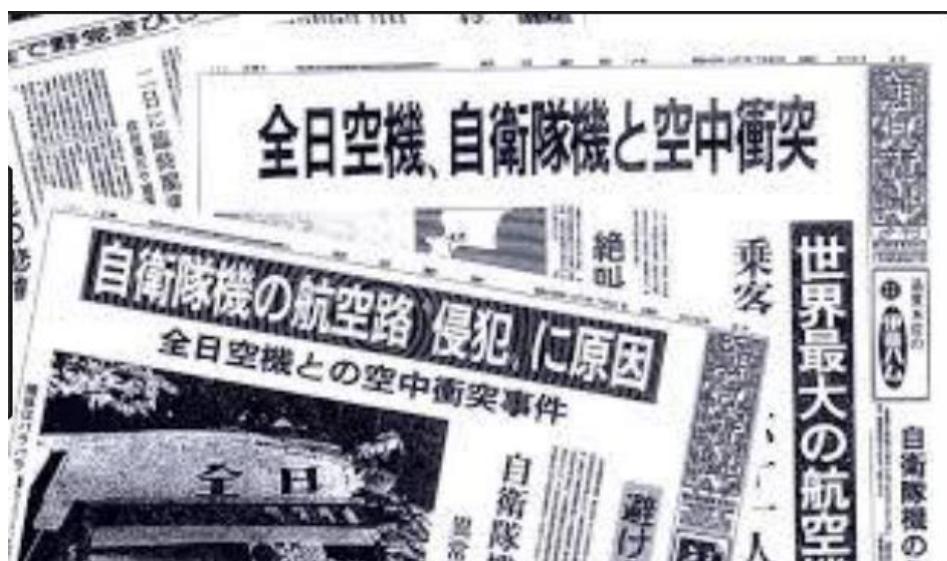
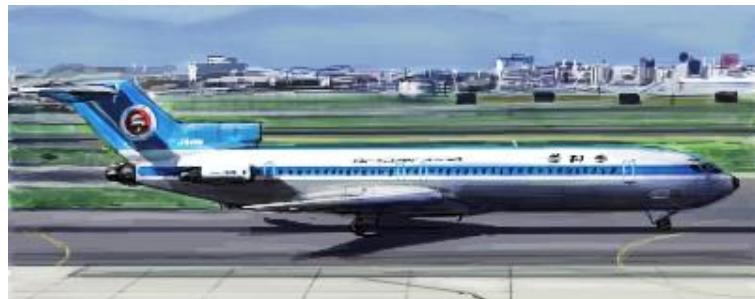
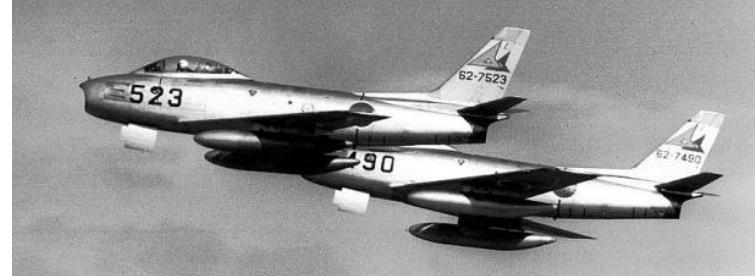
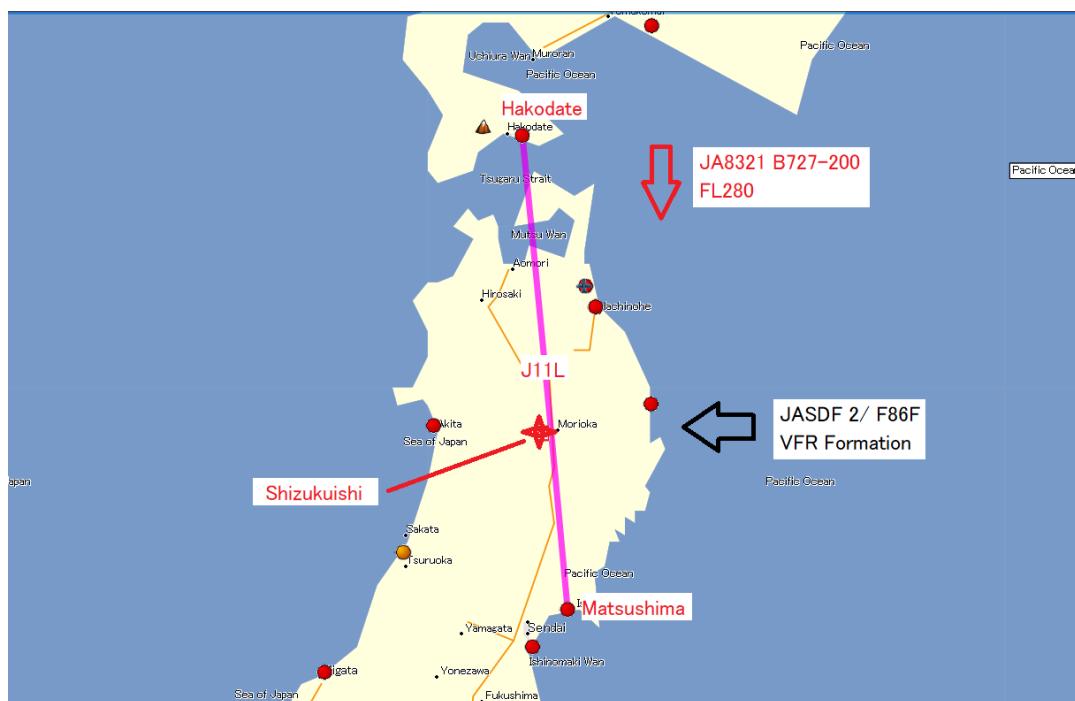
31/07/1971 Shizukuishi, near Morioka, Japan, 727-200, All Nippon Airways (ANA), NH58, Mid Air Collision with F86, 162/162

ANA JA8329 (NH58), Sapporo-Chitose (CTS) to Tokyo-Haneda (HND) climbed to an altitude of FL280. While cruising at this altitude, it approached an area where a Japan Air Self Defense Force student and his instructor were flying in their Mitsubishi-built North American F-86F fighters. The trainee was not watching out for traffic when the 727 approached. The instructor ordered him to break away from the 727. It was too late. He banked to the left but the leading edge of the right wing of his F-86F (92-7932) struck the left horizontal stabilizer of the ANA plane. The fighter's right wing broke off, causing the plane to crash out of control, but the pilot ejected safely. Damage to the stabilizer caused a loss of control of the B727.

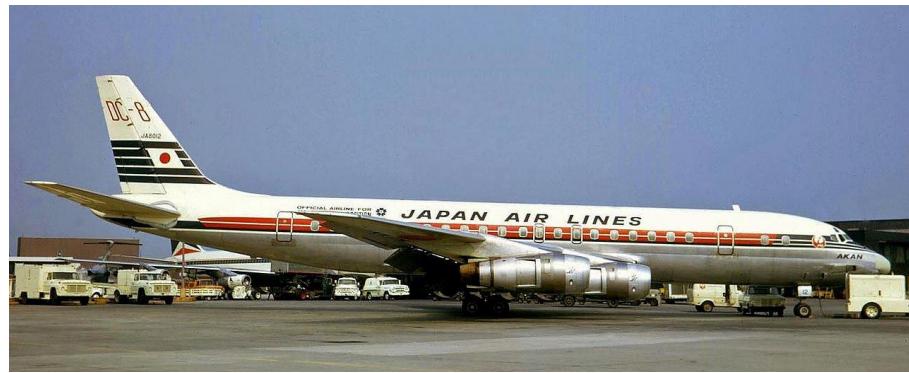
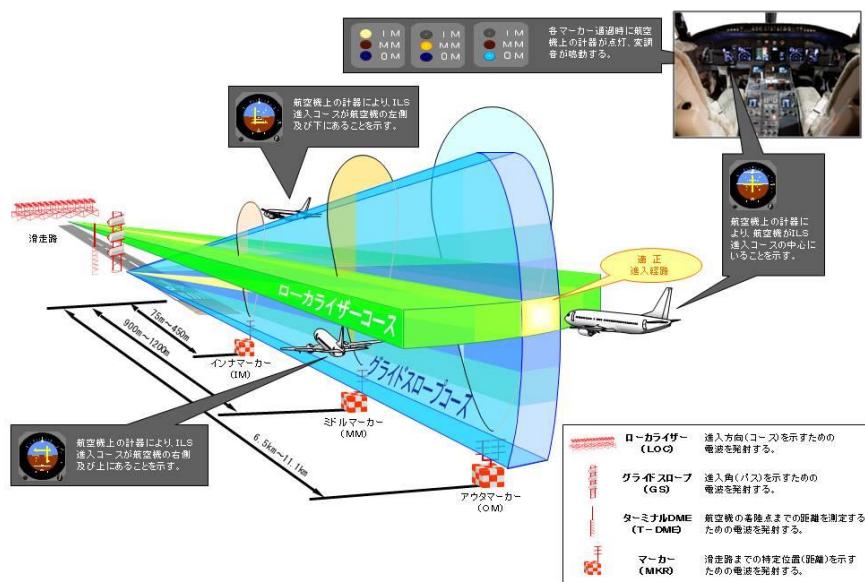
The DC-8 took off from Bangkok at 1121 UTC on a flight to Delhi, India. Clearance for a straight-in ILS approach to Delhi runway 28 was given at 14:43 UTC. Shortly after reporting 23DME, the aircraft struck the banks of River Yamuna. The first officer was Pilot Flying during the approach to Delhi. PROBABLE CAUSE: Japanese investigators claimed a false glide path signal to be responsible for the descent into terrain. Indian investigators say the accident was caused by a total disregard of laid down procedures by the crew and abandoning all instrument indications without properly ensuring sighting of the runway.

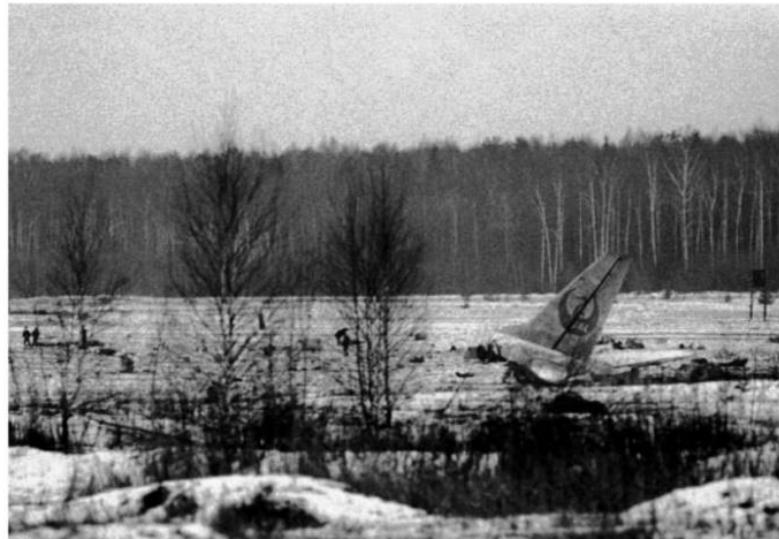
モスクワのシェレメチエボ空港近くで墜落した日本航空DC8-62型ジェット旅客機。1972年11月29日【PANA=時事】

DC-8-62 JA8040, was destroyed when it crashed on takeoff from Moscow's -Sheremetyevo (SVO), Russia. Five of the 14 crew members and ten of the 62 passengers survived the accident. JL446 was a scheduled international flight from Copenhagen (CPH), Denmark to Tokyo-Haneda (HND), Japan with an en route stop in Moscow. JL446 was cleared for takeoff from runway 25 at 19:49.

Probable Cause: The cause of the disaster to aircraft DC-8-62 JA-8040 resided in the fact that during take-off and following attainment of the safety speed V2, the crew put the aircraft into a supercritical angle of attack which resulted in loss of speed and altitude.

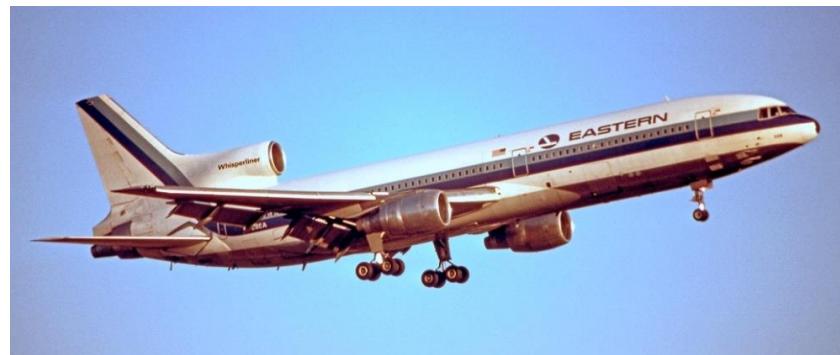
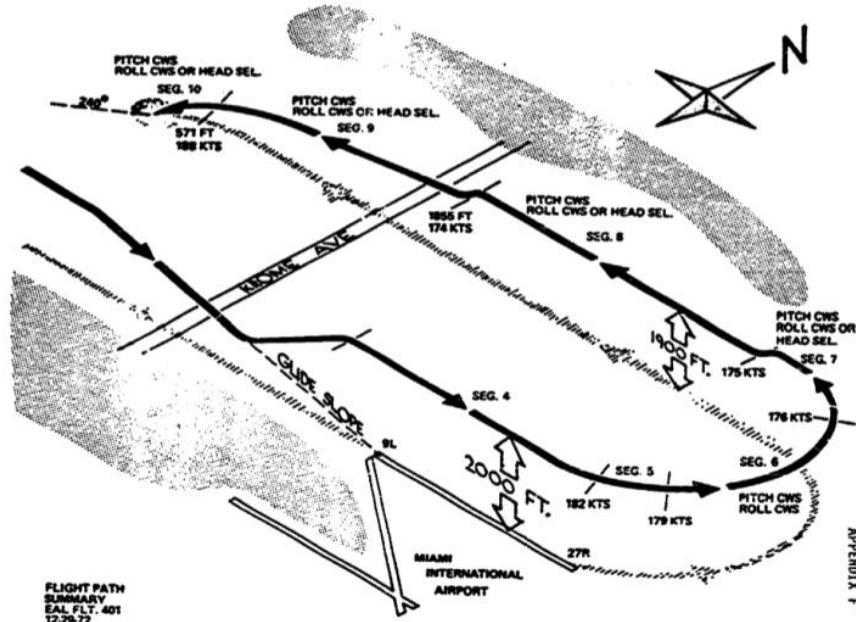
L-1011

EA401 departed New York-JFK at 21:20 EST for a flight to Miami. The flight was uneventful until the approach to Miami. After selecting gear down, the **nosegear light didn't indicate 'down and locked'**. Even after recycling the gear, the light still didn't illuminate. At 23:34 the crew called Miami Tower and were advised to climb to 2000 feet and hold. At 23:37 the captain instructed the second officer to enter the forward electronics bay, below the flight deck, to check visually the alignment of the nose gear indices. Meanwhile, the flight crew continued their attempts to free the nosegear position light lens from its retainer, without success. The second officer was directed to descend into the electronics bay again at 23:38 and the captain and first officer continued discussing the gear position light lens assembly and how it might have been reinserted incorrectly. At 23:40:38 a half-second C-chord sounded in the cockpit, indicating a +/-250 feet deviation from the selected altitude. None of the crewmembers commented on the warning and no action was taken. A little later the Eastern Airlines maintenance specialist, occupying the forward observer seat went into the electronics bay to assist the second officer with the operation of the nose wheel well light. At 23:41:40 Miami approach contacted the flight and granted the crew's request to turn around by clearing him for a left turn heading 180 degrees. At 23:42:05 the first officer suddenly realized that the altitude had dropped. Just seven seconds afterwards, while in a left bank of 28deg, the TriStar's no.1 engine struck the ground, followed by the left main gear. The aircraft disintegrated, scattering wreckage over an area of flat marshland, covering a 1600 ft x 300 ft area. **Five crew members and 94 passengers died in the accident.** Two passengers died more than seven days after the accident as a result of their injuries. **PROBABLE CAUSE:** "The failure of the flight crew to monitor the flight instruments during the final 4 minutes of flight, and to detect an unexpected descent soon enough to prevent impact with the ground. Preoccupation with a malfunction of the nose landing gear position indicating system distracted the crew's attention from the instruments and allowed the descent to go unnoticed."

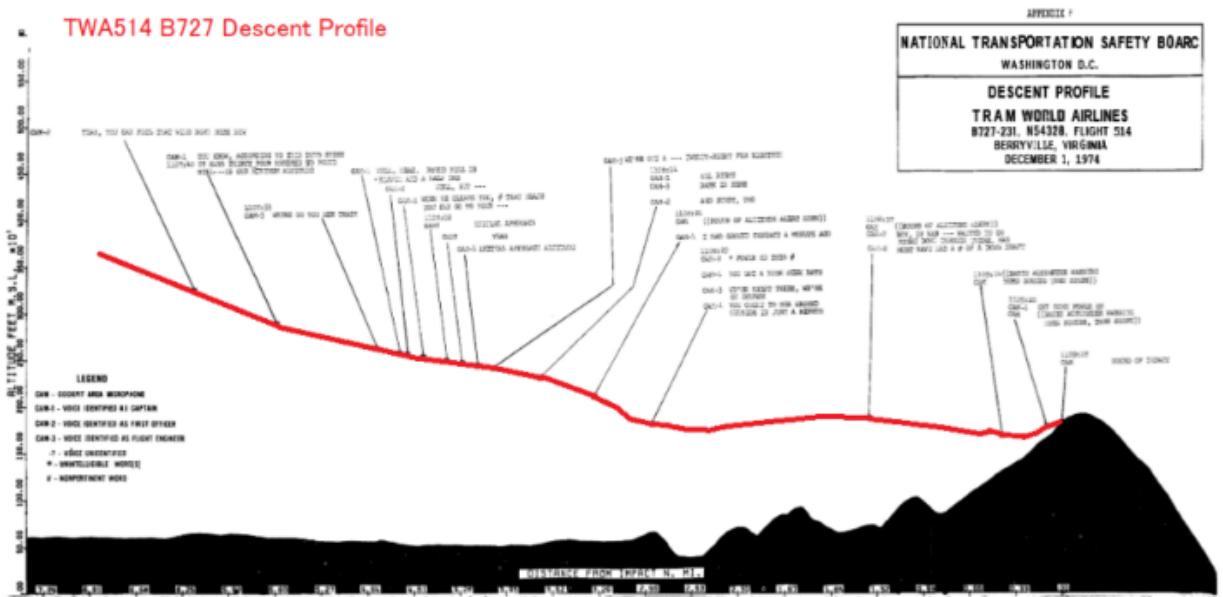
01/12/1974 Berryville, Virginia, USA, 727-231, Transworld Airlines, **TW514**, While Landing in Bad Weather, **CFIT**, 92/92

**PROBABLE CAUSE:** "The crew's decision to descend to 1800ft before the aircraft had reached the approach segment where that minimum altitude applied. The crew's decision was a result of inadequacies and lack of clarity in the air traffic control procedures which led to a misunderstanding on the part of the pilots and of the controllers regarding each other's responsibilities during operations in terminal areas under instrument meteorological conditions. Nevertheless, the examination of the plan view of the approach chart should have disclosed to the captain that a minimum altitude of 1800ft was not a safe altitude. Contributing factors were: 1) The failure of the FAA to take timely action to resolve the confusion and misinterpretation of air traffic terminology although the Agency had been aware of the problem for several years; 2) The issuance of the approach clearance when the flight was 44 miles from the airport on an unpublished route without clearly defined minimum altitudes; and 3) Inadequate depiction of altitude restrictions on the profile view of the approach chart for the VOR/DME approach to runway 12 at Dulles Int. Airport"

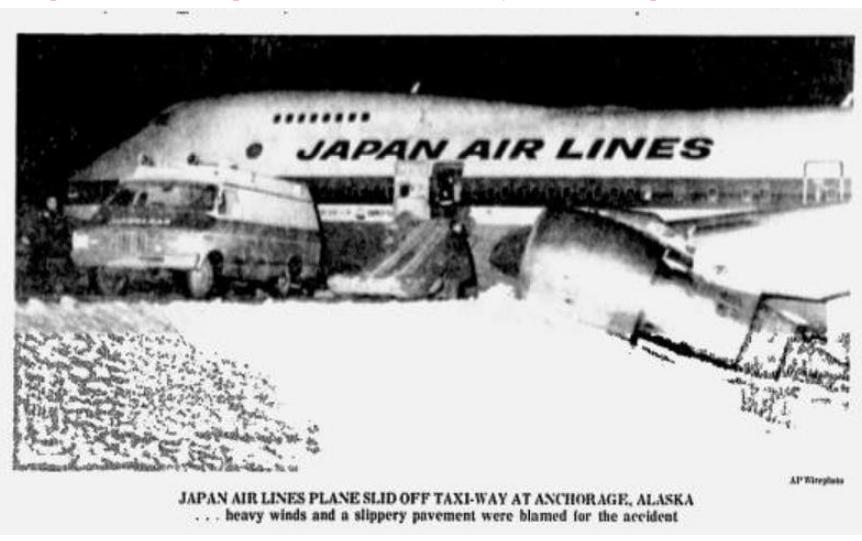
JAPAN AIR LINES PLANE SLID OFF TAXI-WAY AT ANCHORAGE, ALASKA  
... heavy winds and a slippery pavement were blamed for the accident

The aircraft slid off the north side of the east-west taxiway of Anchorage International Airport while taxiing out for a takeoff on runway 06R. The Boeing weathercocked about 70° to the left and slid backward down a snow-covered embankment with an average slope of -13°. The aircraft came to rest on a heading of 150° on a service road approximately 250 feet from, and 50 feet below, the taxiway surface. PROBABLE CAUSE: "The loss of directional control during taxi as a result of ice on the taxiway and strong, direct crosswinds. Contributing to the accident were (1) the captain's decision to take off from runway 6R after receiving reports that taxiing conditions were deteriorating, and (2) failure of airport management to anticipate predictable unsafe icing conditions on the airport. This failure to anticipate these conditions resulted in delayed and insufficient preventive action."

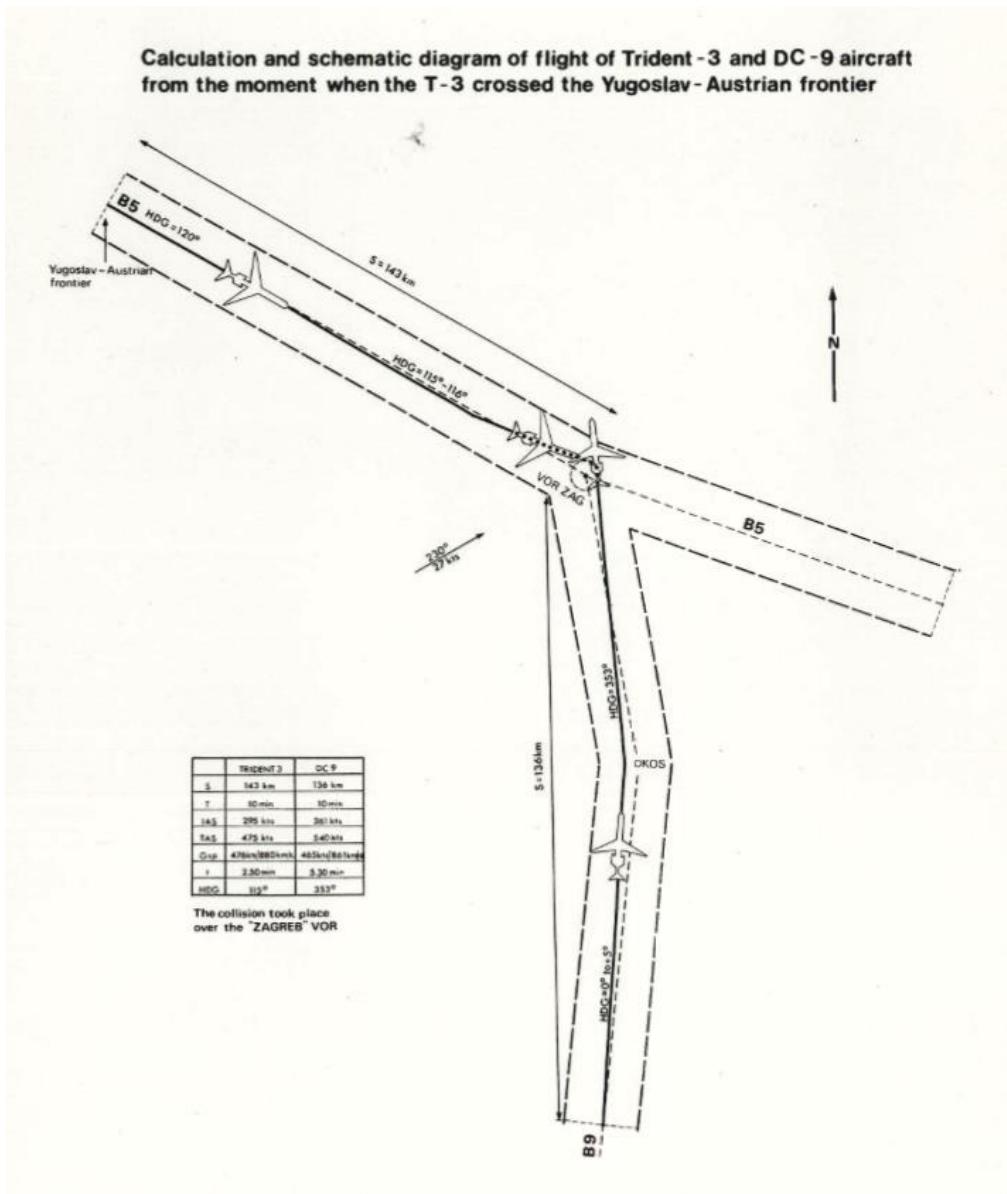
10/09/1976 Zagreb, Yugoslavia (Croatia), DC-9, INEX Adrian (Yugoslavian), Mid-air Collision, 108 pax + 5 crew/113

Hawker Siddeley HS-121 Trident 3B operated by British Airways as flight BE476 and a McDonnell Douglas DC-9-32, operated by Inex-Adria Aviopromet, were destroyed when both aircraft crashed near Vrobec following a mid-air collision. The collision was the result of a [procedural error on the part of Zagreb air traffic controllers](#). All 176 on board both aircraft were killed.

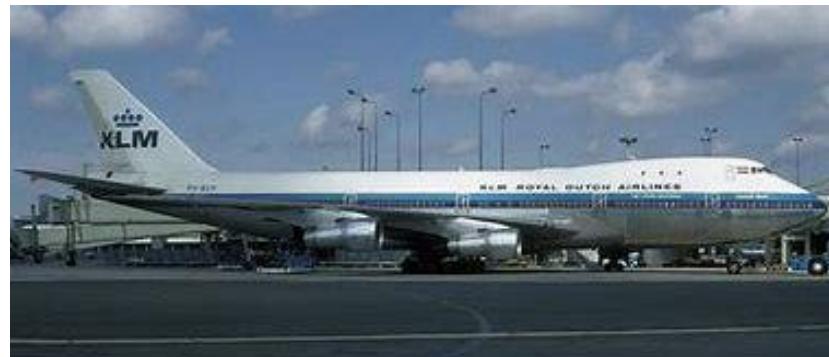
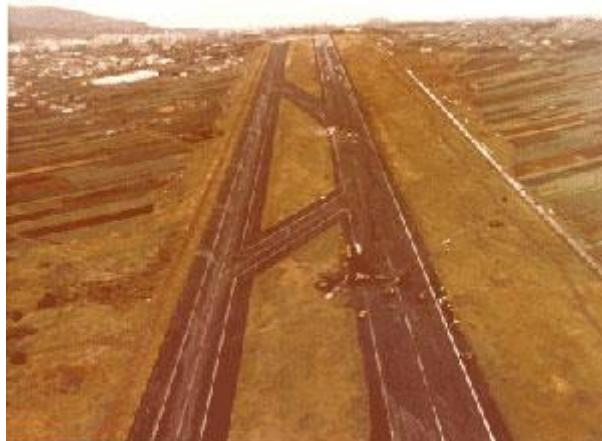
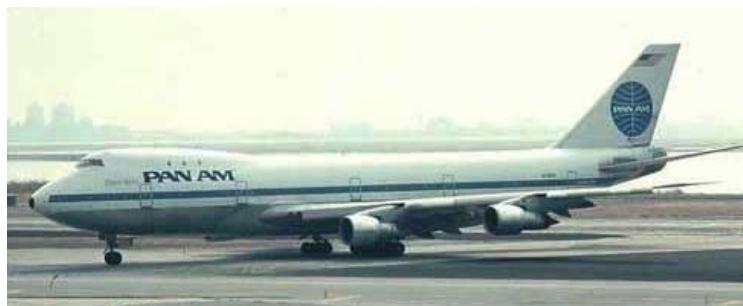
27/03/1977 Tenerife, Canary Island - Spain, B747, Pan Am, Collision on runway, 335/396

27/03/1977 Tenerife, Canary Island - Spain, B747, KLM, Collision on runway, 248/248

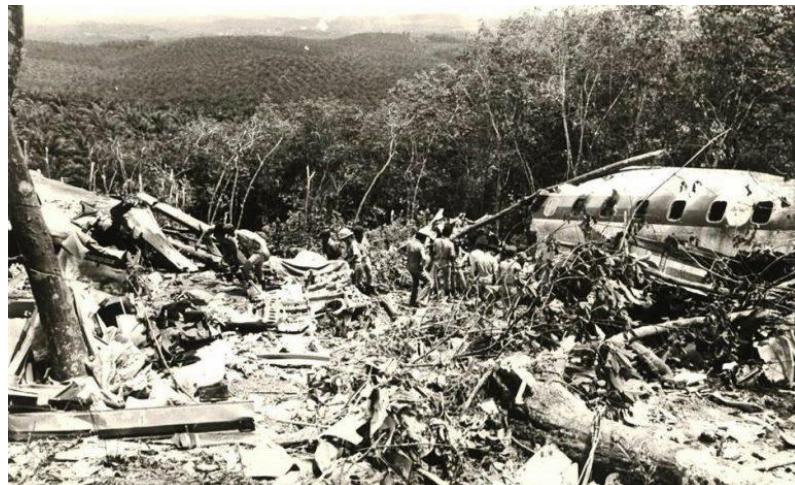
JAL715 crashed short of Kuala Lumpur in 1977

The accident was caused by the captain descending below minimum descent altitude without having the runway in sight, and continuing the descent until the aircraft struck terrain four nautical miles short of the runway threshold. A subsidiary contributory factor was insufficient monitoring of the aircraft's flight path by the captain under the adverse weather conditions with several aircraft in the holding pattern awaiting their turn for approach and, more importantly, the co-pilot's failure to challenge the captain's breach of company regulations.

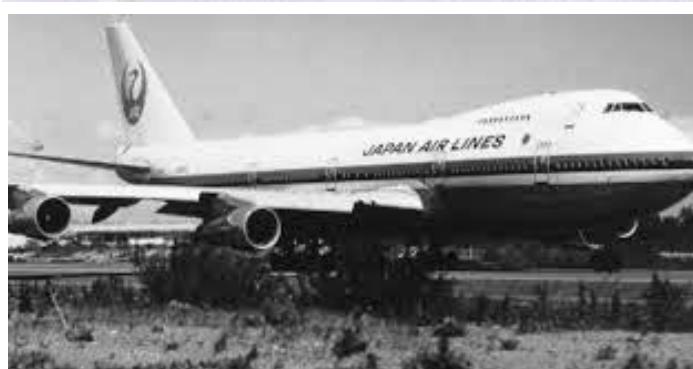
B747 SR

12/08/1985	<b>Mt. Osutaka, Japan, B747 SR, Japan Airlines, JL123, Structural Failure, 520/524</b>

**Probable Cause:** It is estimated that this accident was caused by deterioration of flying quality and loss of primary flight control functions due to rupture of the aft pressure bulkhead of the aircraft, and the subsequent ruptures of a part of the fuselage tail, vertical fin and hydraulic flight control systems.

The reason why the aft pressure bulkhead was ruptured in flight is estimated to be that the strength of the said bulkhead was reduced due to fatigue cracks propagating at the spliced portion of the bulkhead's webs to the extent that it became unable to endure the cabin pressure in flight at that time.

The initiation and propagation of the fatigue cracks are attributable to the improper repairs of the said bulkhead conducted in 1978, and it is estimated that the fatigue cracks having not been found in the later maintenance inspection is contributive to their propagation leading to the rupture of the said bulkhead."

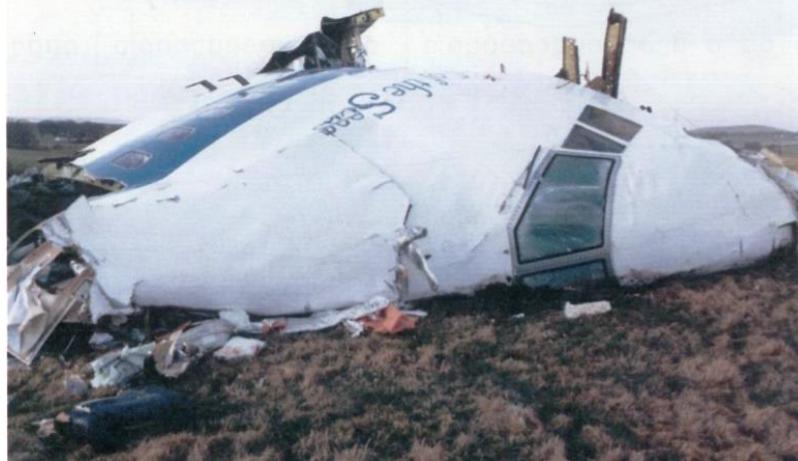
Pan Am Flight 103 was a regularly scheduled Pan Am transatlantic flight from Frankfurt to Detroit via London and New York. On 21 December 1988, N739PA, the aircraft operating the transatlantic leg of the route, was destroyed by a bomb, killing all 243 passengers and 16 crew in what became known as the Lockerbie bombing. Large sections of the aircraft crashed onto residential areas of Lockerbie, Scotland, killing 11 more people on the ground.

**PROBABLE CAUSE** "The in-flight disintegration of the aircraft was caused by the detonation of an improvised explosive device located in a baggage container positioned on the left side of the forward cargo hold at aircraft station 700."

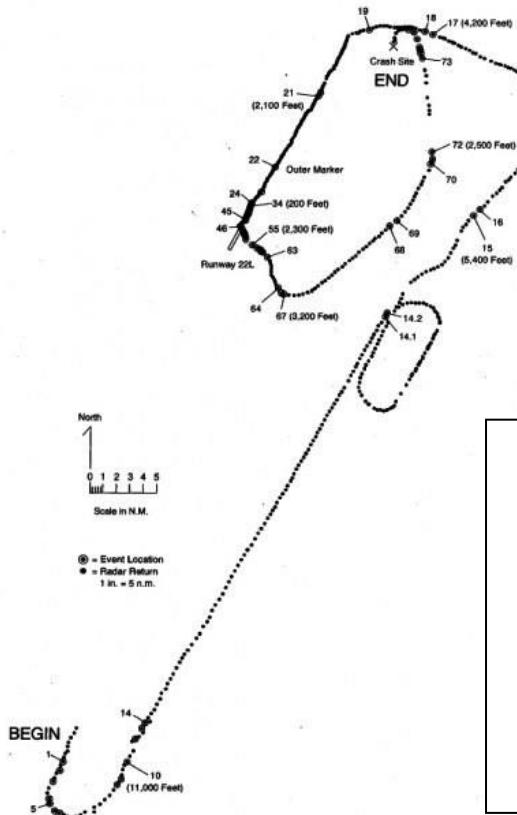
Due to the bad weather (300 feet ceiling, 400 m visibility, RVR - runway Visual Range of 2400 feet and wind shear of ca. 10 kt) the crew had to carry out a missed approach at 21:23. ATC vectored the crew for another approach. About 21:32, at 12 miles SE of JFK Airport, engines number 3 and 4 ran down. Shortly afterwards followed by the remaining two. At 21:34, heading 250° and flaps at 14° and gear up, the aircraft impacted on a hillside in a wooded residential area on the north shore of Long Island. The starboard side of the forward fuselage impacted and fractured the wooden deck of a residential home.

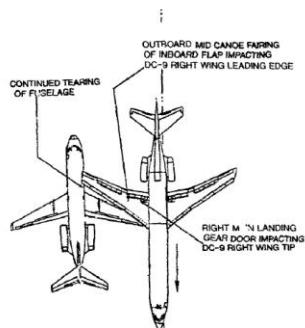
Figure 5a---Impact sequence.

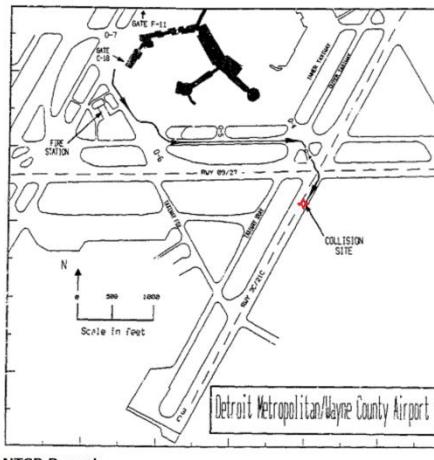
Figure 1.--DTW layout and DC-9 taxi route.

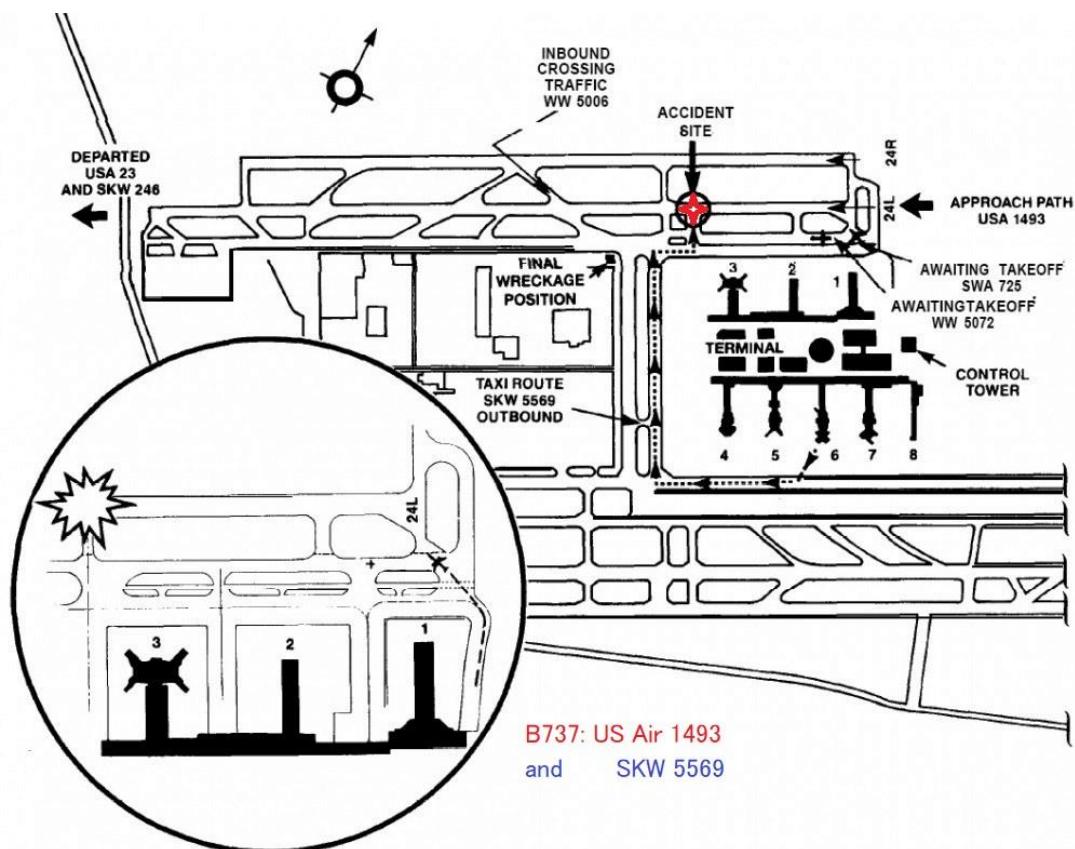
Los Angeles Airport Layout

USAir B737 aircraft entered LAX airspace around 17:57 and was cleared for a CIVET Two Profile Descent and ILS runway 24R approach. At 17:59 this was changed to a runway 24L approach clearance. At about the same time a SkyWest Metro II (Flight 5569 to Palmdale) taxied out from Terminal 6, Gate 32 to runway 24L. At 18:03 the crew were advised to "taxi up to and hold short of 24L" because of other traffic. At 18:04:49 the flight was cleared to **taxi into position and hold**. Immediately thereafter the controller became preoccupied with instructing **WingsWest 5006** who had unintentionally departed the tower frequency. The **WingsWest 5072** reporting ready for takeoff caused some confusion because the controller didn't have a flight progress strip in front of her. The strip appeared to have been misfiled at the clearance delivery position. Meanwhile, Flight 5569 was still on the runway at the intersection with taxiway 45, awaiting takeoff clearance. At 18:07 Flight 1493 touched down. Simultaneous to the nose gear touchdown, the Boeing 737 collided with the SkyWest Metro. Both aircraft caught fire and slid to the left into an unoccupied fire station.

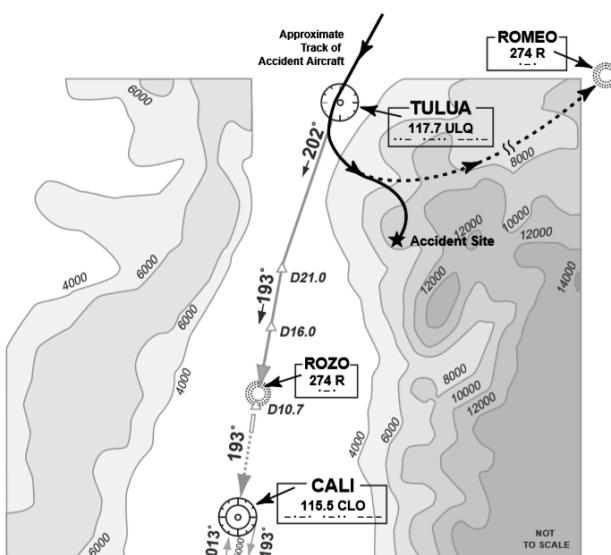
The aircraft had just passed Tulua VOR when it started a turn to the left (towards Romeo). This turn caused some confusion in the cockpit since Rozo I was to be a straight in approach. 87 Seconds after commencing the turn, the crew activated Heading Select (HDG SEL), which disengaged LNAV and started a right turn. The left turn brought the B757 over mountainous terrain, so a Ground Proximity (GPWS) warning sounded. With increased engine power and nose-up the crew tried to climb. The spoilers were still activated however. The stick shaker then activated and the aircraft crashed into a mountain at about 8900 feet (Cali field elevation being 3153 feet).

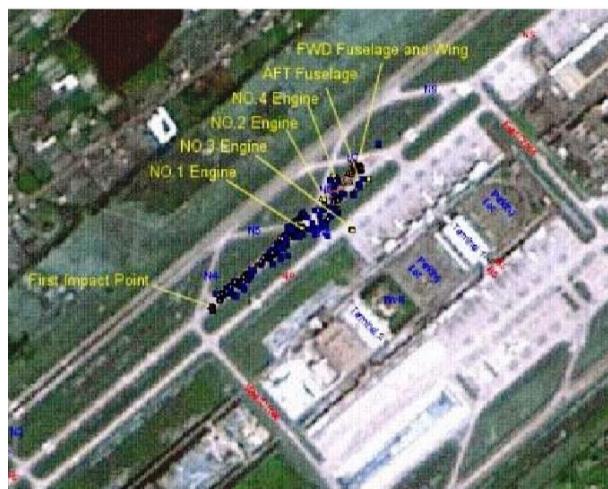
The crew had been cleared for a runway 05L departure because runway 05R was closed because of construction work. After reaching the end of taxiway NP, SQ006 turned right into Taxiway N1 and immediately made a 180-degree turn to runway 05R. After approx 6 second hold, SQ006 started its takeoff roll at 23:15:45. Weather conditions were very poor because of typhoon 'Xiang Sane' in the area. On takeoff, 3.5 seconds after V1, the aircraft hit concrete barriers, excavators and other equipment on the runway. The plane crashed back onto the runway, breaking up and bursting into flames while sliding down the runway and crashing into other objects related to work being done on runway 05R. The aircraft wreckage was distributed along runway 05R beginning at about 4,080 feet from the runway threshold. The airplane broke into two main sections at about fuselage station 1560 and came to rest about 6,480 feet from the runway threshold.

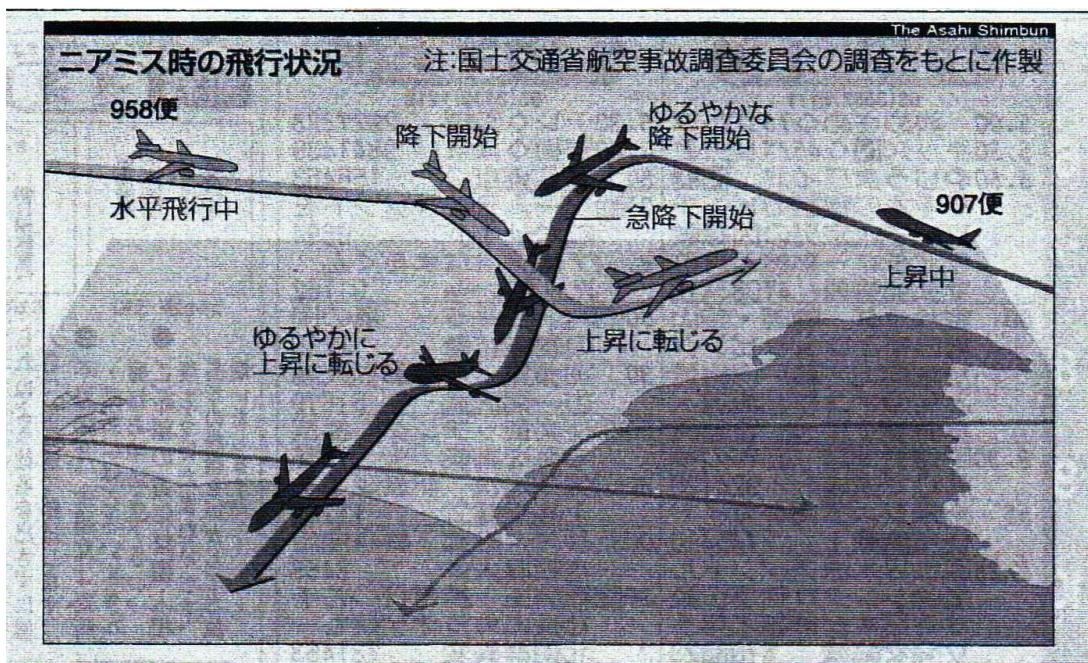
2001年01月31日17時00分頃、静岡県駿河湾上空で異常接近  
 日本航空907便・東京国際空港(HND)発、那覇空港(OKA)行ボーイングB747-446D(JA8904) および  
 日本航空958便・韓国 金海国際空港(PUS)発、新東京国際空港(NRT)行ダグラスDC-10-40(JA8546)

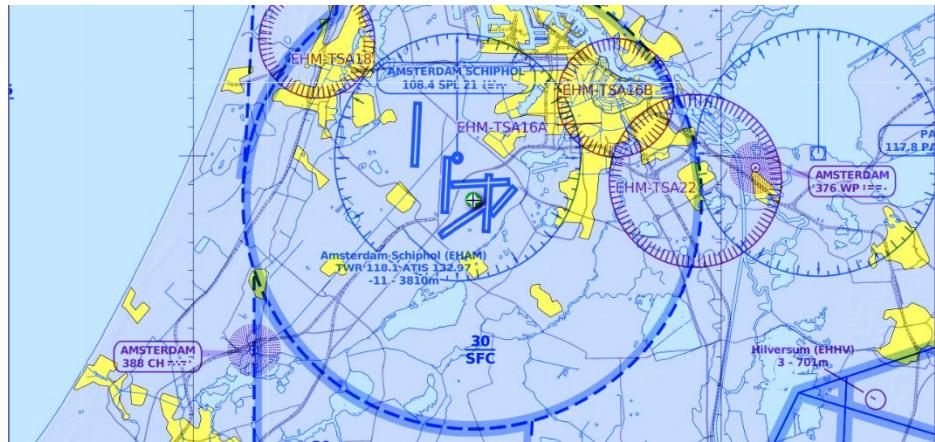
Amsterdam Schiphol Airport

A KLM Boeing 737-300, registration PH-BDP performing flight KL-1369 from Amsterdam (Netherlands) to Warsaw (Poland), was cleared to take off runway 36C at about 20:36L (19:36Z), however actually took off along the parallel taxiway B. The airplane continued to Warsaw for a safe landing.

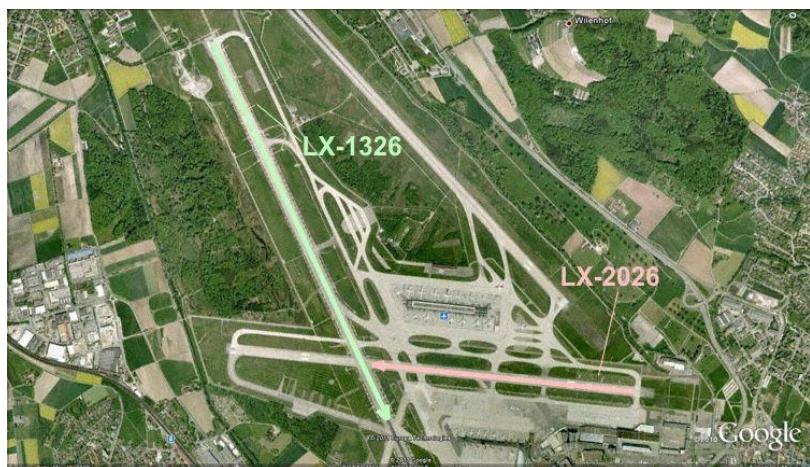
Zurich

The serious incident is attributable to the fact that the **air traffic control officer** concerned gave take-off clearance to an aircraft on runway 28 although another aircraft on runway 16, to which he had given take-off clearance shortly before, was still on its take-off roll. The result was that an **inadvertent convergence of these aircraft occurred**, involving a high risk of collision.

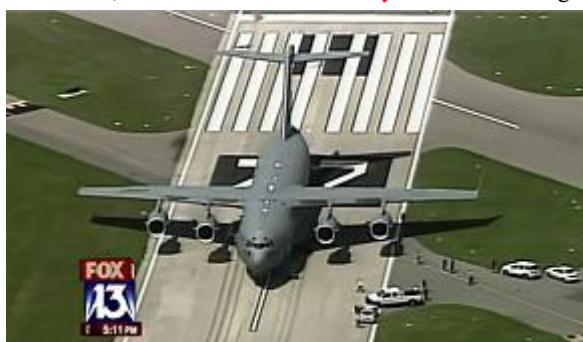
USAF C-17

### 20/07/2012 USAF C-17, bound for MacDill AFB mistakenly landed at Peter O'Knight Field (TPF)

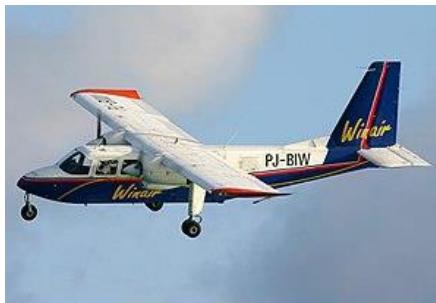
Britten-Norman BN2

A preliminary report released by the East Caribbean Civil Aviation Authority on Oct 13th 2012 states, that the aircraft yawed to the right shortly after becoming airborne and stopped climbing while rolling to the right. The aircraft subsequently lost height and impacted ground right wing tip first at low forward speed and cart wheeled before coming to rest in an upright position. The fuselage section forward of the wing was destroyed, the rest of the aircraft sustained

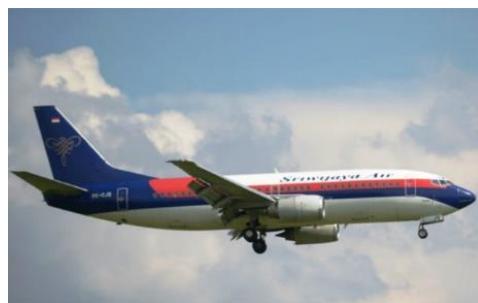
Sriwijaya Boeing 737-400

Sriwijaya Boeing 737-400, registration PK-CKD performing flight SJ-21 from Medan (WIMM) to Padang (WIPT) with 96 people on board, was supposed to land on Padang's new Minangkabau International Airport (WIPT), but landed on Padang's former civil, now only military Tabing Airport (WIMG) about 7nm south of Minangkabau International Airport. The landing at about 17:00L was safe.

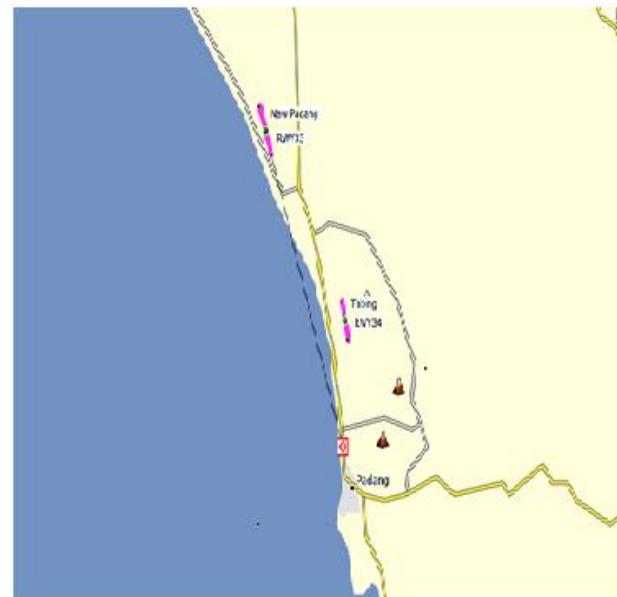
Location of two, new and old airports

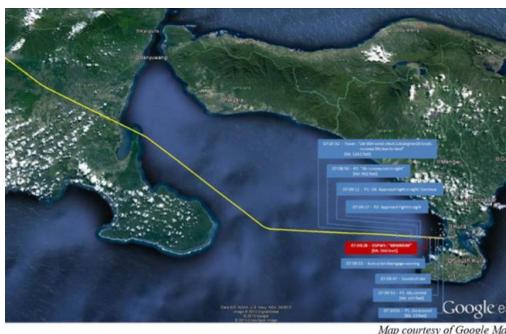
**Figure 1: The sequence of events**

Final Report: "Final Report No. KNKT.13.04.09.04, PT Lion Mentari Airlines (Lion Air) Boeing 737-800 PK-LKS Ngurah Rai International Airport, Bali Republic of Indonesia 13 April 2013"

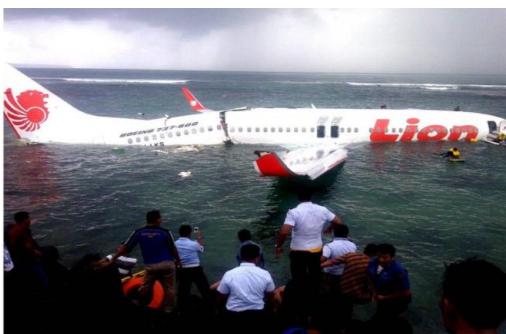
**Figure 2: The aircraft after the accident**

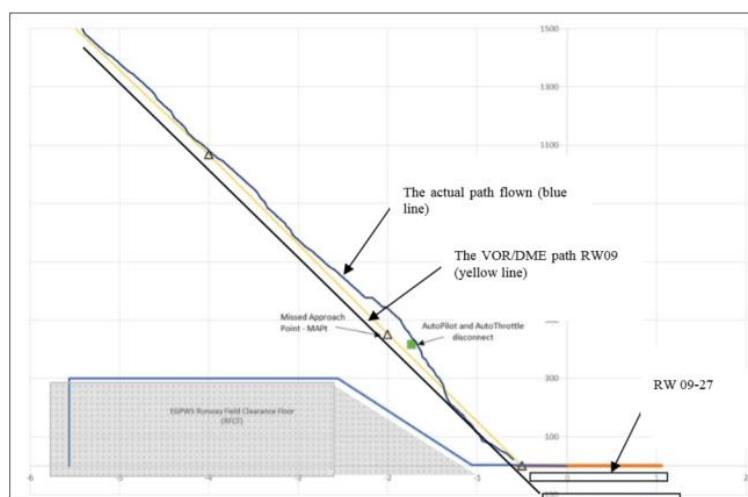
Figure 3: Aircraft flight path with respect to EGPWS envelope

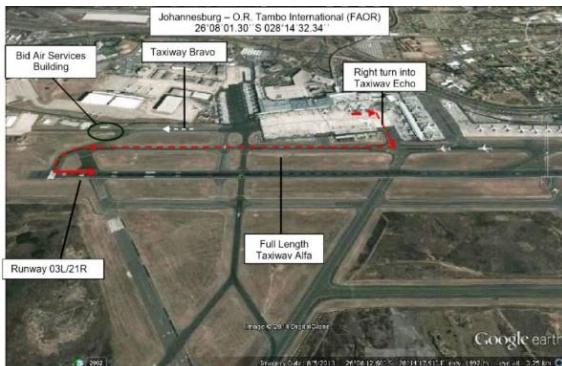
Figure 1 The expected taxi route which the flight crew discussed during the taxi and take-off briefing session

Contributory Factors: The crew did not conduct a briefing to discuss the cleared route, nor did they refer to the correct taxiway information in chart 10-6. In combination with the ground movement visual aids, this created confusion and loss of situational awareness when taxiing on taxiway Bravo.

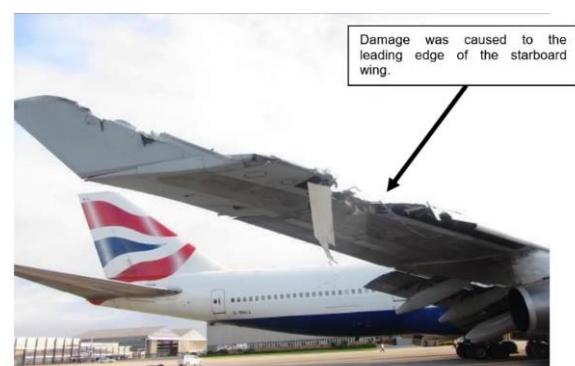
Figure 4 Damage caused to the starboard wing of the BA034 aircraft

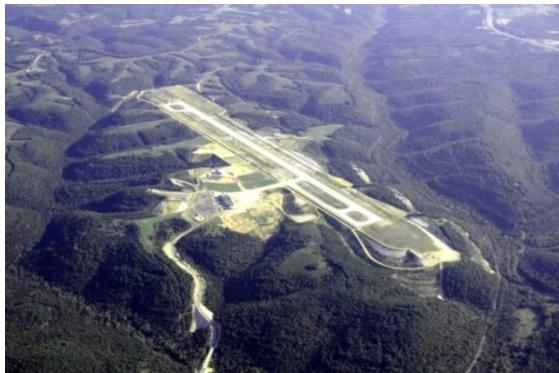
Rwy14/32 (7140ft) Hollister's Branson [KBBG]

Southwest Airlines B737-700, N272WN, WN-4013 Chicago Midway, IL to Hollister Branson Airport, MO with 124 passengers and 5 crew, was on approach to Hollister's Branson Airport [KBBG] but managed to touch down on runway 12 of Hollister/Branson's Graham Clark Airport [KPLK] about 5.5nm north of Branson Airport at about 18:11L (00:11Z Jan 13th) and stopped just at the end of the short runway with the main gear on the "piano keys". On Jan 17th 2014 the NTSB reported that the aircraft was piloted by a captain with about 16,000 hours of flying experience and a first officer with about 25,000 hours of flying experience. The captain was on his first approach to Branson Airport, the first officer had flown into Branson one time before however in daylight. Air Traffic Control informed the crew they were 15nm from their destination, the crew advised they had the airfield in sight, and the air traffic controller cleared the flight for a visual approach to Branson's runway 14. The crew did not realize until after landing that they were at the wrong airport. The NTSB collected two hours of good recordings from the cockpit voice recorder and about 27 hours of data from the flight data recorder. In addition to the interviews with the two pilots the NTSB also talked to a Southwest Airlines dispatcher who was occupying the observer's seat. The crew reported they had programmed the approach into the flight management system, however then saw the airport beacon and runway lights that they identified as Branson Airport. They believed to be at Branson Airport until after touchdown when they applied heavy braking to stop the aircraft on the runway, then they radioed Branson Tower that they had landed at the wrong airport.

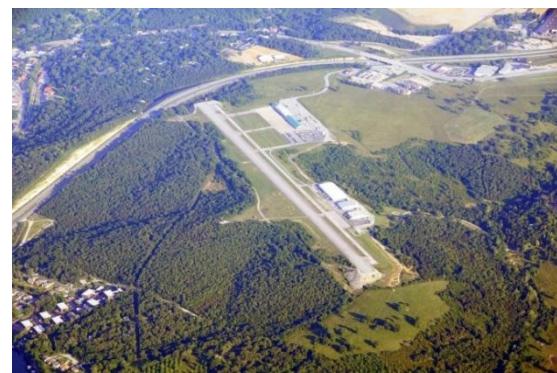
Rwy12/30 (3738ft) Hollister/Branson's Graham Clark [KPLK]

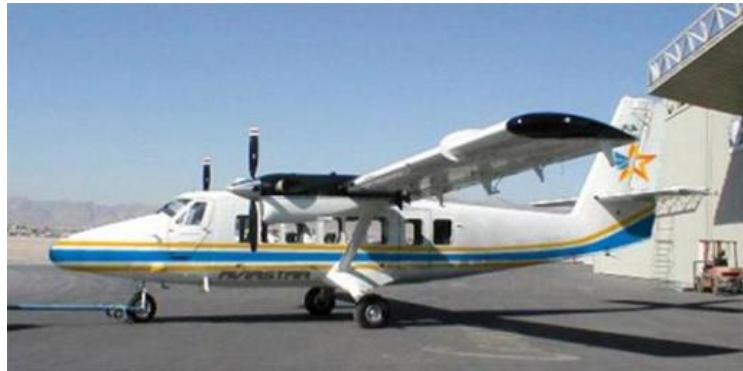
DHC-6

Aviastar Mandiri DHC-6-300 Twin Otter, PK-BRM from Masamba (WAWM) to Makassar with 10 passengers and 3 crew, was enroute at 8000 feet about 60nm before Makassar at about 15:15L (07:15z) when contact with the aircraft was lost.

At 06:50 UTC, the PIC told the SIC that he wanted to climb and the CVR stopped recording. The aircraft impacted treetops and crashed on the top of a mountain at an elevation of 7734 feet. The wreckage was located on Mount Latimojong on October 5. Mount Latimojong is a mountain range with several peaks. One of the peaks is the highest peak of Sulawesi at 3430 m above sea level.

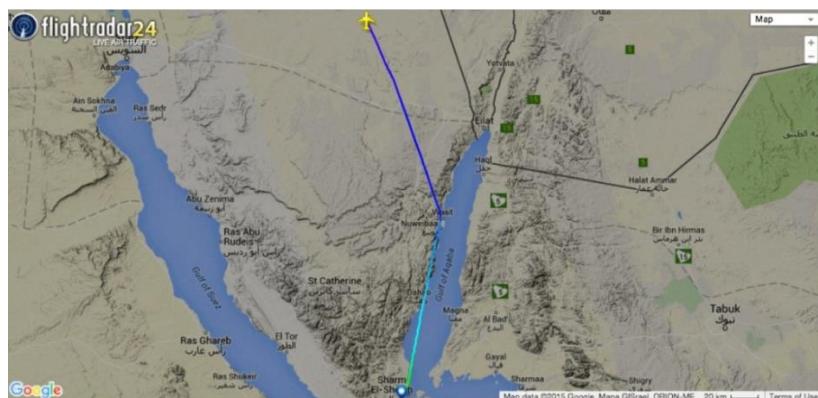
Metrojet (former Kogalym Avia, Kolavia) Airbus A321-200, EI-ETJ, 7K-9268 from Sharm el Sheikh (Egypt) to St. Petersburg (Russia) with 217 passengers and 7 crew, was climbing through FL307 out of Sharm el Sheikh over the Sinai Peninsula (Position N30.16 E34.17, 60nm south of Al-Arish) at 04:12Z when the aircraft disappeared from radar. Wreckage of the aircraft was later located in mountainous terrain about 20nm south of Al-Arish (Sinai, Egypt).

4:13:22z      KGL9268      N30.183 E34.161 27925ft 62kts 351mag 6528ft (vertical) AP32000ft
