# 民間航空機の主な航空事故一覧

## Major Air Disasters Involving Commercial Airlines

1937-2025

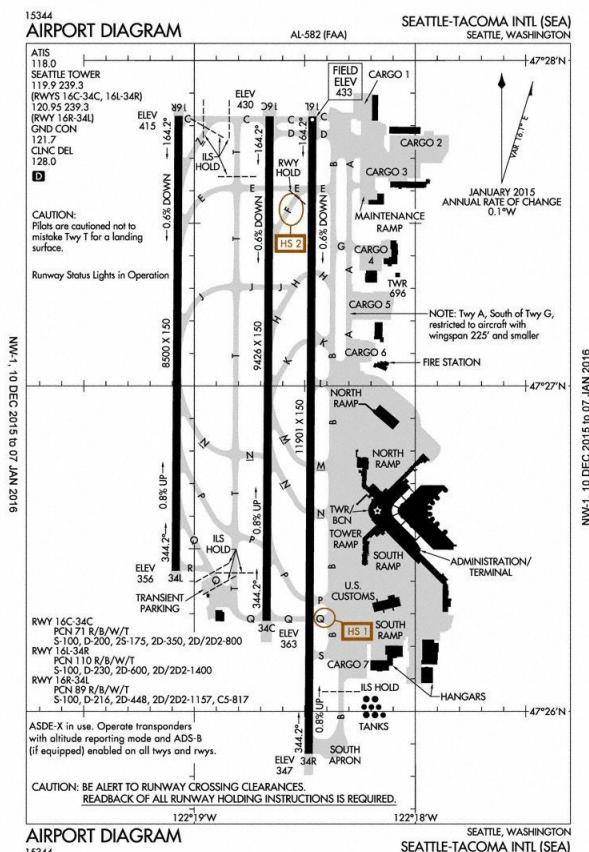
Alaska Airlines B737-900, N477AS, flight AS-27 from Chicago O'Hare, IL to Seattle, WA (USA) with 153 pax on board, was on an ILS approach to rwy 16R cleared to land on rwy 16R, when tower offered a visual swing over to rwy 16C, the crew opted to accept rwy 16C but aligned with taxiway T in between rwys 16R and 16C and continued for a safe landing on taxiway T at 08:31L (16:31Z), no other traffic was on taxiway T at that time. Tower, maintaining routine communication, cleared the aircraft to cross rwy 16L, the crew read that clearance back after a slight hesitation and maintained routine communication, too. On Feb 13th 2016 the NTSB announced that they have opened an investigation into the occurrence rated an incident. At the time of landing visual meteorologic conditions prevailed when the aircraft touched down on taxiway T instead of the intended rwy 16C.

A few points from the FO that was the non flying pilot for that flight.. Light rain had just finished, making the rwys wet. With the type of overcast and light conditions, the rwys and T don't have markings at that angle/alt. 16L "hides" in the ramp/terminal view, and 16R, T, 16L look like the 3 rwys. So T looks like

16C. When one is the NFP, going heads down to retune the LOC and reprogram the FMC, ya kinda loose some situational awareness when coming heads up. Officially, there have been only a few landings on T. Unofficially, the FAA understands there have been almost 20 landing on T in half as many years. Opinion: In Toronto's airport, the highly landed taxiway now has obvious paint on it. The cost of painting clear markings on T clearly is too expensive to support safety.

The flight crew inadvertently landed on a taxiway that ran parallel to the intended landing rwy. About 5 miles from the rwy and having been cleared to land on rwy 16R, the tower controller asked if the flight would like to sidestep to rwy 16C which had recently opened. The flight crew accepted and visually lined up with taxiway T, instead of the intended landing rwy 16C. Although visual meteorological conditions were present, the sun was reflecting off taxiway T resulting in the flight crew visually focusing on it during landing. The flight crew and controller did not recognize the error until after landing.

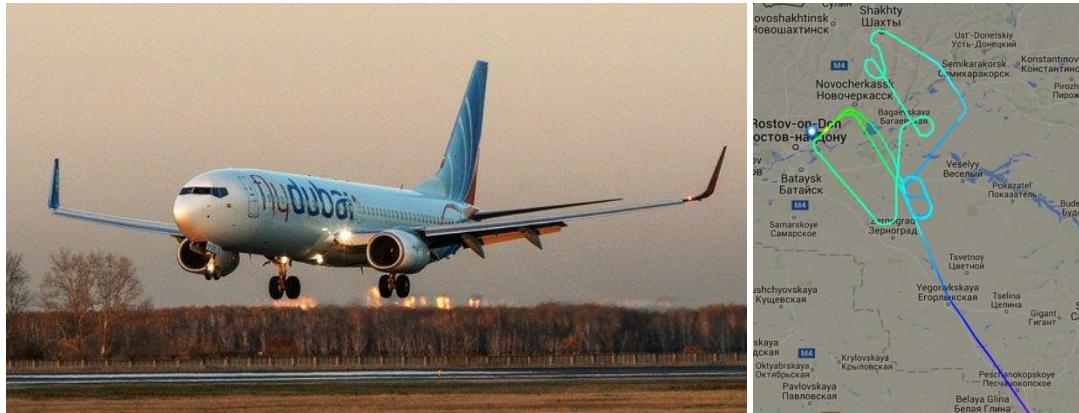
Flight path

Flydubai B737-800, A6-FDN, FZ-981 from Dubai to Rostov on Don (Russia) with 55 pax and 7 crew, had aborted the approach to Rostov's rwy 22 at 01:41L (22:41Z) due to weather and entered a hold initially at 8000 feet, after 30 minutes at 8000 feet the aircraft climbed to FL150. After about 2 hours of holding the aircraft commenced another approach to Rostov's rwy 22, winds 240/27 knts (14 m/s) +42 knts (22 m/s), but struck a wing onto the rwy at about 3:43 (00:43Z), broke up, came to a rest near the end and to the right of the rwy and burst into flames.

Cause of accident: an incorrect aircraft configuration and crew piloting, the subsequent loss of PIC's situational awareness in nighttime in IMC. This resulted in a loss of control of the aircraft and its impact with the ground.

Flydubai B737-800, A6-FDN, FZ-981

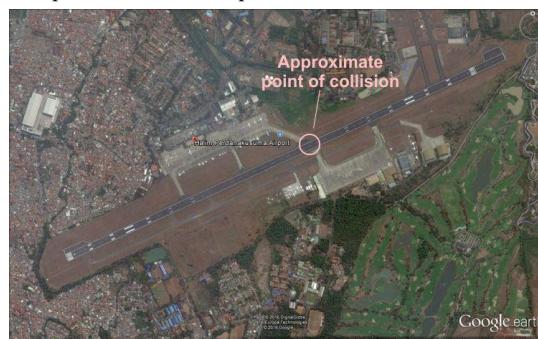
WIHH R/W 06/24

Batik Air B737-800, PK-LBS, ID-7703 from Jakarta Halim Perdanakusuma to Ujung Padang (INA) with 49 pax and 7 crew, was in the takeoff roll on rwy 24 at 19:55L (12:55Z) when its left wing tip entangled with the vertical tail and left wing of a Transnusa ATR ATR-42-600, PK-TNJ crossing the rwy under tow and separated the most of the vertical tail plane as well as the left wing from the ATR, the left wing tank ruptured open. Both aircraft caught fire. The B737 was evacuated via slides. Fire engines responded and were able to put the fires out in a matter of minutes. No injuries, both aircraft received substantial damage.

On Apr 14th 2016 the French BEA reported based on preliminary information from NTSC Indonesia, that the Batik B737-800 had been cleared to enter rwy 24 via taxiway C and backtrack the rwy. In the meantime the tug driver of the Transnusa ATR requested clearance to cross the rwy from the north to the south apron and received clearance to taxi via taxiway C, rwy 06/24 and taxiway G. While crossing the rwy the tug driver saw the B737 accelerate for takeoff and attempted to steer the tug and aircraft to the right rwy shoulder, however the left wing of the Boeing collided with the vertical stabilizer and left wing of the ATR. The Boeing rejected takeoff and came to a stop 400 meters past the point of collision.

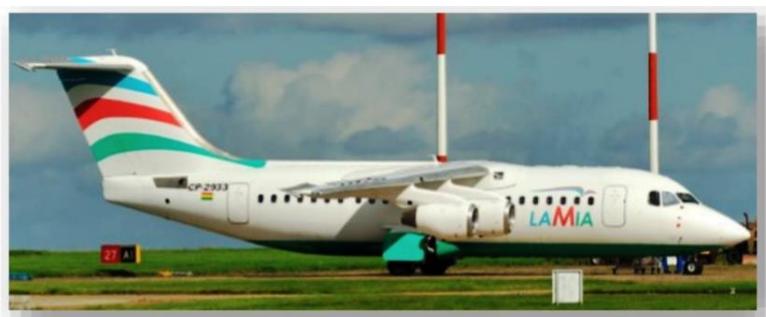
General appearance of the AVRO 146-RJ85

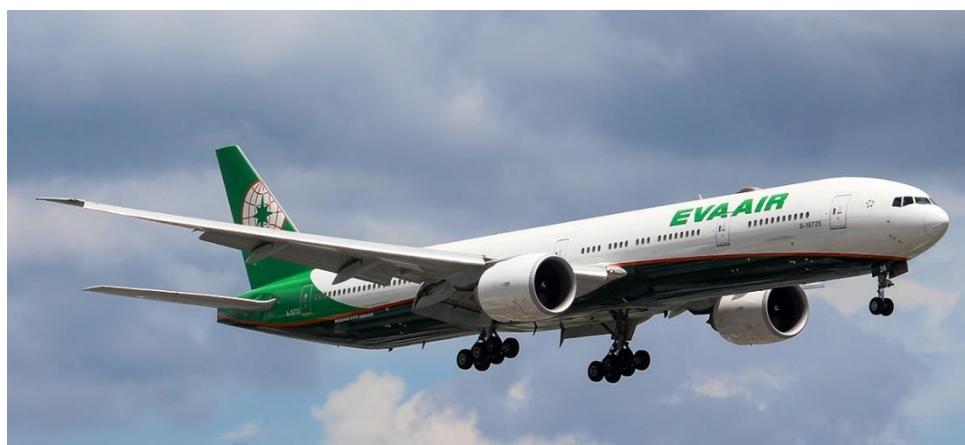
Eva Air B777-300, B-16726, flight BR-15 (scheduled Dec 15th, actual Dec 16th) from Los Angeles, CA (USA) to Taipei (Taiwan), departed LAX rwy 07R, contacted departure and was instructed to climb to 7000 feet, heading 090. The aircraft was subsequently instructed to climb to 7000 feet and turn left heading 180. The crew correctly acknowledged the instruction and turned left. Shortly after BR-15 an Air Canada Boeing 787-800, C-GHPX performing flight AC-788 (scheduled dep Dec 15th, actual dep 16th) from LAX to Toronto, ON (Canada), departed Los Angeles' rwy 06R, was instructed to climb to 7000 feet and join GABRE departure (which involves a left turn to the north). A conflict arose between AC-788 and BR-15, when BR-15 unexpectedly turned to the north, the controller instructed BR-15 to turn right heading 180. The crew acknowledged turn right heading 180, but continued to turn left. With raised voice the controller instructed BR-15 to stop climb. In an attempt to resolve the situation the controller now instructed [BR-15 to turn left](#) onto a heading

270, the aircraft continued to the north however. "What are you doing now" the controller asked and instructed to turn southbound NOW, crew asked "confirm heading", "turn southbound NOW", "left or right?" In the mean time the controller instructed AC-788 to climb to 12000 feet and expedite the climb, AC-788 complied and continued to Toronto for a safe landing without further incident.

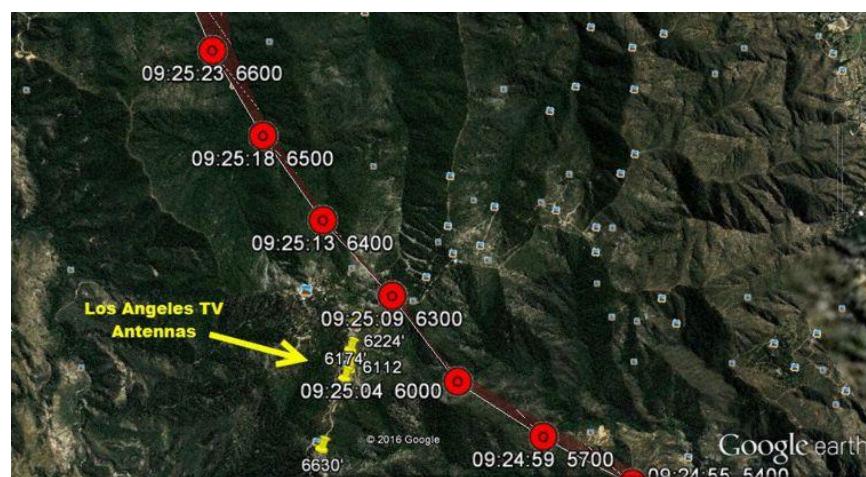
The incident was caused by the air traffic controller assigning the pilots **a left turn instead of the required right turn** after departure which placed the aircraft in an unsafe proximity with terrain and obstructions. Contributing to the incident was the air traffic controller's inadequate recovery technique during the development of the incident.

Due to weather in the area, LAX was operating in an east flow configuration with aircraft departing to the east. The B777-300 pilot contacted the SCT controller and was given an initial climb to 7,000 feet. A short time later, the SCT controller instructed the pilot to **turn left to a heading of 180 degrees** which required a left 270-degree turn. The turn resulted in the aircraft turning toward rising terrain and back toward the airport; normal procedures in an east flow would have been **for a right turn to a heading of 180 degrees**. While in the left turn, the pilot requested a high-speed climb which resulted in the aircraft accelerating beyond the 250 knot LAX class B speed restriction and required additional airspace in order to complete an assigned turn. After recognizing the aircraft was in a left turn, the SCT controller issued the crew a right turn to a heading of 180 degrees. As the aircraft began to turn right, the air traffic controller instructed the crew to expedite the turn due to recognizing a developing proximity issue with another aircraft that had departed from LAX. The air traffic controller stopped the climb of the B777-300 and issued a left turn to a heading of 270 degrees. These turns in quick succession, combined with the speed of the aircraft, resulted in the flight tracking northbound toward rising terrain. The closest lateral and vertical proximity between the airplane and terrain/obstructions was about 0.3 miles and 0 ft, respectively, which is less than the minimum separation requirements.

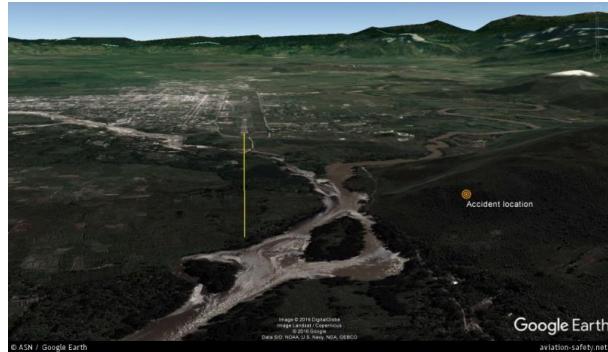
Lockheed C-130H Hercules was destroyed when it impacted mountainous terrain near Wamena, Papua, Indonesia. All 13 on board were killed. The aircraft left Timika at 05:35 and was expected to arrive at Wamena at 06:13. It was approaching rwy33 at the time of the accident. The aircraft went through the center line of the final approach and impacted the south slope of the hills to the right of the center line, about 0.9 NM from the rwy threshold at about 5,700 ft, Wamena EL is 5,085 ft.

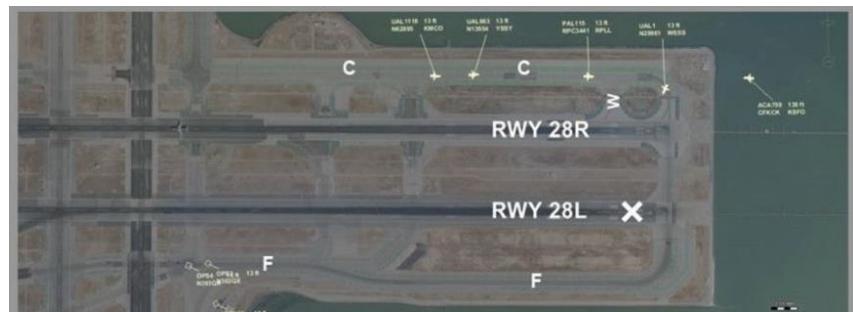
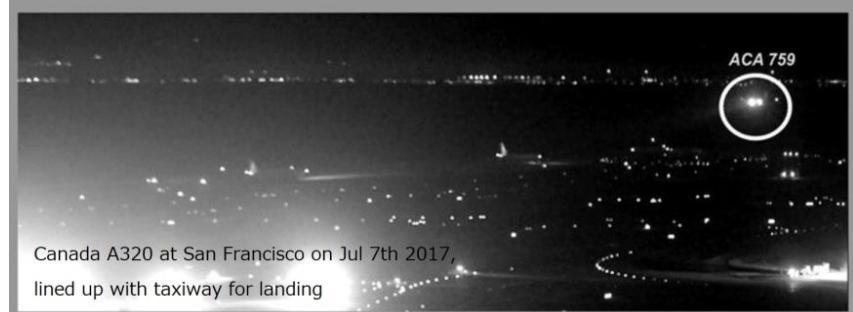
Canada A320 at San Francisco on Jul 7th 2017,  
lined up with taxiway for landing

UAL1 (23:56:01): where's this guy going?

Air Canada A320-200, C-FKCK, AC-759 from Toronto, ON (Canada) to San Francisco, CA (USA) with 140 people on board, was on final approach to rwy 28R in night conditions being cleared to land at about 23:56L (06:56Z Jul 8th), when a short time after reading back the landing clearance the crew queried tower to confirm they were cleared to land advising they were seeing lights on the rwy, tower advised the rwy was clear and they were cleared to land indeed. Another voice chimed in calling they were lined up with the taxiway, tower immediately instructed AC-759 to go around as result commenting it looked like they were lined up for taxiway C. The aircraft went around from below 100 feet AGL. Other flight crew taxiing their aircraft on taxiway C commented the A320 was flying straight over them. The A320 positioned for another approach and landed safely about 15 minutes later.

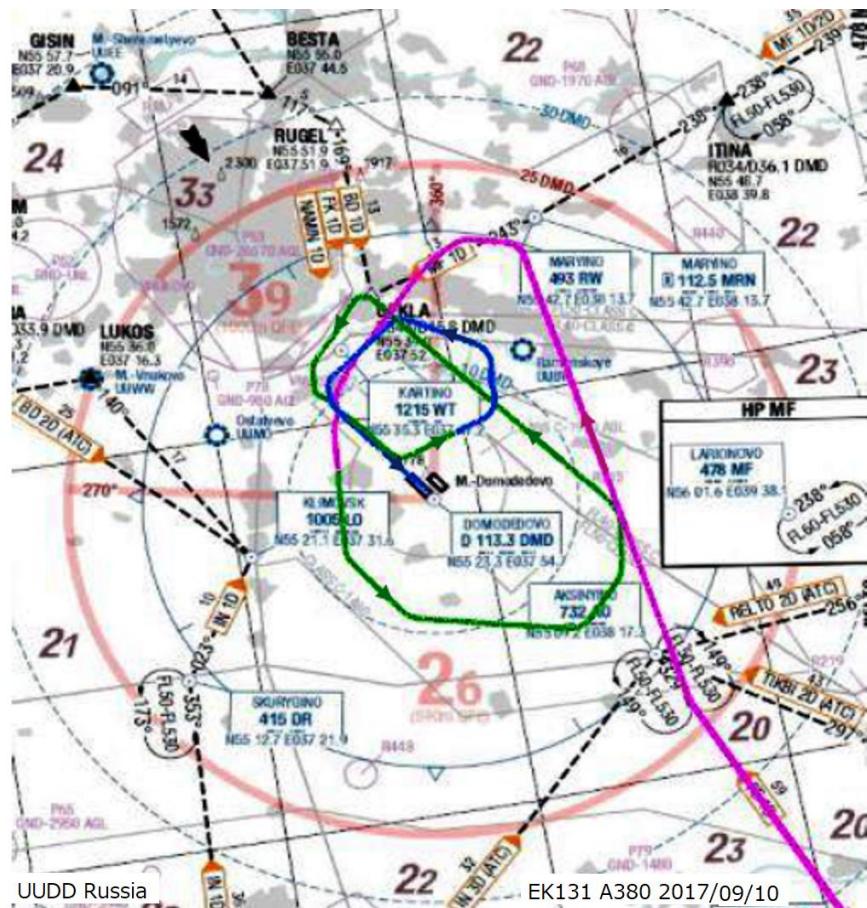
Incident Report: by UAE GCAA

The flight crew flew one go-around and one discontinued approach and landed on runway 14R from the third approach. The go-around, discontinued and landing are shown in figure above. The trajectory in magenta depicts the first approach and go-around, the green line illustrates the second approach and discontinued approach, and the third approach and landing is shown by the blue line.

UAE General Civil Aviation Authority (GCAA) reports: during approach to UUDD, the aircraft was cleared for the rwy 14R ILS approach when it was on the base leg. The aircraft descended below its cleared altitude of 500m QFE prior to establishing on the localizer. The Radar Controller alerted EK131 to stop the descent. The flight crew then performed a go-around and requested vectors for a second approach. During the go-around, **the minimum radio altitude reached was 395 ft above ground level**, and EGPWS “Glideslope” and “Terrain Ahead - Pull Up” alerts were activated.

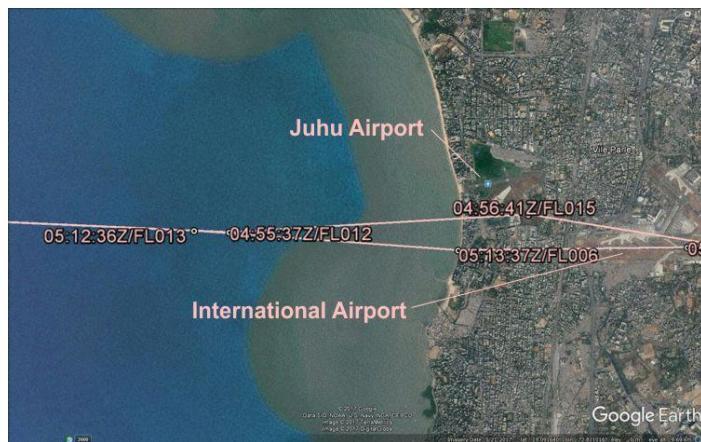
Singapore Airlines A350-900, 9V-SMH, SQ-422 from Singapore to Mumbai (India), was cleared for the approach to Mumbai International Airport's rwy 09 and was descending through about 1000 ft MSL when the crew initiated a go around, positioned for another approach to rwy 09 of the Airport and landed safely on that rwy about 18 minutes later.

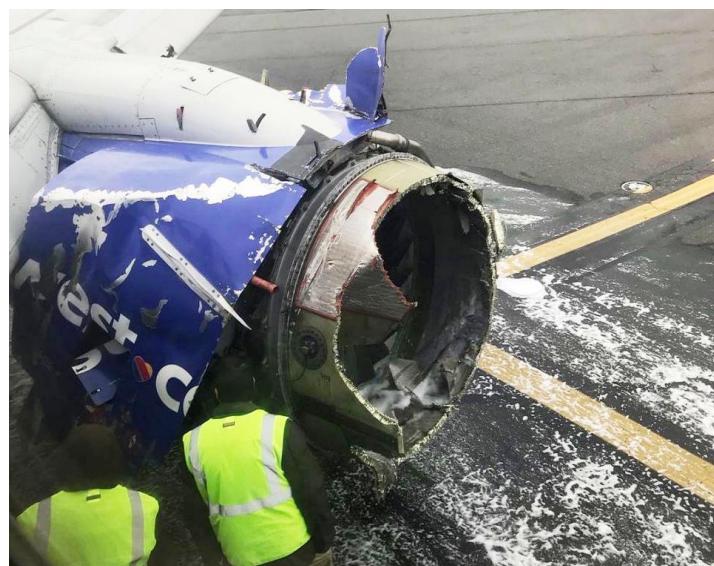
An engine on Southwest Airlines exploded, killing one passenger

17/04/2018 Southwest Airlines B737-700, WN1380 diverted to Philadelphia, Pennsylvania, USA, after suffering an in-flight uncontained engine failure. The flight originated from New York-La Guardia Airport at 10:43 for a flight to Dallas-Love Field, Texas. 1/149

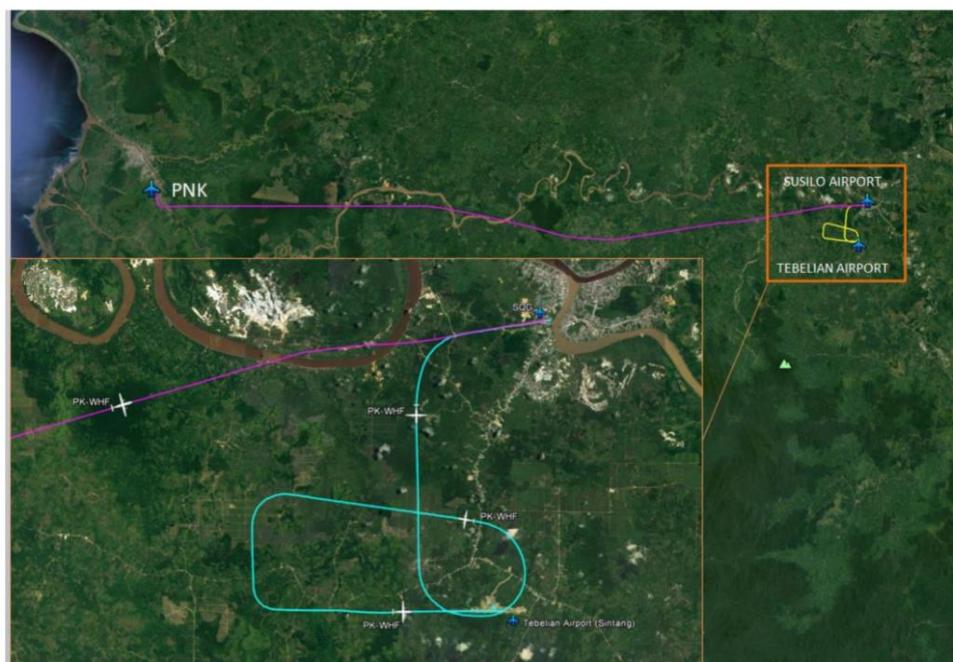
**Figure 2: The flight track as recorded on the FDR. Purple line indicated the flight from Pontianak to Susilo Airport, and the blue line indicated the flight from Susilo Airport to Tebelian Airport.**

19/06/2018 Sintang, Kalimantan, INA, Wings AT72 at Sintang on Jun 19th 2018, landed at wrong airport  
 Wings Air ATR-72-212A, PK-WHF, IW-1370 from Pontianak to Sintang Tebelian (w/o Indonesia), landed safely on Sintang's former Susilo Airport. Susilo Airport had been in use until April 26th 2018. On April 26th 2018 00:00Z (07:00L) the new Tebelian Airport (rwy 09/27 length 1660 meters) located about 11km south replaced Susilo Airport (rwy 08/26 length 1300 meters) maintaining the ICAO and IATA identifiers of Susilo Airport, Susilo Airport was shut down. (Old Sintang Sisulo: N0.063619E111.473428)

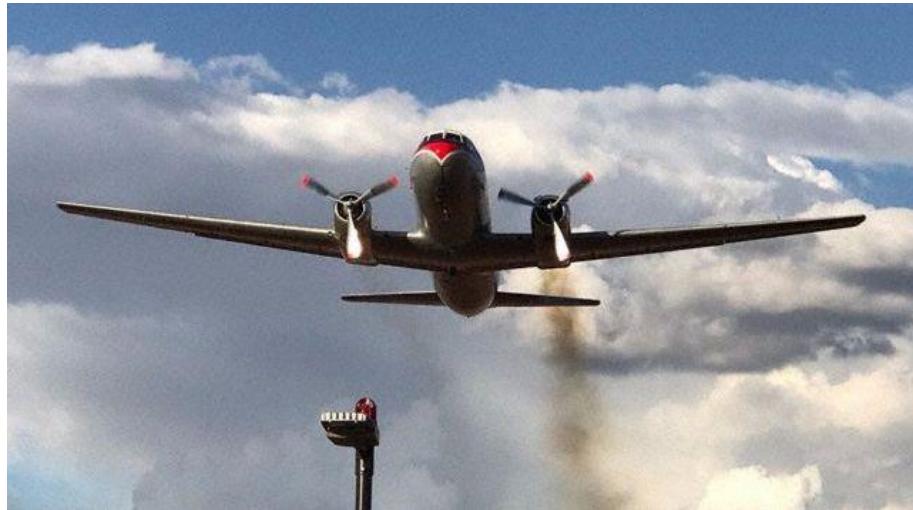
Convair CV-340

10/07/2018 Pretoria, South Africa, Rovos Rail CVLP, engine problem, [1/19+1 on gmd](#)  
 Rovos Rail Tours Convair [CV-340](#) in MAC Martin's Air Charter colours, registration ZS-BRV performing a test flight from Pretoria Wonderboom to Pilanesberg (South Africa) with 4 crew and 15 passengers, was climbing out of Wonderboom's rwy 29 when ground observers observed smoke from the lefthand engine, the aircraft appeared to not climb anymore, estimated height was about 300 feet. The aircraft appeared to manoeuvre to join a right downwind and turn for final when it lost height, impacted and broke through an industrial building and came to rest about 5.7km/3.1nm east of the airport at position

S25.6711 E28.2838. About 20 people on the aircraft and on the ground received injuries, the flight engineer received critical injuries and subsequently died, three other people - reportedly including the pilots - received serious injuries.

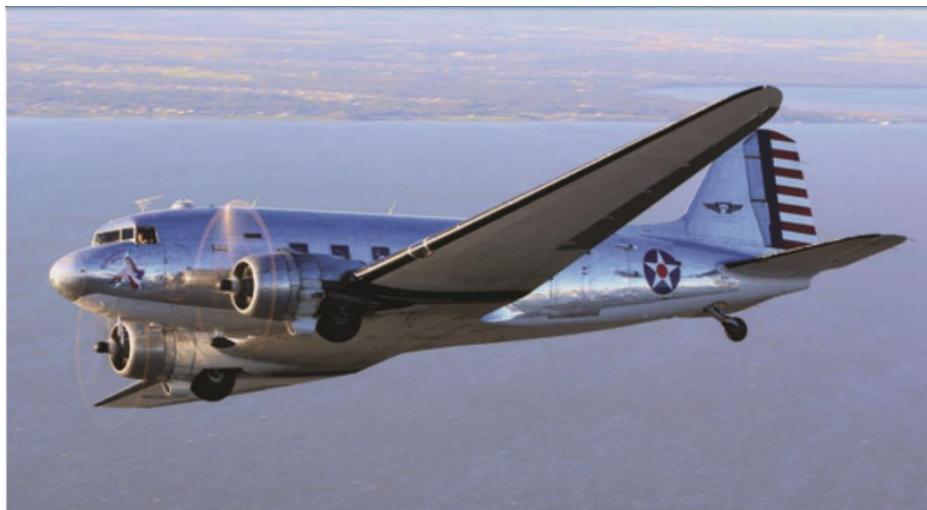
Commemorative Air Force, Highland Lakes Squadron C-47B (DC-3)

Examination of the accident site revealed that the airplane came to rest upright on a heading of about 113° magnetic, about 145 ft east of the left side, and 2,638 ft from the approach end of rwy 19. The postimpact fire consumed the fuselage from the nose cone aft to about 3 ft forward of the left side cargo door along with a majority of the wing center section.

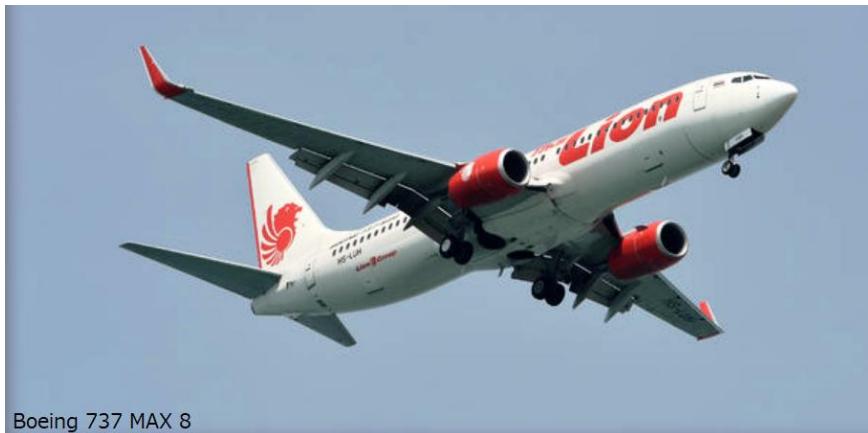
On Monday 29 October 2018 at 0631z a Lion Air B737 MAX 8, PK-LQP, lost height and crashed into Java Sea, 15 km (9.4 mls) N off Tanjung Bungin, Indonesia. The flight departed Jakarta-Soekarno-Hatta International Airport (CGK/WIII), to Pangkal Pinang Airport (PGK/WIKK), Indonesia. The aircraft is commanded by Captain. Bhavye Sunuja and co-pilot Harvino with six cabin crew Shintia Melina, Citra Noivita Anggelia, Alviani Hidayatul Solikha, Damayanti Simarmata, Mery Yulianda, and Deny Maula. The captain (Indian national) has 6,000 flight hours and the co-pilot (Indonesian) has more than 5,000 flight hours.

The Aircraft Flight Maintenance Log (AFML) recorded that since October 26, 2018 until the occurrence date several problems occurred related to airspeed and altitude flags that appeared on the captain's (left) Primary Flight Display (PFD) on three occasions, SPEED TRIM FAIL light illumination and MACH TRIM FAIL light illumination that occurred twice.

Several attempts were made by engineers to rectify these issues. The day before the accident the Angle of Attack (AoA) sensor was replaced by engineers at Denpasar Airport. During takeoff from Jakarta, the DFDR recorded a difference between left and right Angle of Attack of about 20° which continued until the end of the recording. During rotation of the aircraft, the left control column stick shaker activated and continued for most of the flight. After the flaps were retracted, the FDR recorded automatic aircraft nose down (AND) trim for 10 seconds followed by flight crew commanded aircraft nose up (ANU) trim.

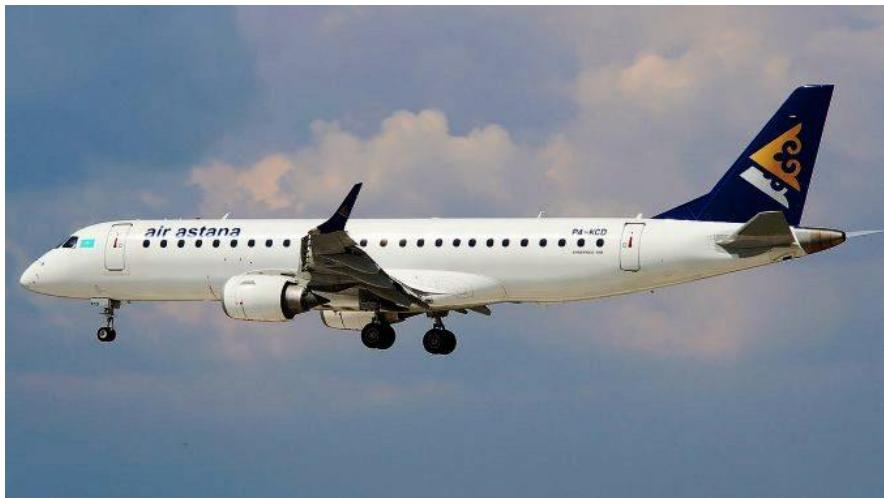
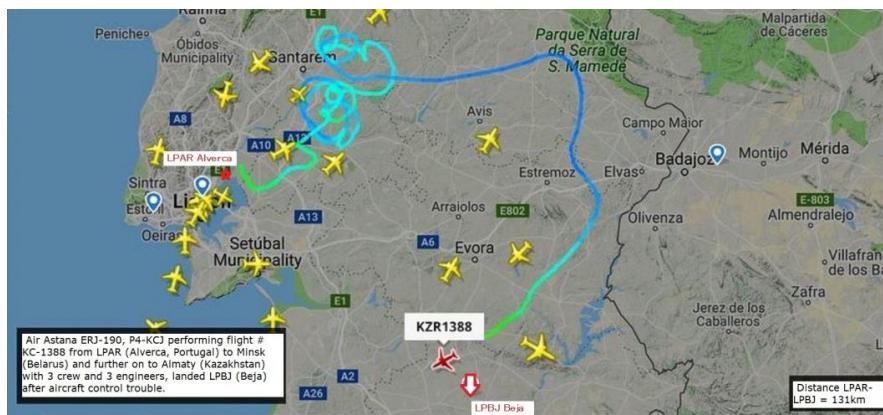
ATC Comm:

02:40 MAYDAY  
11:30 First ditching statement  
13:00 ATC offers "the river"  
17:55 "Completely uncontrollable"  
20:00 Request for VMC  
21:50 6 POB "Completely uncontrollable. Flight control problem" Planning a sea ditching  
23:55 ATC suggests southbound heading to better weather.  
27:10 Confirming planning to ditch  
29:10 Controller change

04:50 "Improved our conditions" ?  
06:42 "Request vectoring to the sea" Discussion about river and "weather below us"  
09:30 Requested confirmation that they could reach the sea on present heading

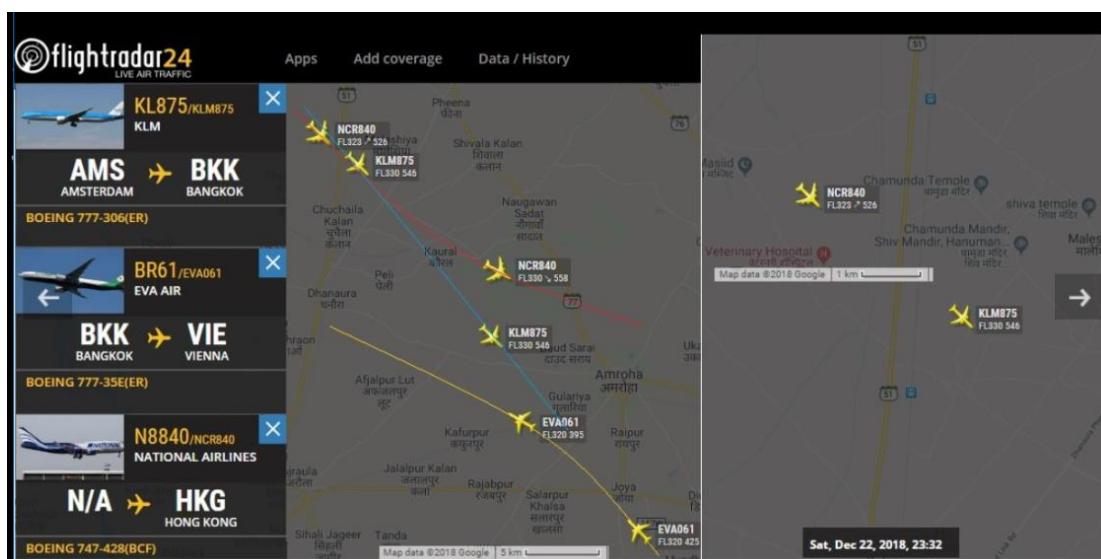
23/12/2018 BOBCAT L509 near New Delhi NAC B744 climbed without ATC clearance, loss of separation with KLM875 and BR61

Location: N28 59 35.3 E78 18 57.3 at Dec 23 in India (but Dec 22 2332Z)

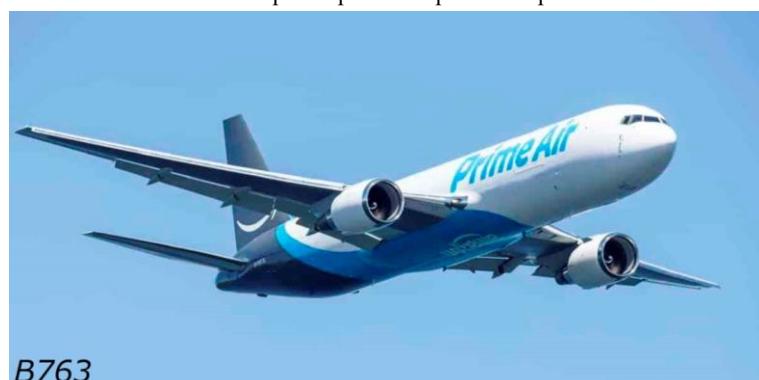
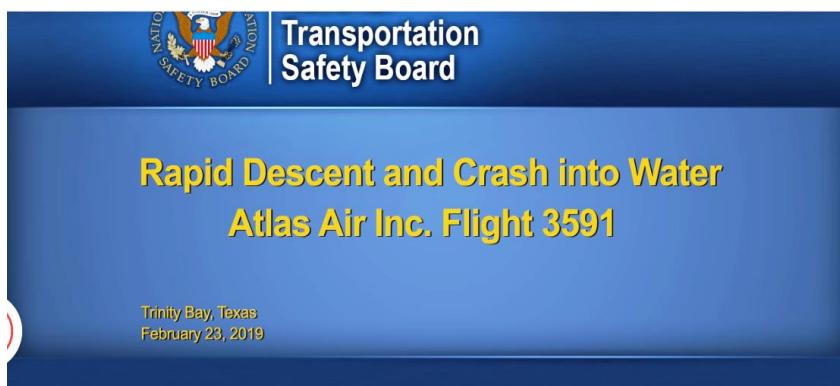
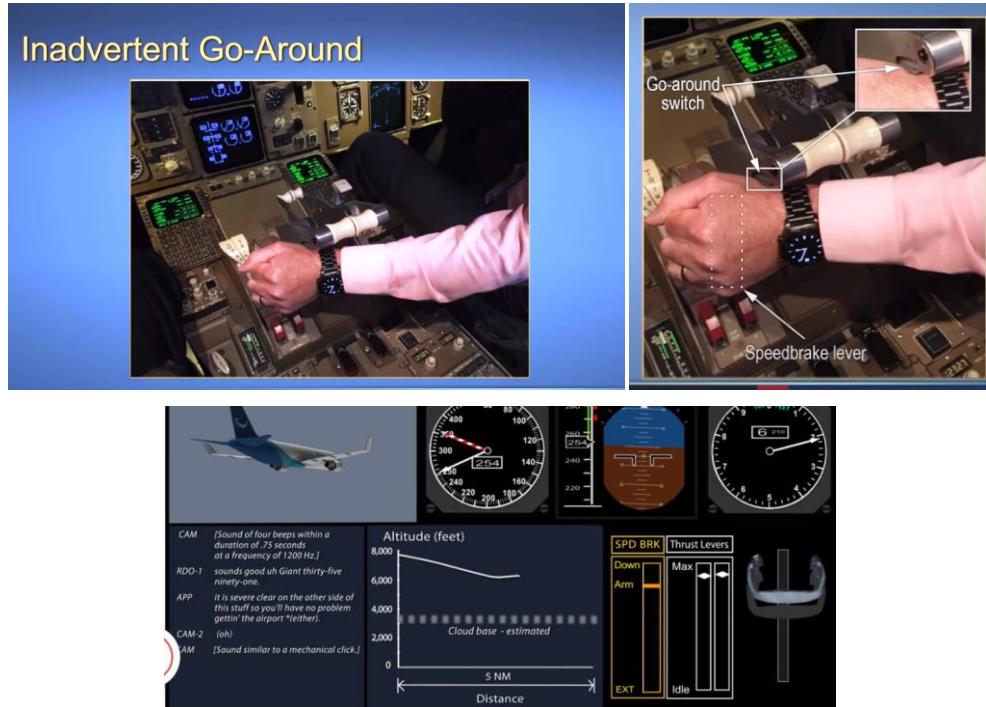
B763 cargo aircraft with 3 crew, was on approach to Houston in contact with Houston Approach, routine communication, when radio and radar contact with the aircraft was lost about 30nm southeast of Houston Intercontinental Airport at about 12:40L (18:40Z). The aircraft was found near position N29.7636 W94.7145 having impacted the waters of Trinity Bay about 1.5nm northwest of Anahuac Bayside Community Hospital. NTSB determines that the probable cause of this accident was the [inappropriate response by the first officer](#) as the pilot flying to an [inadvertent activation of the go-around mode](#), which led to his spatial disorientation and nose-down control inputs that placed the airplane in a steep descent from which the crew did not recover.

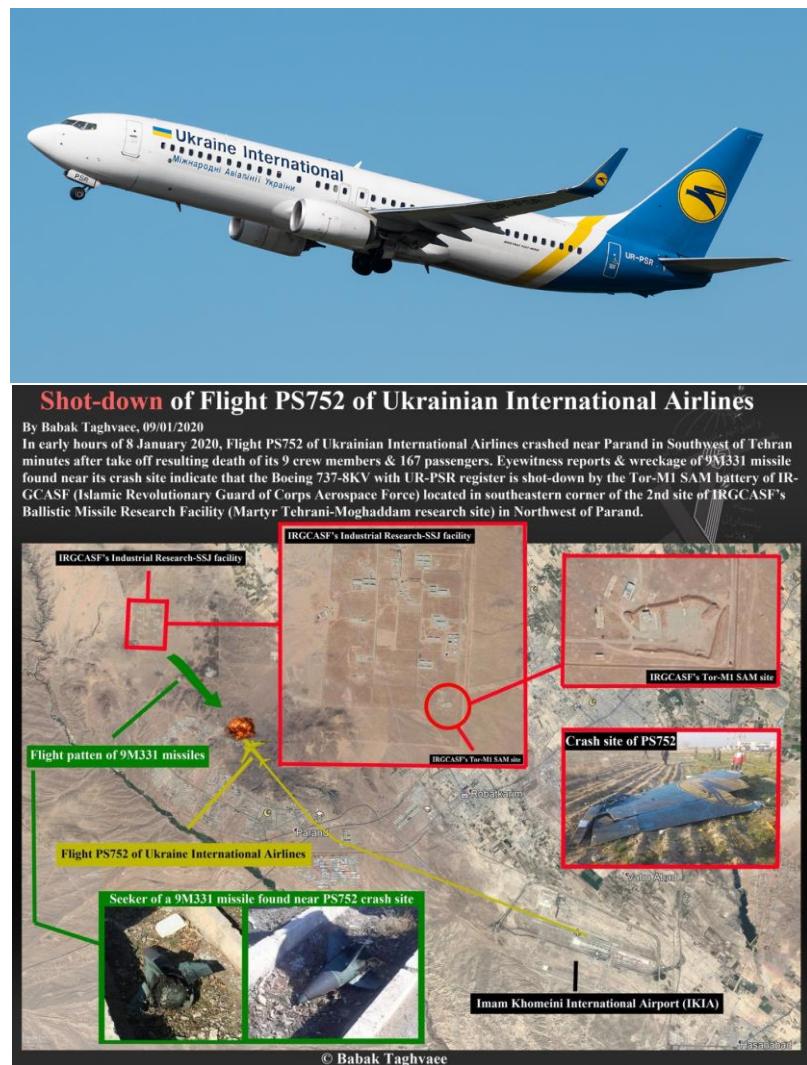
UIA Ukraine International Airlines B737-800, UR-PSR flight PS-752 from Tehran Imam Khomeini (Iran) to Kiev (Ukraine) with 167 pax and 9 crew, was climbing through 8000 feet MSL out of Tehran's rwy 29R about 12nm northwest of the airport at about 06:18L (02:48Z), when the aircraft's transponder signals ceased. The aircraft was found in an open field near Parand, a suburb of Tehran, at position N35.5529 E51.1121 about 10nm east of the last transponder position (N35.52 E50.91). All occupants perished in the crash.

The air defense's launching two surface-to-air missiles at the flight PS752, UR-PSR aircraft the detonation of the first missile warhead in proximity of the aircraft caused damage to the aircraft systems and the intensification of damage led the aircraft to crash into the ground and explode instantly.

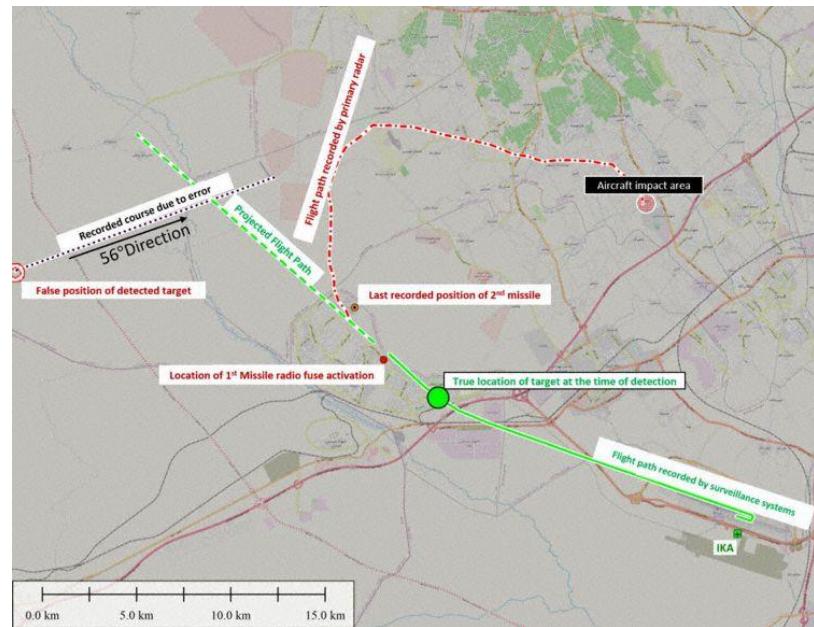
Complete flight trajectory and missile last positions (Graphics: Iran's AIB):

Mar 17th 2021 Iran's CAO released their **final report**, concluding the probable causes of the crash were: **The air defense's launching two surface-to-air missiles at the flight PS752, UR-PSR aircraft**, the detonation of the first missile warhead in proximity of the aircraft caused damage to the aircraft systems, and the intensification of damage led the aircraft to crash into the ground and explode instantly. Other Contributing Factors- The mitigating measures and defense layers in risk management proved to be ineffective due to the occurrence of an unanticipated error in threat identifications, and ultimately failed to protect the flight safety against the threats caused by the alertness of defense forces.

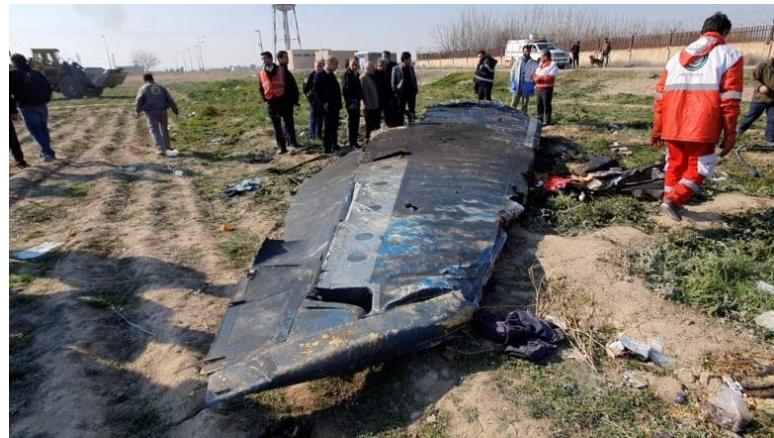
Iran's Revolutionary Guard Corp fired two surface-to-air missiles at PS752, killing all 176 people onboard, on Jan. 8, 2020. (Reuters)

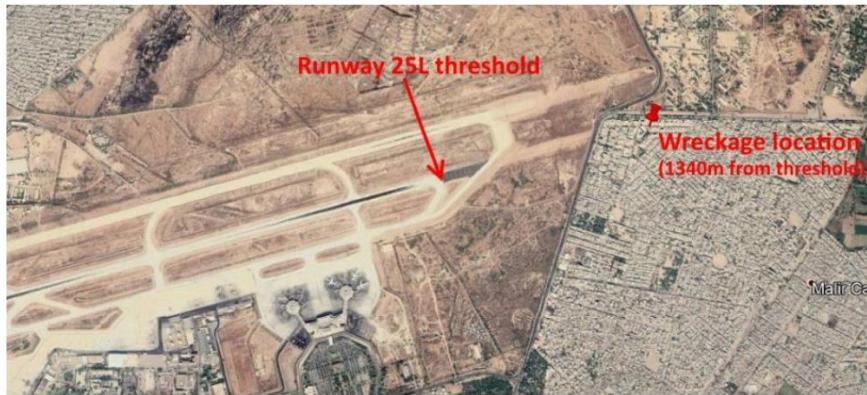
Fig 1: Google Earth crash site location (direction of flight from right to left)

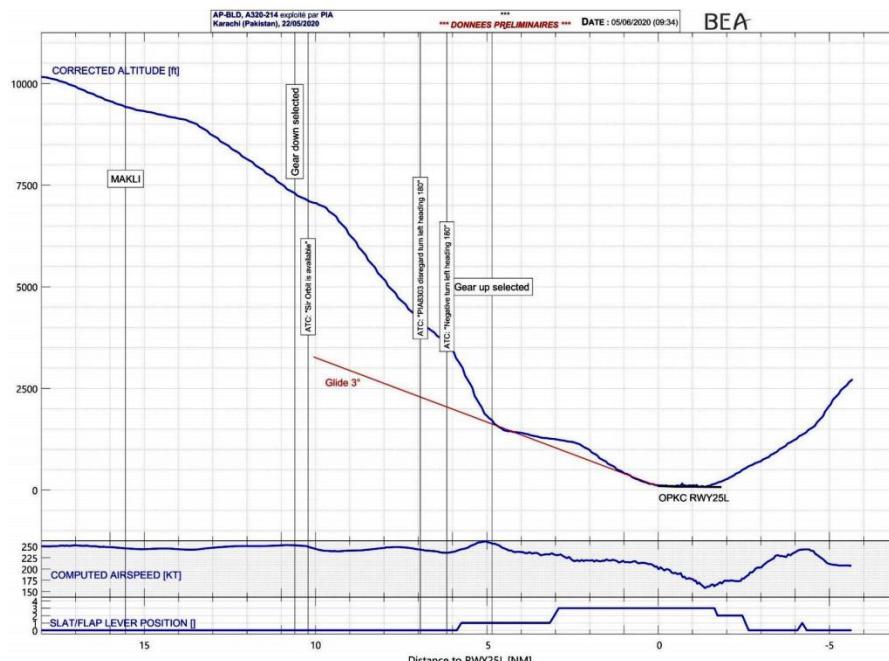
Fig 21 : Selected FDR parameters during last part of the first approach

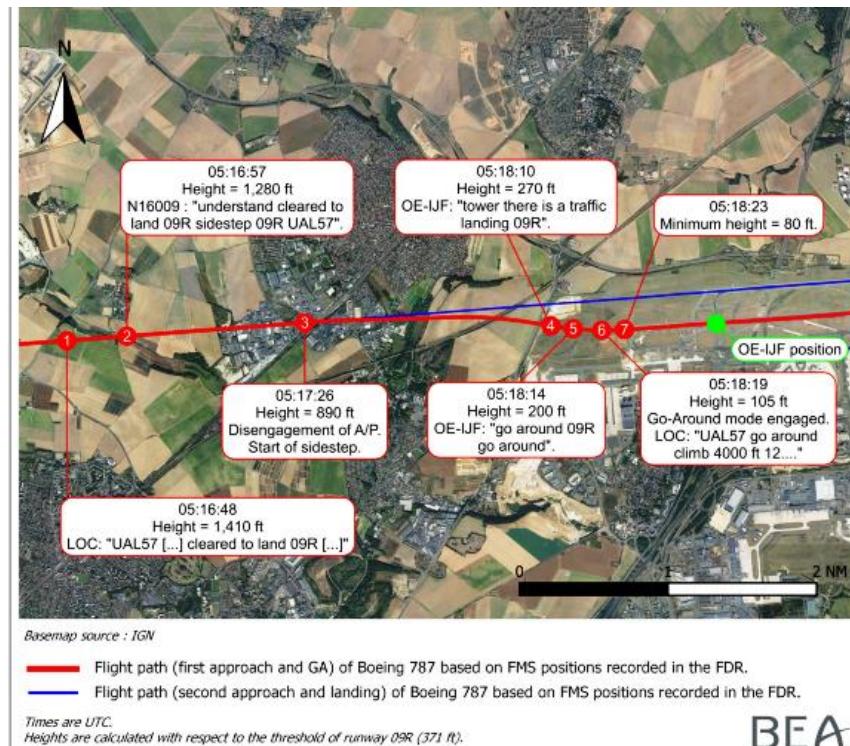
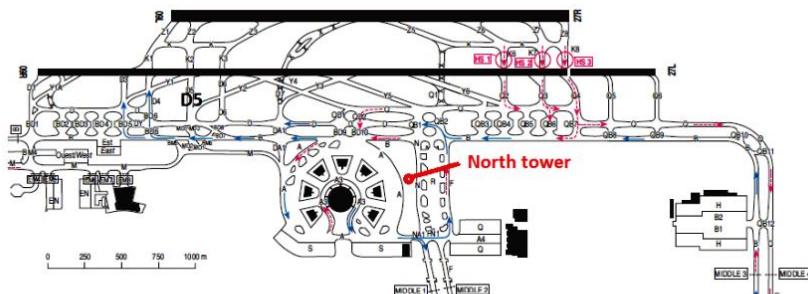
Figure 2: Excerpt from airport chart

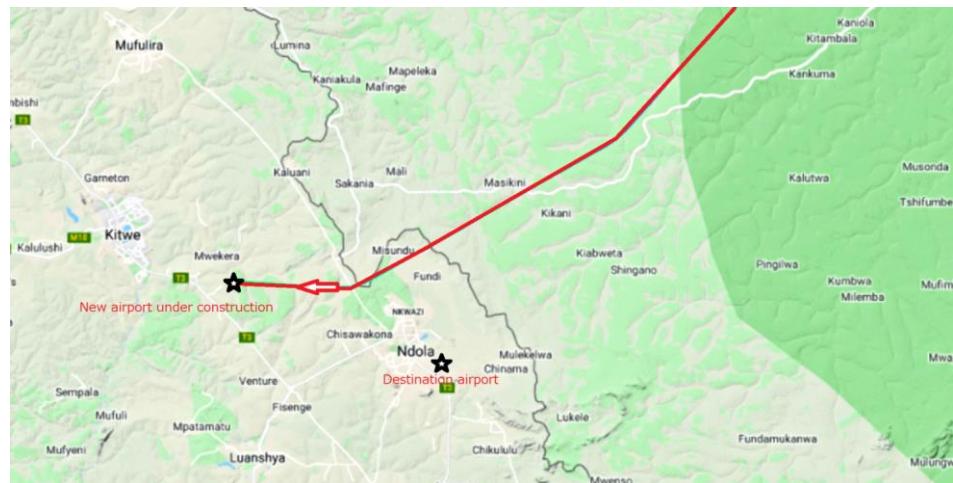
Simon Mwansa Kapwepwe Intl Airport with parallel rwy, 10L/28R, 2515m/8250 ft + 10R/28L 1215m/3980 ft. New Airport, rwy ca 09/27, 3500m.

Ethiopian Airlines B737-800 freighter, ET-AYL freight flight ET-3891 from Addis Ababa (Ethiopia) to Ndola (FLSK, Zambia), was expected to land at Ndola's current (and old) Simon Mwansa Kapwepwe International Airport (S12.9977 E28.6634) but landed on Ndola's new Copperbelt International Airport (S12.9624 E28.5141), about 9nm westnorthwest of the current airport and is still under construction. The aircraft taxied to the apron, where airport construction workers signalled to the crew they were not expected at that airport. The [crew thus continued taxi across the apron, entered the runway via the next taxiway and departed again](#).

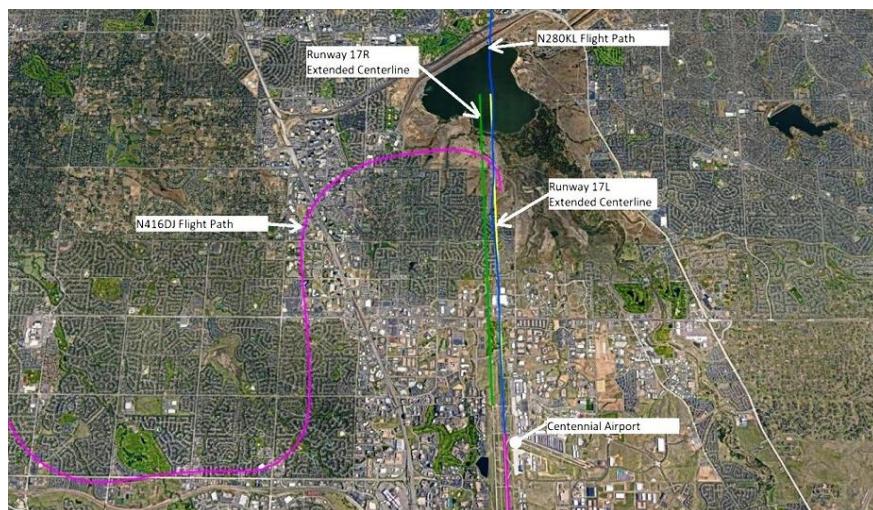
17L/35R: 10001 x 100 ft/3048 x 30 m Asphalt/Grooved El: 5793.0/5884.9 Traffic Pattern: Left/Right

17R/35L: 7001 x 75 ft/2134 x 23 m Asphalt/Grooved El: 5803.7/5868.7 Traffic Pattern: Right/Left

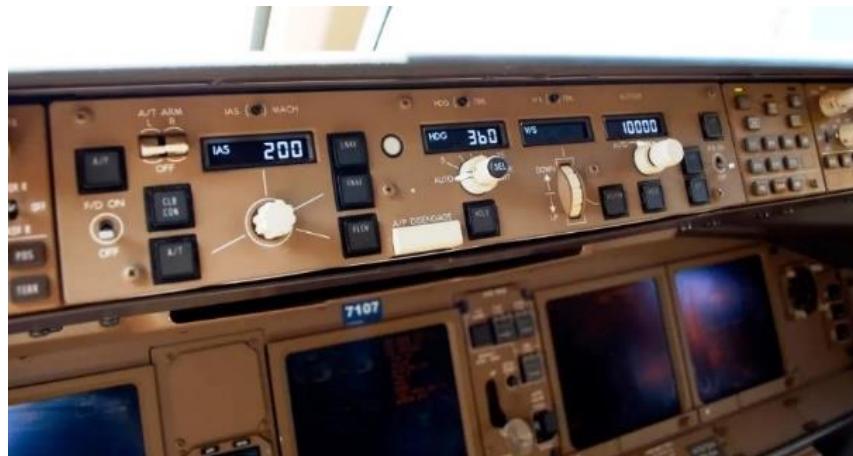
B777-300-mode-control-panel

On Dec 27th 2021 Emirates Airlines released a crew alert to their pilots following the occurrence suggesting the crew had not picked up [the previous flight crew had left the altitude setting at the Master Control Panel at airport elevation/00000 ft causing the flight director to not indicate takeoff rotation and climb out but instead indicate to maintain that altitude \(ALT mode\)](#).

CREWS ARE REMINDED THAT THERE ARE NO FCOM NORMAL PROCEDURE (NP) REQUIREMENTS TO CHANGE THE MCP AFTER LANDING OR SHUTDOWN. THERE HAVE BEEN TIMES WHEN THE MCP "ALTITUDE WINDOW" HAS BEEN SET TO THE AIRPORT ELEVATION WHICH MAY CAUSE ISSUES ON THE SUBSEQUENT DEPARTURE. THE FCOM 4.10.2 STATES THAT THE AFDS WILL ENGAGE IN "ALT" WHEN THE FIRST FLIGHT DIRECTOR SWITCH IS TURNED ON, IF THE MCP SELECTED ALTITUDE IS WITHIN 20 FEET OF THE DISPLAYED BARO ALTITUDE. CREWS SHALL NOT SET AIRPORT ELEVATION ON THE MCP AFTER LANDING OR SHUT DOWN.

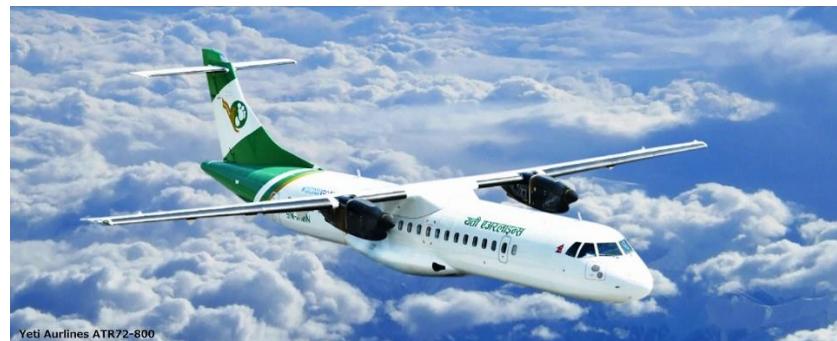
Yeti Airlines AT-72

Yeti AT72 crashed on Jan 15th 2023, **found**, lost height on final approach, both propellers went into feather by **human error**.

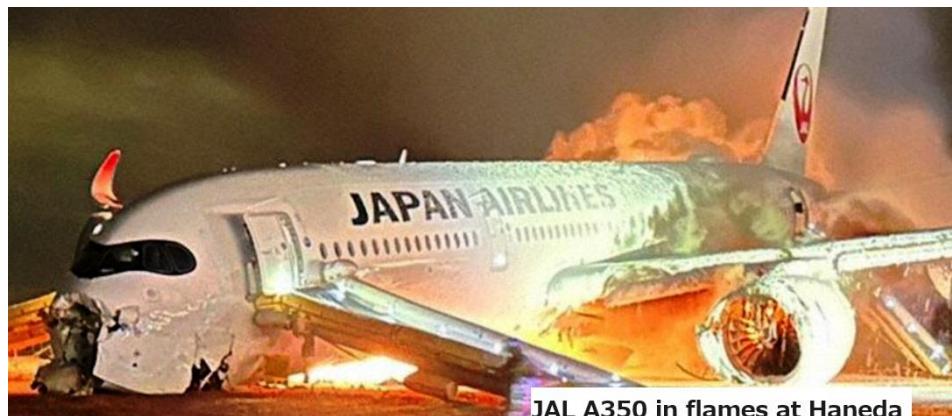
Haneda Airport Runway Layout (Red star indicates collision point)

JAL A350-900, JA13XJ, JL516 from Sapporo to Tokyo Haneda (Japan) with 367 pax and 12 crew, landed on Haneda's rwy 34R at 1747i (0847Z) in night time conditions but collided with a Japan Coast Guard Dash 8-300, JA722A (Coast Guard code MA722) on the rwy shortly after touchdown and burst into flames. The A350 came to a stop off the righthand edge of the rwy about 1680 m/5510 ft down the rwy and was evacuated. All occupants were able to evacuate. The other aircraft carrying 6 people also burst into flames, 5 of the six occupants are confirmed dead. Both aircraft burned down. 15 pax of the A350 received injuries, the captain of the Dash 8 received serious injuries. The aircraft fires were extinguished about 8 hrs after the collision.

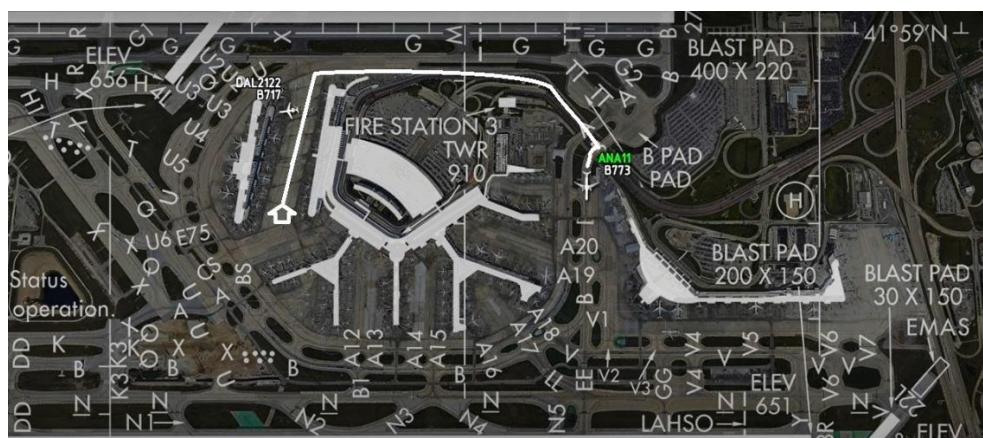
Chicago O'Hare Airport Complicated Taxiways (white line shows ANA track)

15/01/2024 ANA B777-381ER JA784A, Flight NH11 when departs from KORD to RJAA clipped wing of B171 on taxi way at Chicago O'Hare.

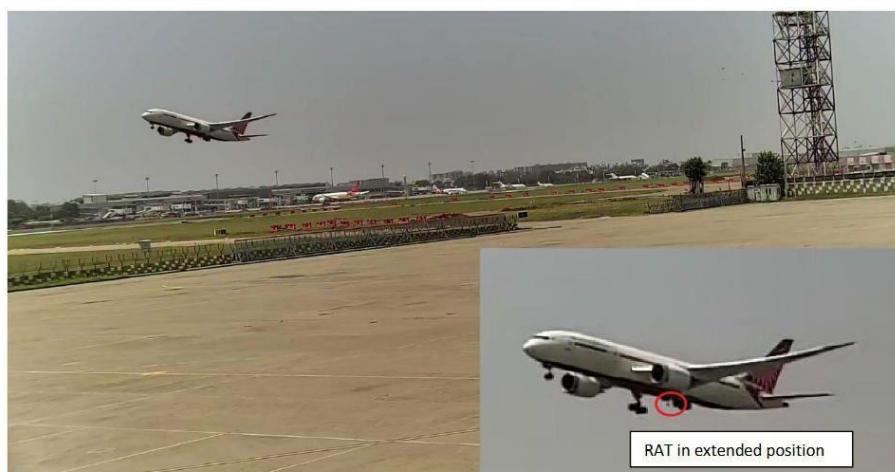
Figure 15 CCTV screenshot of RAT Deployment

The CCTV footage obtained from the airport showed Ram Air Turbine (RAT) getting deployed during the initial climb immediately after lift-off (fig. 15). No significant bird activity is observed in the vicinity of the flight path. The aircraft started to lose altitude before crossing the airport perimeter wall.
