民間航空機の主な航空事故一覧

Major Air Disasters Involving Commercial Airlines

1937-2024

作成者: 前川 博和 (Hirokazu (Mike) Maekawa)

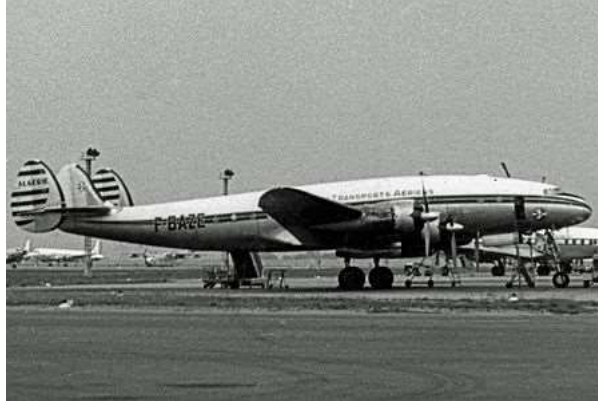
Lockheed L-749A Constellation

F-BAZN departed Paris-Orly at 20:05 for a flight to New York with an intermediate stop at Santa Maria, Azores. At 01:41 the crew reported 150nm from Santa Maria with an ETA of 02:45. The ETA was later changed to 02:55. At 02:51 the flight reported flying at 3000 feet with the airfield in sight. After acknowledging landing instructions, nothing more was heard from the flight. The Constellation had struck the Redondo Mountain at an elevation of 900 m.

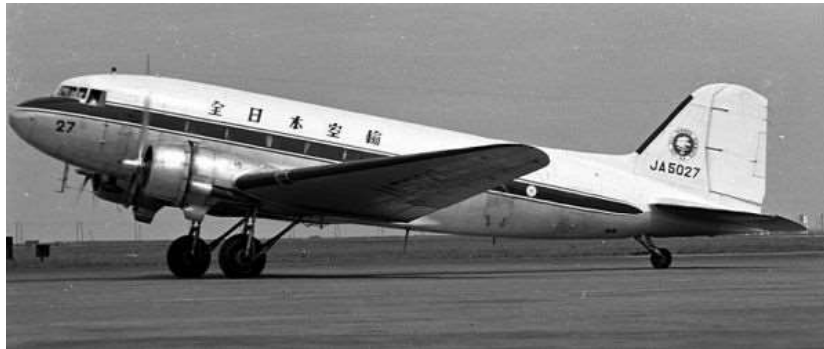
Douglas DC-3 (C-47)

After landing at Nagoya, JA5018 made a u-turn and taxied towards the terminal. At the same time, a Japan Air Self Defense Force (JASDF) North American F-86D Sabre fighter (94-8137) took off from the same runway. The fighter plane collided with the aft fuselage and tail of the All Nippon aircraft. The Sabre crashed and burned but the pilot survived.

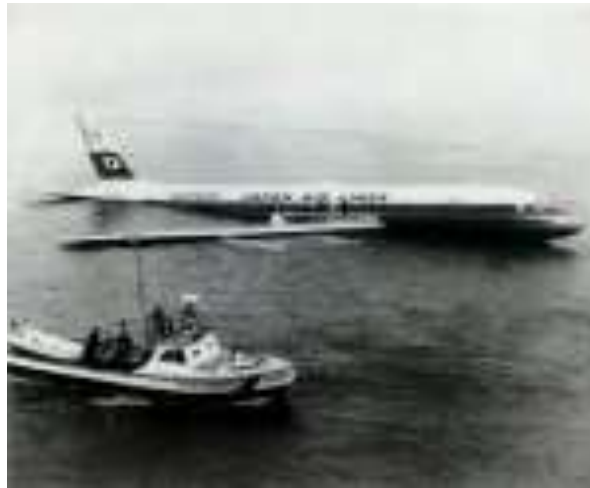
JAL DC8 JA8032 ditched short final RWY28L

- 22/11/1968 San Francisco, CA, USA, JAL DC-8 JA8032 "Shiga" Capt. Kohei Aso (麻生幸平機長、元航空管制官 4 期生、1922.11 生れ), arrived in the San Francisco area after an uneventful flight from Tokyo Haneda. Normal communications were established, and the crew was radar vectored to the Woodside VOR and thence to intercept the ILS for runway 28L at San Francisco. The flight crossed the Woodside VOR at 17:16 at approximately 4,000 feet and, at 17:18:30, was cleared to descend to 2,000 feet. The flight descended in a constant, uninterrupted rate of descent from this time until about 6 seconds before water impact at 17:24:25. The aircraft was on the localizer and contacted the water about 2,5 miles from the end of runway 28L. There were no injuries to any of the passengers or crew during the accident and ensuing evacuation. The aircraft was recovered from the waters of San Francisco Bay about 55 hours after the accident. Repairs were carried out by United Air Lines and the plane was delivered back to JAL on March 31, 1969. This will a **CFIT. 0/107**

- PROBABLE CAUSE: "The improper application of the prescribed procedures to execute an automatic-coupled ILS approach. This deviation from the prescribed procedures was, in part, due to a lack of familiarization and infrequent operation of the installed flight director and autopilot system."

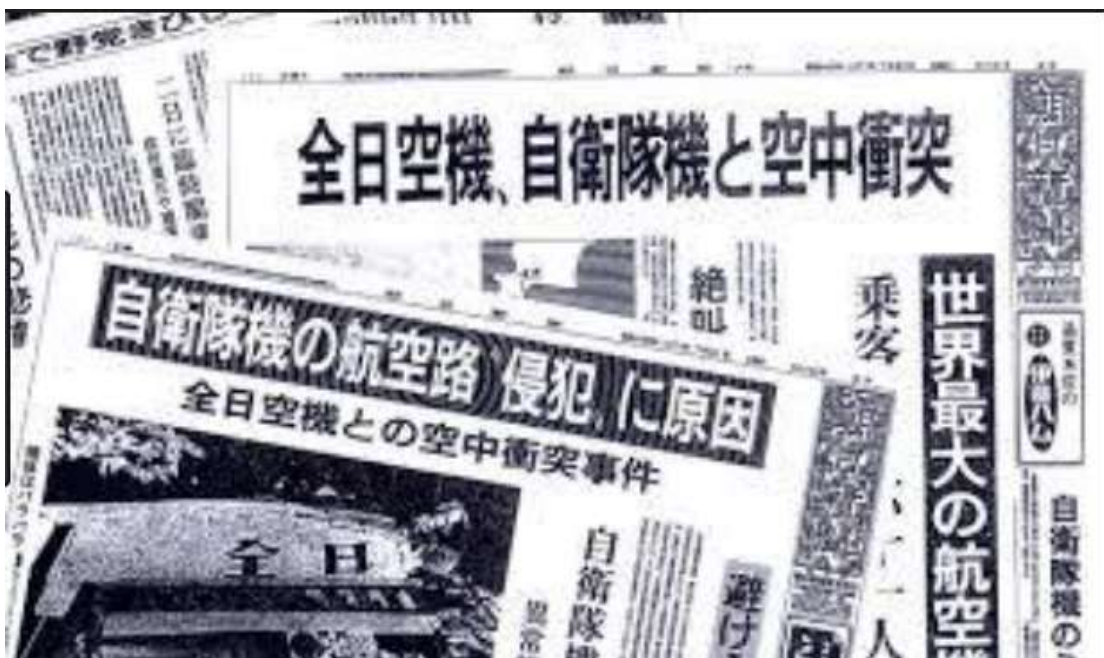
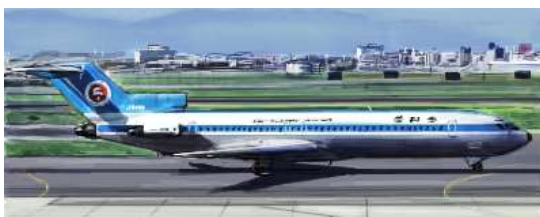
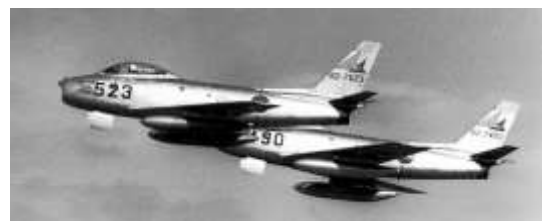
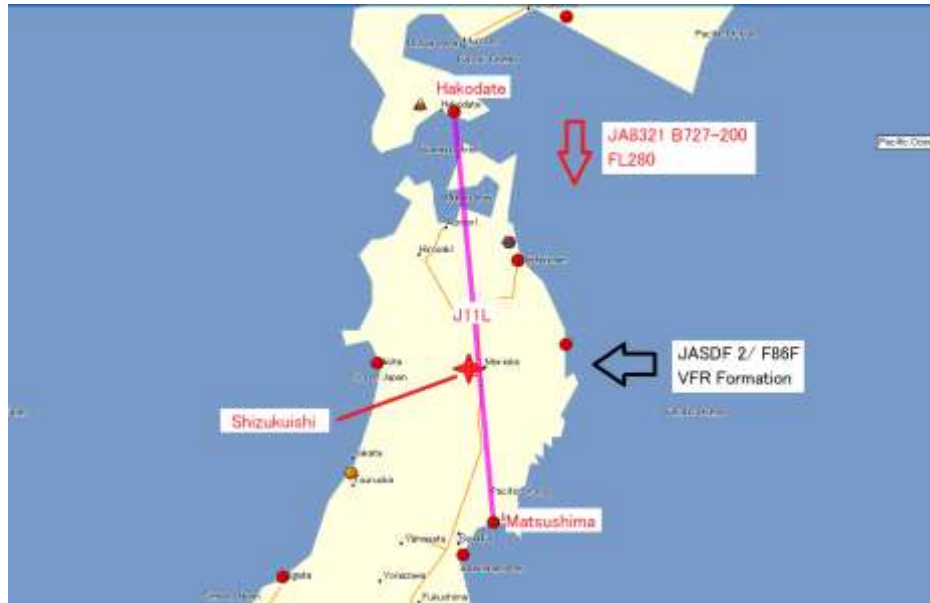
31/07/1971 Shizukuishi, near Morioka, Japan, 727-200, All Nippon Airways (ANA), NH58, Mid Air Collision with F86, 162/162

ANA JA8329 (NH58), Sapporo-Chitose (CTS) to Tokyo-Haneda (HND) climbed to an altitude of FL280. While cruising at this altitude, it approached an area where a Japan Air Self Defense Force student and his instructor were flying in their Mitsubishi-built North American F-86F fighters. The trainee was not watching out for traffic when the 727 approached. The instructor ordered him to break away from the 727. It was too late. He banked to the left but the leading edge of the right wing of his F-86F (92-7932) struck the left horizontal stabilizer of the ANA plane. The fighter's right wing broke off, causing the plane to crash out of control, but the pilot ejected safely. Damage to the stabilizer caused a loss of control of the B727.

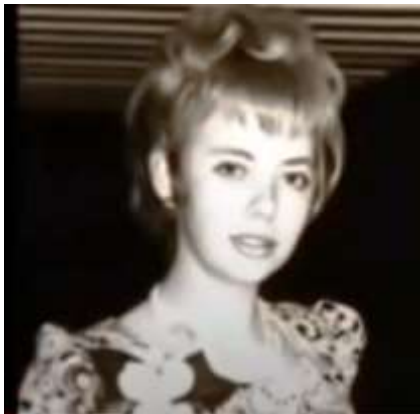
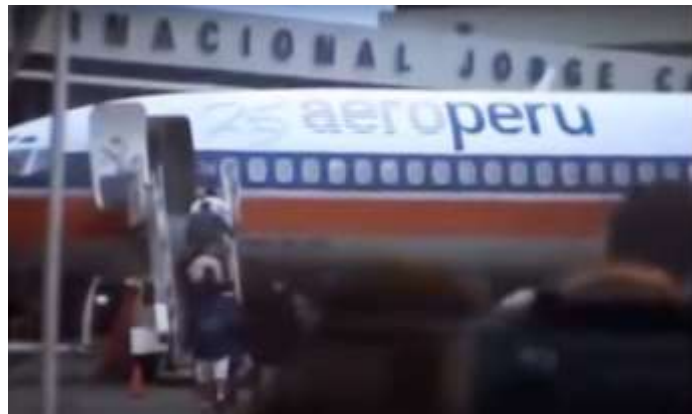
About 40 minutes after takeoff, the aircraft entered a zone of strong turbulence and lightning. After flying for 20 minutes in this weather at FL210 lightning struck the aircraft, causing fire on the right wing which separated, along with part of the left wing. The aircraft crashed in flames into mountainous terrain. Structural failure occurred because of the loads imposed on the aircraft flying through a severe thunderstorm, but also because of stresses resulting from the maneuver to level out the aircraft.

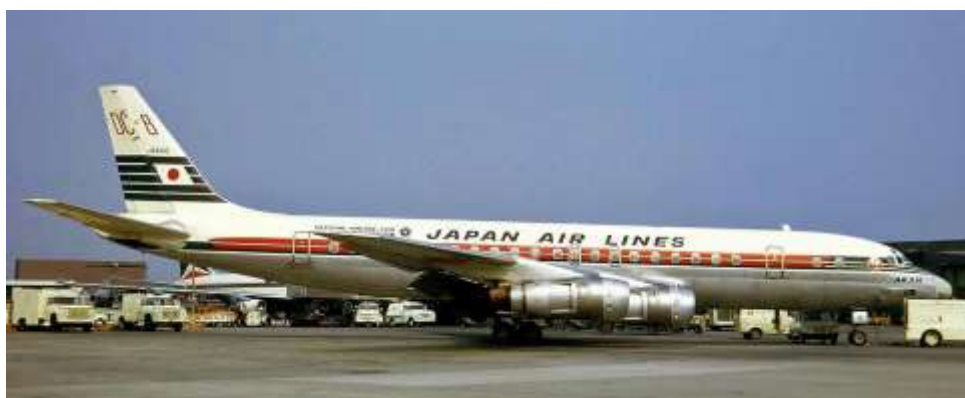
The DC-8 took off from Bangkok at 1121 UTC on a flight to Delhi, India. Clearance for a straight-in ILS approach to Delhi runway 28 was given at 14:43 UTC. Shortly after reporting 23DME, the aircraft struck the banks of River Yamuna. The first officer was Pilot Flying during the approach to Delhi.

PROBABLE CAUSE: Japanese investigators claimed a false glide path signal to be responsible for the descent into terrain. Indian investigators say the accident was caused by a total disregard of laid down procedures by the crew and abandoning all instrument indications without properly ensuring sighting of the runway.

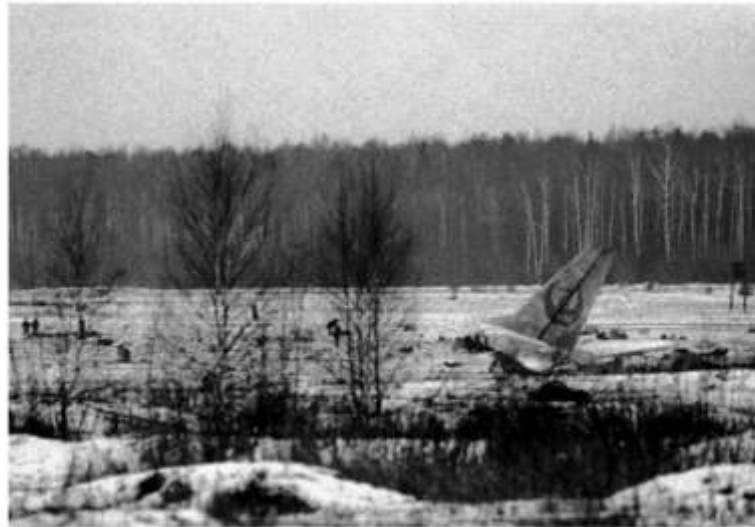
モスクワのシェレメチエボ空港近くで墜落した日本航空DC8-62型ジェット旅客機。1972年
11月29日【PANA=時事】

Probable Cause: The cause of the disaster to aircraft DC-8-62 JA-8040 resided in the fact that during take-off and following attainment of the safety speed V₂, the crew put the aircraft into a supercritical angle of attack which resulted in loss of speed and altitude.

- inadvertent extension of the spoilers in flight, leading to a fall in the maximum value of the lift ratio and an increase in drag;
- loss of control of the aircraft by the crew in conditions associated with malfunctioning of the No. 1 or No. 2 engine consequent upon possible ice formation on the engine intake at a time when the de-icing system was switched off.

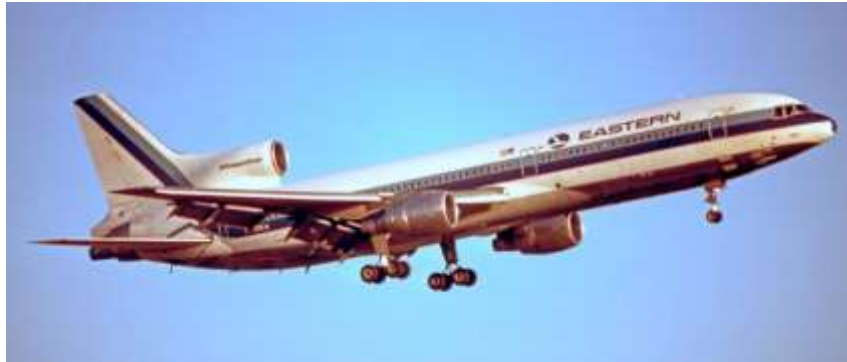
L-1011

EA401 departed New York-JFK at 21:20 EST for a flight to Miami. The flight was uneventful until the approach to Miami. After selecting gear down, the **nosegear light didn't indicate 'down and locked'**. Even after recycling the gear, the light still didn't illuminate. At 23:34 the crew called Miami Tower and were advised to climb to 2000 feet and hold. At 23:37 the captain instructed the second officer to enter the forward electronics bay, below the flight deck, to check visually the alignment of the nose gear indices. Meanwhile, the flight crew continued their attempts to free the nosegear position light lens from its retainer, without success. The second officer was directed to descend into the electronics bay again at 23:38 and the captain and first officer continued discussing the gear position light lens assembly and how it might have been reinserted incorrectly. At 23:40:38 a half-second C-chord sounded in the cockpit, indicating a +/-250 feet deviation from the selected altitude. None of the crewmembers commented on the warning and no action was taken. A little later the Eastern Airlines maintenance specialist, occupying the forward observer seat went into the electronics bay to assist the second officer with the operation of the nose wheel well light. At 23:41:40 Miami approach contacted the flight and granted the crew's request to turn around by clearing him for a left turn heading 180 degrees. At 23:42:05 the first officer suddenly realized that the altitude had dropped. Just seven seconds afterwards, while in a left bank of 28deg, the TriStar's no.1 engine struck the ground, followed by the left main gear. The aircraft disintegrated, scattering wreckage over an area of flat marshland, covering a 1600 ft x 300 ft area. Five crew members and 94 passengers died in the accident. Two passengers died more than seven days after the accident as a result of their injuries. **PROBABLE CAUSE:** "The failure of the flight crew to monitor the flight instruments during the final 4 minutes of flight, and to detect an unexpected descent soon enough to prevent impact with the ground. Preoccupation with a malfunction of the nose landing gear position indicating system distracted the crew's attention from the instruments and allowed the descent to go unnoticed."

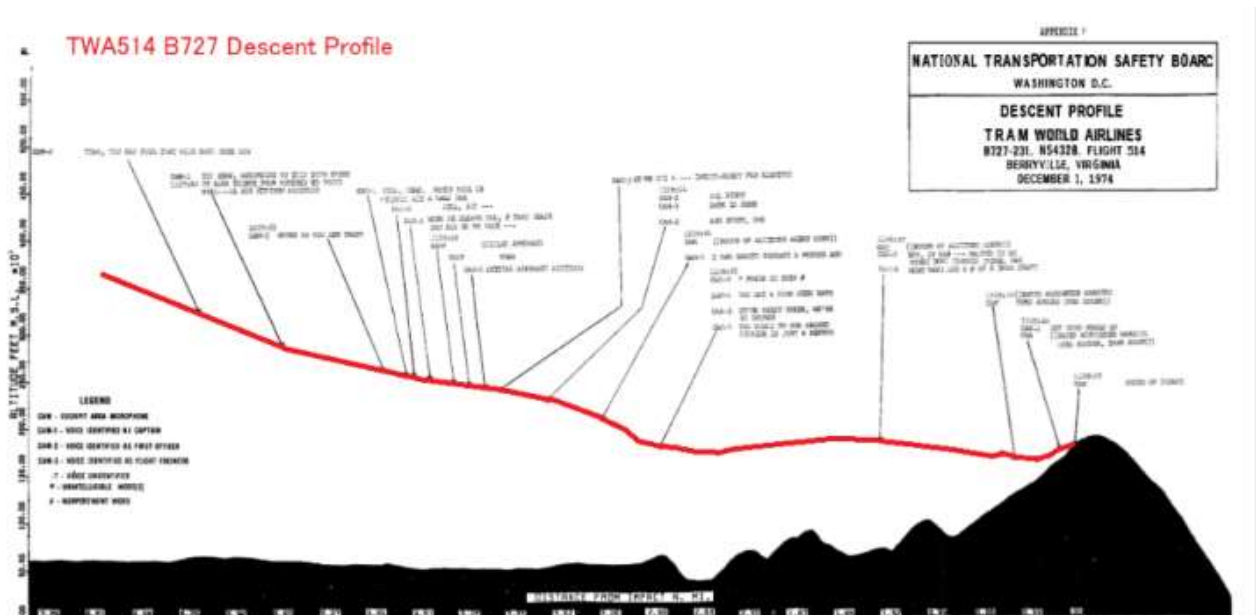
PROBABLE CAUSE: "The crew's decision to descend to 1800ft before the aircraft had reached the approach segment where that minimum altitude applied. The crew's decision to descend was a result of inadequacies and lack of clarity in the air traffic control procedures which led to a misunderstanding on the part of the pilots and of the controllers regarding each other's responsibilities during operations in terminal areas under instrument meteorological conditions. Nevertheless, the examination of the plan view of the approach chart should have disclosed to the captain that a minimum altitude of 1800ft was not a safe altitude. Contributing factors were: 1) The failure of the FAA to take timely action to resolve the confusion and misinterpretation of air traffic terminology although the Agency had been aware of the problem for several years; 2) The issuance of the approach clearance when the flight was 44 miles from the airport on an unpublished route without clearly defined minimum altitudes; and 3) Inadequate depiction of altitude restrictions on the profile view of the approach chart for the VOR/DME approach to runway 12 at Dulles Int. Airport."

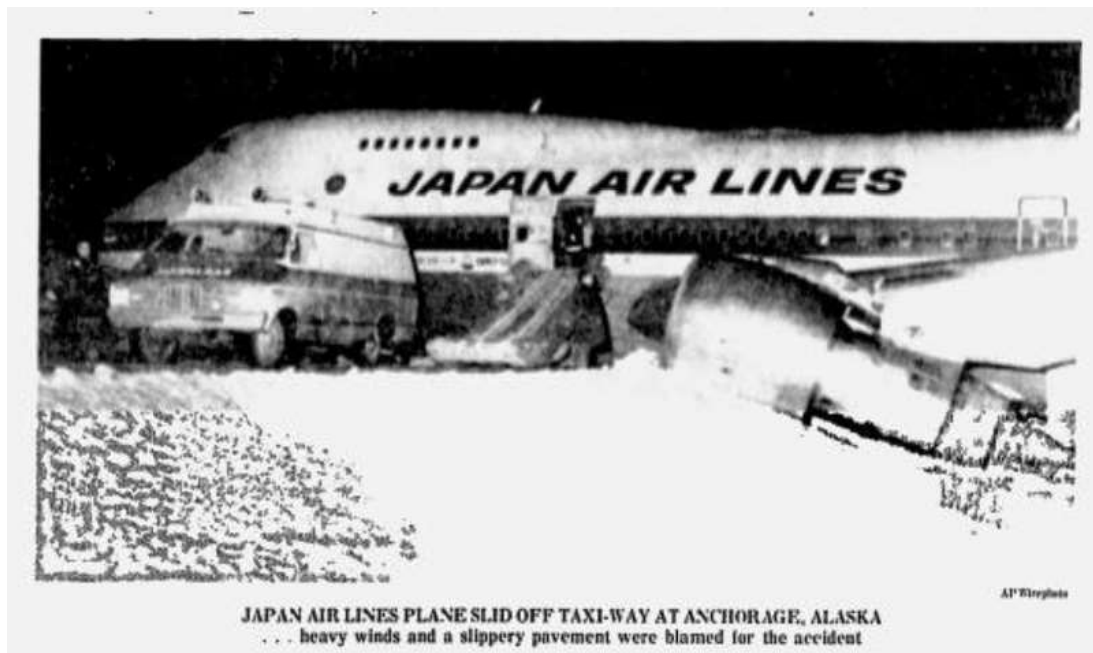
The aircraft slid off the north side of the east-west taxiway of Anchorage International Airport while taxiing out for a takeoff on runway 06R. The Boeing weathercocked about 70° to the left and slid backward down a snow-covered embankment with an average slope of -13°. The aircraft came to rest on a heading of 150° on a service road approximately 250 feet from, and 50 feet below, the taxiway surface. **PROBABLE CAUSE:** "The loss of directional control during taxi as a result of ice on the taxiway and strong, direct crosswinds. Contributing to the accident were (1) the captain's decision to take off from runway 6R after receiving reports that taxiing conditions were deteriorating, and (2) failure of airport management to anticipate predictable unsafe icing conditions on the airport. This failure to anticipate these conditions resulted in delayed and insufficient preventive action."

JAPAN AIR LINES PLANE SLID OFF TAXI-WAY AT ANCHORAGE, ALASKA
... heavy winds and a slippery pavement were blamed for the accident

Hynes said the plane's fuselage was cracked in three places and the turbine on each wing was bent by the force of its slide.

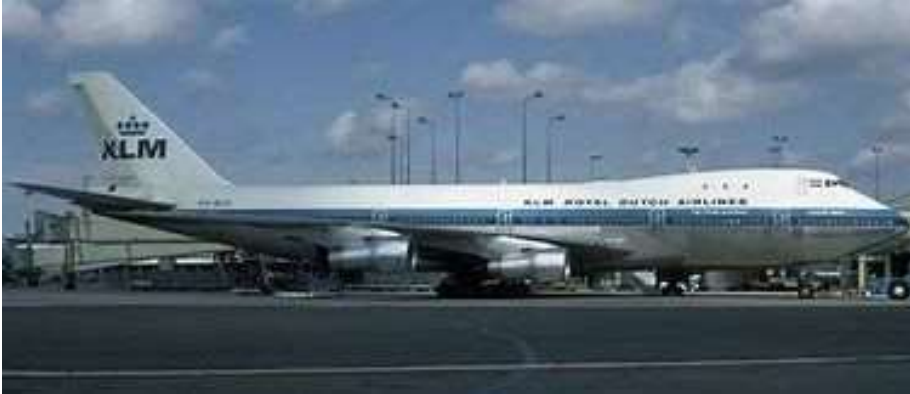
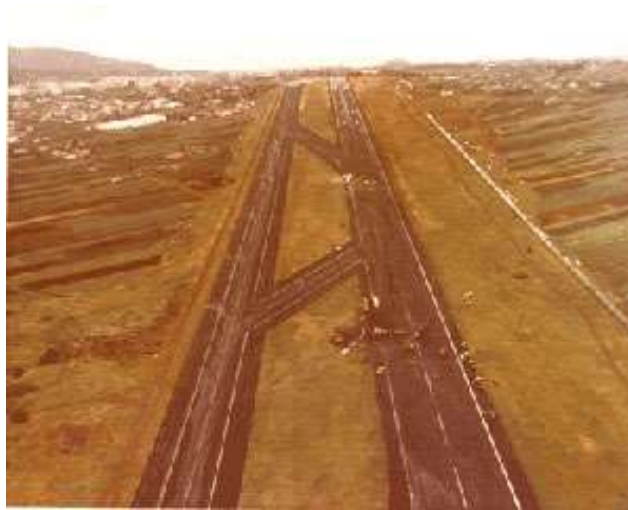
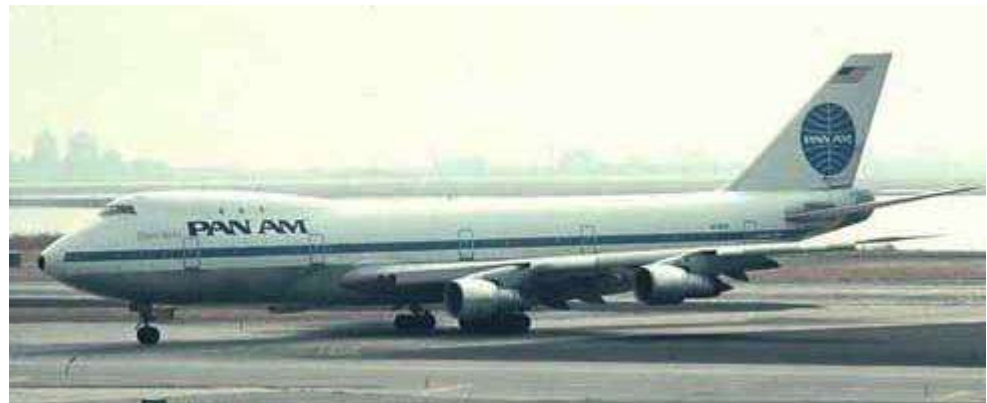
- [27/03/1977 Tenerife, Canary Island - Spain, 747, Pan Am, Collision on runway, 335/396](#)
- [27/03/1977 Tenerife, Canary Island - Spain, 747, KLM, Collision on runway, 248/248](#)

KLM B747, PH-BUF, KL4805, took off from Amsterdam Schipol Airport at 0900L on March 27, 1977, en route to Las Palmas, Canary Islands.

Pan Am B747, N73PA, PA1736, left Los Angeles International Airport at 1729L on March 26, 1977, arriving at New York JFK Airport at 0117L on March 27, 1977. After refueling and a crew change, the aircraft departed for Las Palmas, Canary Islands at 0242L.

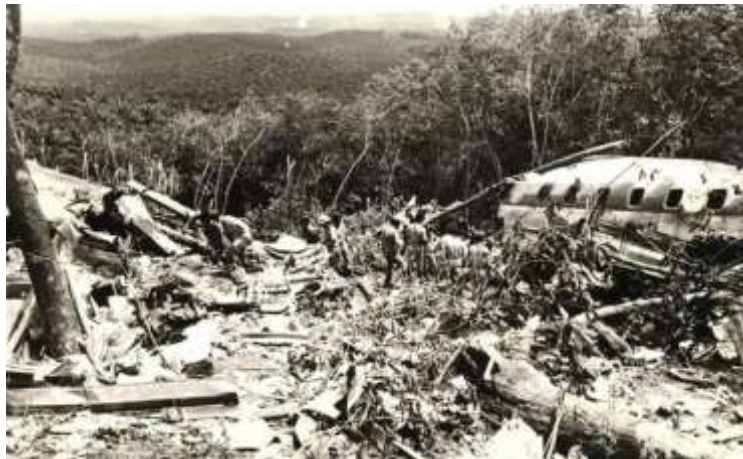
The accident was caused by the captain descending below minimum descent altitude without having the runway in sight, and continuing the descent until the aircraft struck terrain four nautical miles short of the runway threshold. A subsidiary contributory factor was insufficient monitoring of the aircraft's flight path by the captain under the adverse weather conditions with several aircraft in the holding pattern awaiting their turn for approach and, more importantly, the co-pilot's failure to challenge the captain's breach of company regulations.

JAL715 crashed short of Kuala Lumpur in 1977

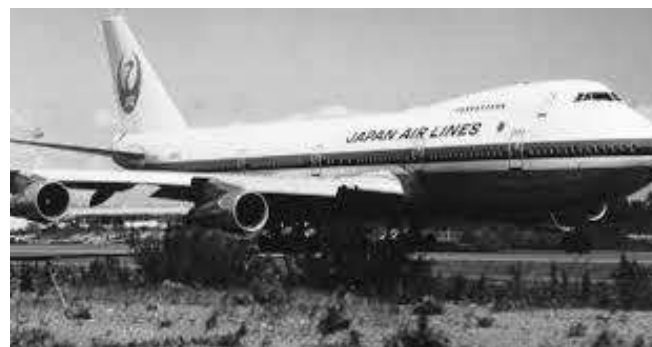
B747 SR

Probable Cause: It is estimated that this accident was caused by deterioration of flying quality and loss of primary flight control functions due to rupture of the aft pressure bulkhead of the aircraft, and the subsequent ruptures of a part of the fuselage tail, vertical fin and hydraulic flight control systems.

The reason why the aft pressure bulkhead was ruptured in flight is estimated to be that the strength of the said bulkhead was reduced due to fatigue cracks propagating at the spliced portion of the bulkhead's webs to the extent that it became unable to endure the cabin pressure in flight at that time.

The initiation and propagation of the fatigue cracks are attributable to the improper repairs of the said bulkhead conducted in 1978, and it is estimated that the fatigue cracks having not be found in the later maintenance inspection is contributive to their propagation leading to the rupture of the said bulkhead."

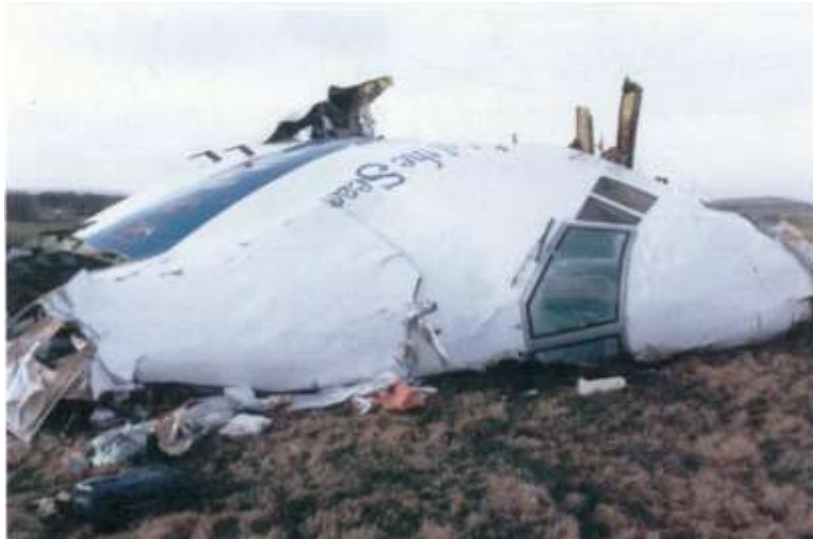
Pan Am Flight 103 was a regularly scheduled Pan Am transatlantic flight from Frankfurt to Detroit via London and New York. On 21 December 1988, N739PA, the aircraft operating the transatlantic leg of the route, was destroyed by a bomb, killing all 243 passengers and 16 crew in what became known as the Lockerbie bombing. Large sections of the aircraft crashed onto residential areas of Lockerbie, Scotland, killing 11 more people on the ground.

PROBABLE CAUSE: "The in-flight disintegration of the aircraft was caused by the detonation of an improvised explosive device located in a baggage container positioned on the left side of the forward cargo hold at aircraft station 700."

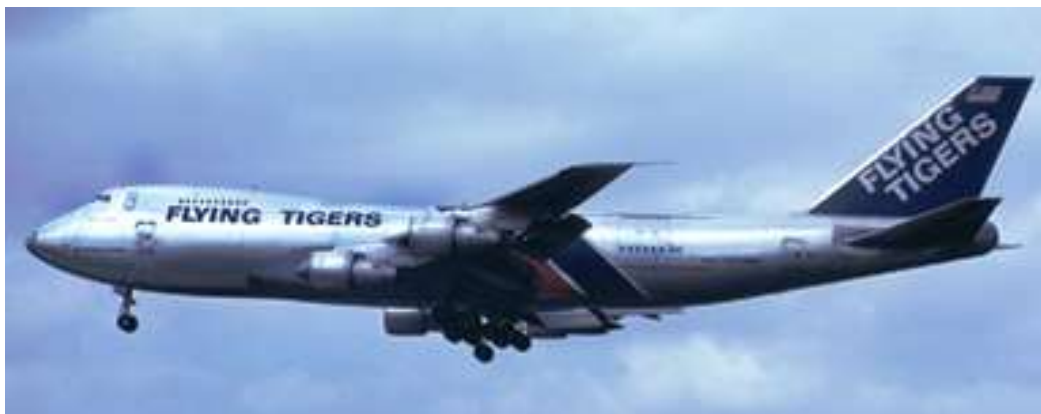
B747 Cargo

19/02/1989 Kuala Lumpur, Malaysia, Flying Tiger B747Cargo, crashed 12 km (7.5 mls) from Kuala Lumpur Subang Airport (KUL), 4/4

The Boeing, named "Thomas Haywood", was less than half loaded with textiles, computer software and mail when it departed Singapore. Approaching Kuala Lumpur, the crew were cleared to route direct to the Kayell (KL) beacon for a runway 33 approach. While on the NDB approach, the crew were cleared to **"...descend two four zero zero..."** which was interpreted by the crew as "...to 400...". The aircraft descended below minimum altitude and crashed into a hillside at 600 feet/180 m msl just before reaching the Kayell NDB, where minimum descent height was 2400 feet. The Boeing hit treetops and started to break up until bursting into flames.

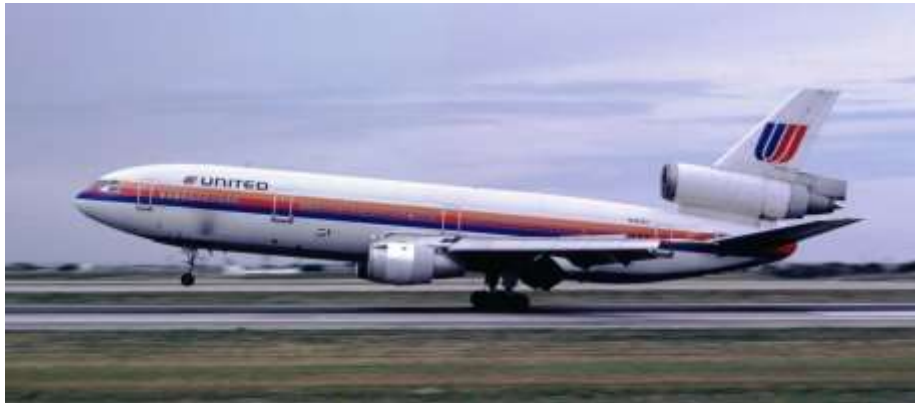
UAL232 departed Denver at 14:09 CDT for a flight to Philadelphia. Cruising altitude was FL370. About 1 hour and 7 minutes after takeoff the crew heard a loud bang, followed by vibration and a shuddering of the airframe; the no.2 engine had suffered an uncontained failure. It then appeared that the hydraulic pressure was zero. The DC-10 didn't respond anymore to flight control inputs and the descending right turn was arrested by using no. 1 engine power reduction. The air driven generator (ADG), which powers the no.1 auxiliary hydraulic pump, was deployed but hydraulic power couldn't be restored. An emergency was declared at 15:20, and vectors to Sioux City were given by Minneapolis ARTCC. An off-duty training check airman was travelling on Flight 232 and offered his assistance. He was asked to manipulate the throttles to control pitch and roll, which was difficult because the plane had a continuous tendency to turn to the right. The no.1 and 3 thrust levers couldn't be used symmetrically, so he used two hands to manipulate the throttles. Sioux City Airport was sighted at 9 miles out, but the aircraft was aligned with the closed runway 22 (6600 feet long) instead of the longer (8999 feet) runway 31. Given the position and the difficulty in making left turns, the approach to runway 22 was continued. The aircraft approached with a high sink rate (1620 feet/min for the last 20 seconds) at an airspeed of 215 knots. At about 100 feet above the ground the nose began to pitch downward and the right wing dropped. The plane touched down on the threshold slightly left of the center line, skidded to the right and rolled inverted. The DC-10 caught fire and cartwheeled.

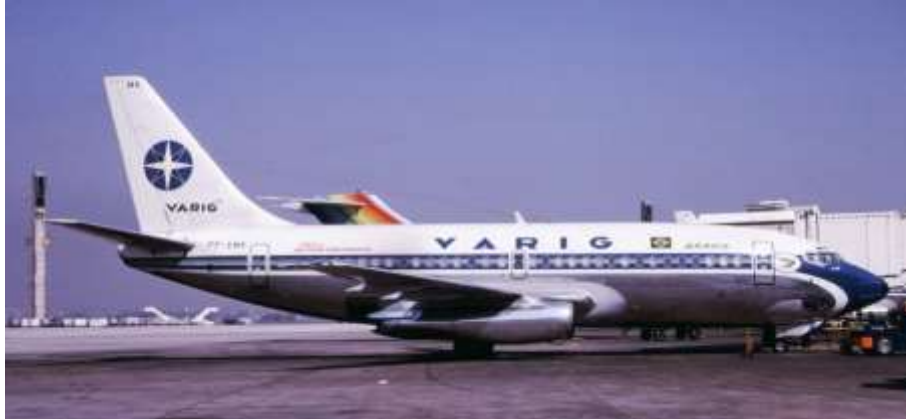
B737-200 aircraft that actually crashed

Upon investigation, it was concluded that the crash had been caused primarily by **negligence on the part of the flight crew**. Customary investigations showed that the aircraft was in perfect condition for the flight, and that its mandatory periodic inspections had been properly conducted. It was concluded that the main factor for the accident was an error in reading the correct heading from the flight plan by the commander, compounded by the co-pilot copying the setting from the commander's panel instead of checking the flight plan. The fact that plan course 0270 actually asked for 027.0 degrees was due to the Varig standardization of flight planning for all its fleet, but only aircraft equipped with an inertial navigation system actually used headings with decimals. Despite the pilots having been told about this peculiarity in the airline's training program, the value expressed in the flight plan 0270 was interpreted by the commander as 270° (he was on vacation during the change of standard). **This misinterpretation changed the general direction north-northeast (27.0°) to west (270°)**. The Boeing 737 was not equipped with INS, using only automatic direction finders (ADF) and VOR. Months after the accident, the flight plan VARIG 254 used was shown to 21 pilots of major airlines in the world during a test conducted by the International Federation of Air Line Pilots' Associations (IFALPA). No fewer than 15 pilots committed the same mistake that the VARIG flight 254 crew had made. After the flight 254 accident, VARIG would install [Omega navigation systems](#) in their aircraft.

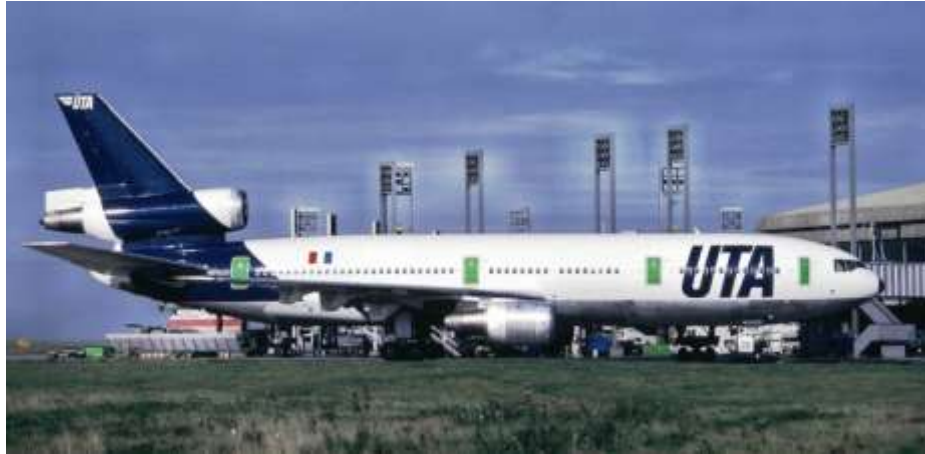
The DC-10 was operating as UTA Flight 772 on the Brazzaville-N'Djamena-Paris route. The aircraft took off from N'Djamena at 13:13 and climbed to a cruising altitude of FL350. At 13:59 **an explosion on board** caused the aircraft to crash into the desert. The explosive device was located at location 13R in the cargo hold. The device was most probably hidden in baggage, placed aboard at Brazzaville. **Possible groups responsible for the explosion are the Islamic Jihad group** (demanding the freedom of a Shi'ite Muslim in Israel) or the Secret Chadian Resistance. Co-incident on March 10, 1984 another UTA aircraft was destroyed when a bomb exploded; in this case the bomb exploded during embarkation at N'Djamena.

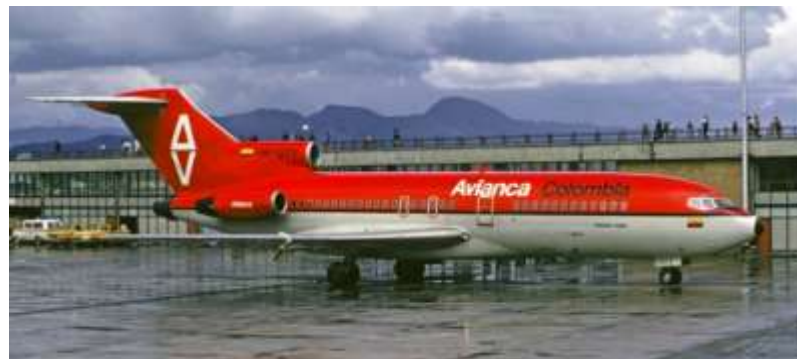
B727

Flight 203 departed Bogotá at 07:11 for a flight to Cali. While climbing through FL130, a **bomb detonated** on board, igniting fuel vapours in an empty fuel tank. The subsequent explosion caused the aircraft to crash.

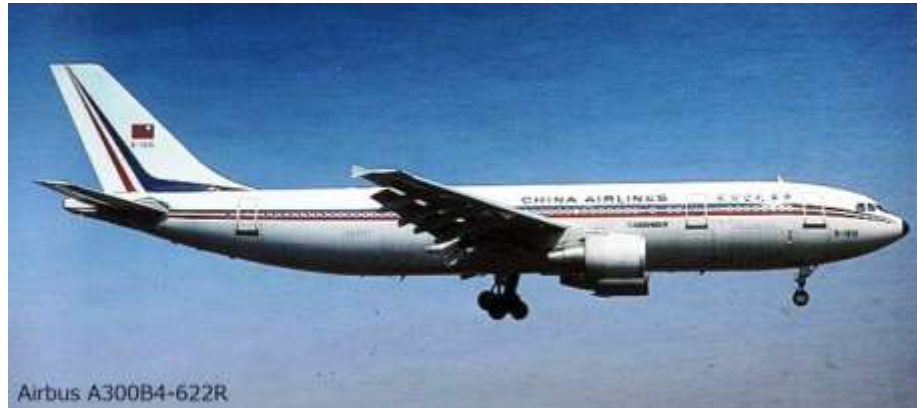
- 06/04/1994 Kigali, Rwanda, President Habyarimana's Falcon 50, shot down by missile, terrorism, 12
- 07/04/1994 Memphis Tennessee, USA, FEDEX Cargo flight705, DC-10-30, **hijack attempt** by its employee, 3 crew fought, calvit arrested.
- 26/04/1994 **Nagoya Komaki, Japan, A-300-600R, China Airlines, During Landing, 264/271**
 CAL 140 from Taipei Intl Airport, Taiwan, to Nagoya Airport, Japan, while on ILS approach to rwy 34 crashed onto the airport.

While the aircraft was making an ILS approach to runway 34 of Nagoya Airport, under manual control **by the F/O**, the F/O inadvertently activated the GO lever, which changed the FD (Flight Director) to GO AROUND mode and caused a thrust increase. This made the aircraft deviate above its normal glide path. The APs were subsequently engaged, with GO AROUND mode still engaged. Under these conditions the F/O continued pushing the control wheel in accordance with the CAP's instructions. As a result of this, the THS (Horizontal Stabilizer) moved to its full nose-up position and caused an abnormal out-of-trim situation. The crew continued approach, unaware of the abnormal situation. The AOA increased the Alpha Floor function was activated and the pitch angle increased.

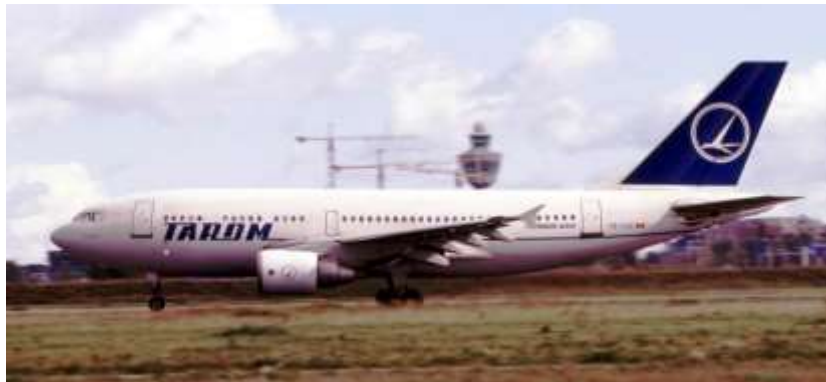
A-310

31/03/1995 Balotesti, Romania, A-310-324, Transporturile Aeriene Romane RO371, Crashed at Take-off, faulty autothrottle, 60/49+11

Tarom flight 371 was a scheduled passenger service from Bucharest Otopeni Airport (OTP) in Romania to Brussel Airport (BRU), Belgium. On board were 49 passengers and eleven crew members. The **first officer was pilot flying**, the captain was pilot monitoring. The aircraft started dive while climbing at 4200ft and crashed.

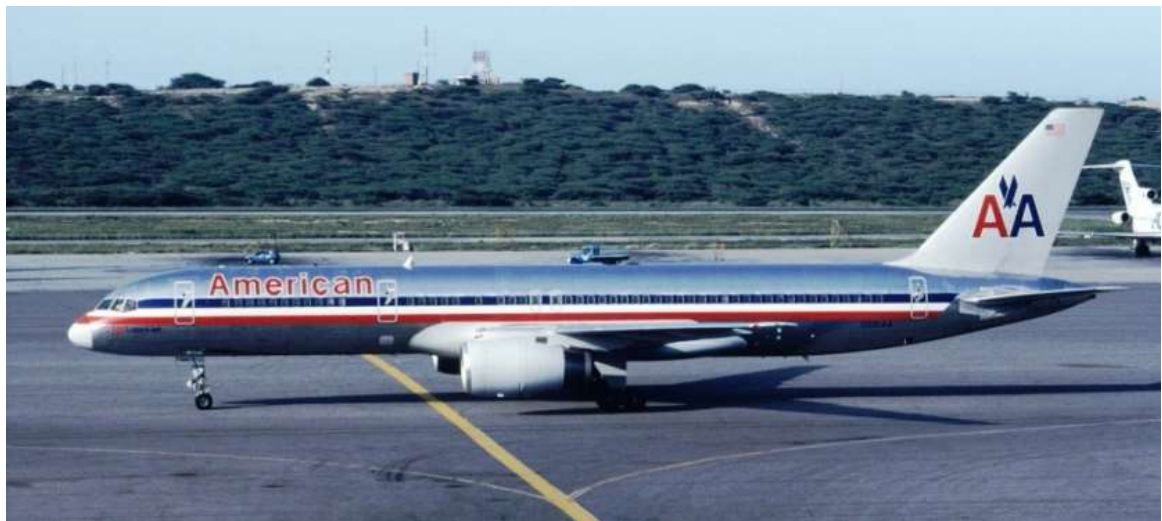
At about 18:34 EST, American Airlines Flight 965 took off from Miami for a flight to Cali. At 21:34, while descending to FL200, the crew contacted Cali Approach. The aircraft was 63nm out of Cali VOR (which is 8nm South of the airport) at the time. Cali cleared the flight for a direct Cali VOR approach and report at Tulua VOR. Followed one minute later by a clearance for a straight in VOR DME approach to runway 19 (the Rozo 1 arrival). The crew then tried to select the Rozo NDB (Non Directional Beacon) on the Flight Management Computer (FMC). Because their Jeppesen approach plates showed 'R' as the code for Rozo, the crew selected this option. But 'R' in the FMC database meant Romeo. Romeo is a navaid 150nm from Rozo, but has the same frequency. The aircraft had just passed Tulua VOR when it started a turn to the left (towards Romeo). This turn caused some confusion in the cockpit since Rozo 1 was to be a straight in approach. 87 Seconds after commencing the turn, the crew activated Heading Select (HDG SEL), which disengaged LNAV and started a right turn. The left turn brought the B757 over mountainous terrain, so a Ground Proximity (GPWS) warning sounded. With increased engine power and nose-up the crew tried to climb. The spoilers were still activated however. The stick shaker then activated and the aircraft crashed into a mountain at about 8900 feet (Cali field elevation being 3153 feet).

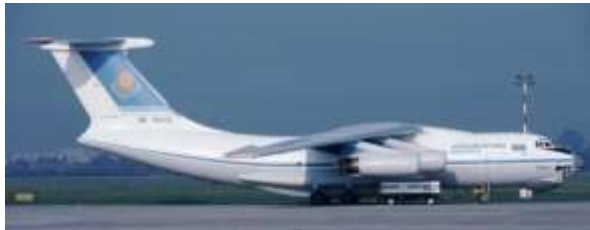
Kazakhstan Il-76

Apparently, the Kazakh aircraft had descended below its assigned altitude and was flying at 14500 feet. A few second later seconds later the Ilyushin had descended another 310 feet. Shortly afterwards both aircraft collided, plummeted down in flames and crashed in an arid farming area.

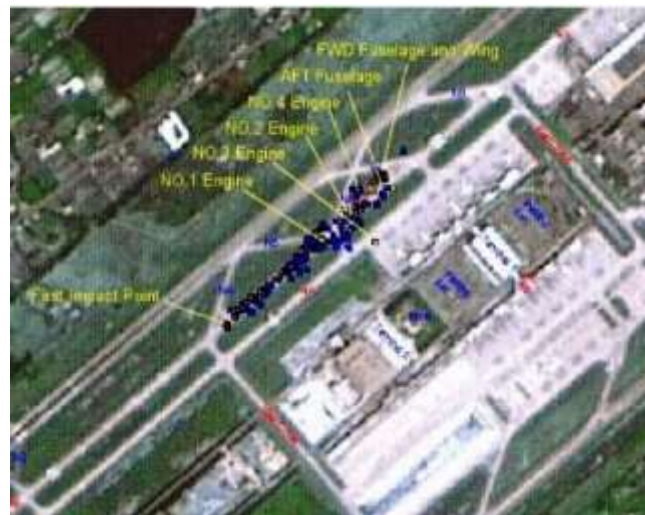
31/10/2000 Taipei, Taiwan (台灣) , Singapore Airlines SQ006 B747-400, crashed taking off wrong r/w, 83 of 159 pax + 20 crew

The crew had been cleared for a runway 05L departure because runway 05R was closed because of construction work. After reaching the end of taxiway NP, SQ006 turned right into Taxiway N1 and immediately made a 180-degree turn to runway 05R. After approx 6 second hold, SQ006 started its takeoff roll at 23:15:45. Weather conditions were very poor because of typhoon 'Xiang Sane' in the area. On takeoff, 3.5 seconds after V1, the aircraft hit concrete barriers, excavators and other equipment on the runway. The plane crashed back onto the runway, breaking up and bursting into flames while sliding down the runway and crashing into other objects related to work being done on runway 05R. The aircraft wreckage was distributed along runway 05R beginning at about 4,080 feet from the runway threshold. The airplane broke into two main sections at about fuselage station 1560 and came to rest about 6,480 feet from the runway threshold.

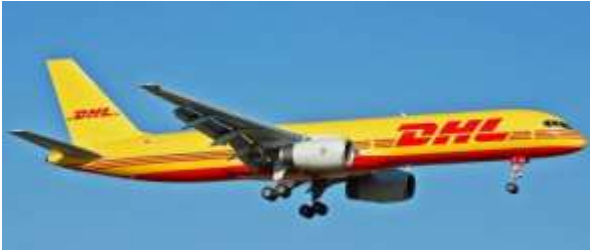
- 01/07/2002 Uberlingen, Switzerland, Bashkirian Airlines (BTC) Tu-154 and DHL B757, mid air collision, 69 BTC+2 DHL
- 01/07/2002 Uberlingen, Switzerland, DHL B757 and Bashkirian Airlines (BTC) Tu-154, mid air collision, 69 BTC+2 DHL

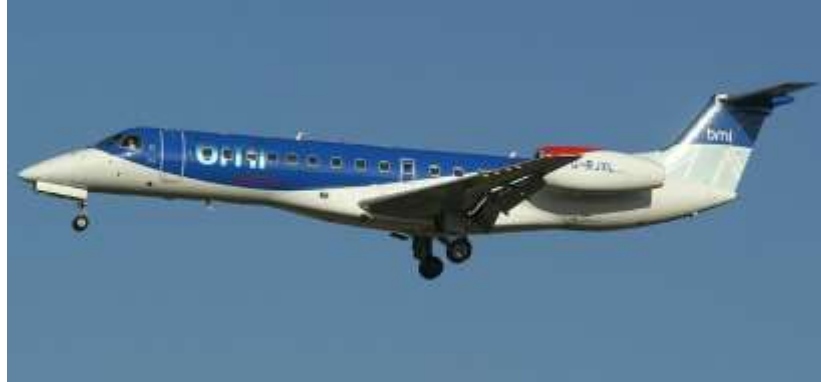
Embraer EMB-135BJ Legacy 600

29/09/2006 São Félix do Xingu, Brazil, Embraer EMB-135BJ Legacy 600, 0/7

Relatively to the crew of the N600XL, the following active failures were identified: lack of an adequate planning of the flight, and insufficient knowledge of the flight plan prepared by the Embraer operator; non-execution of a briefing prior to departure; unintentional change of the transponder setting, failure in prioritizing attention; failure in perceiving that the transponder was not transmitting; delay in recognizing the problem of communication with the air traffic control unit; and non-compliance with the procedures prescribed for communications failure.

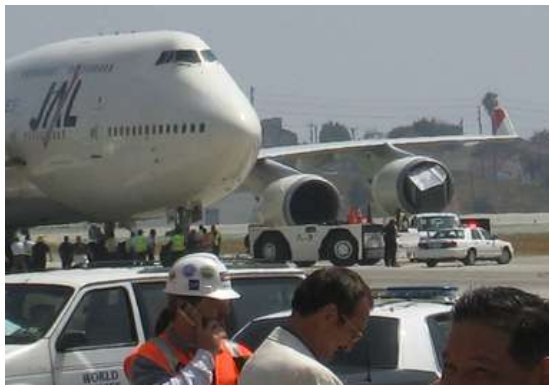
JAL B747 at Los Angeles

30/04/2009 **Mt Salak, INA, Curug Training Center small airplane crashed, 3/3 (?)**
 11/05/2009 **Indonesian AF C130 lost four tires when land. No casualties**
 11/05/2009 LAX, USA, JAL 機がコンテナ吸い込み、離陸中止 ロサンゼルス

米ロサンゼルス国際空港 (Los Angeles International Airport) で離陸準備をしていた日本航空 (JAL) のジェット旅客機が 11 日、エンジンに貨物用コンテナが吸い込まれていることが確認され、離陸を中止した。空港管理当局が明らかにした。

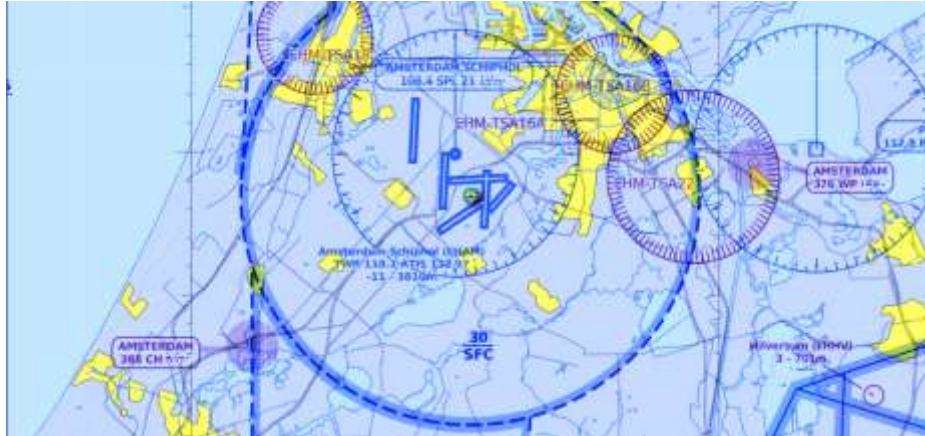
Amsterdam Schiphol Airport

10/02/2010 Schiphol, Amsterdam Netherland, KLM **took off from taxiway.**

A KLM Boeing 737-300, registration PH-BDP performing flight KL-1369 from Amsterdam (Netherlands) to Warsaw (Poland), was cleared to take off runway 36C at about 20:36L (19:36Z), however actually took off along the parallel taxiway B. The airplane continued to Warsaw for a safe landing.

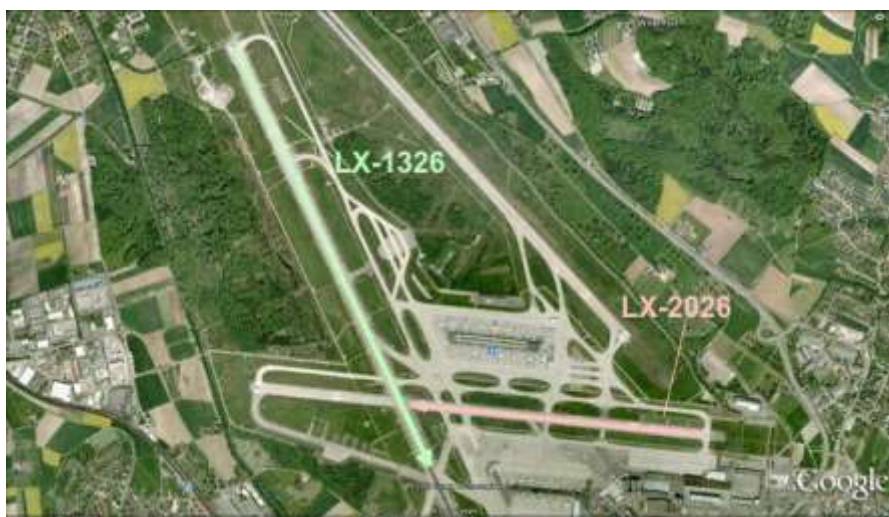
Zurich

The Swiss BFU have released their final report concluding the probable causes of the serious incident were:

The serious incident is attributable to the fact that the **air traffic control officer** concerned gave take-off clearance to an aircraft on runway 28 although another aircraft on runway 16, to which he had given take-off clearance shortly before, was still on its take-off roll. The result was that an **inadvertent convergence of these aircraft occurred**, involving a high risk of collision.

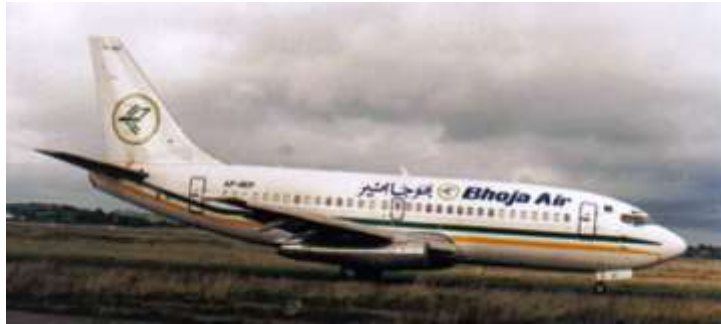
- 20/04/2012 Islamabad, Pakistan, Bhoja Air B737-200 crashed on final, **127/121+6**
 Bhoja Air Boeing 737-200, AP-BKC, **27.4 yr old**, B4-213 from Karachi to Islamabad (Pakistan) with 121 passengers and 6 crew, impacted terrain about 5 km short of and slightly left of the extended runway center line of Islamabad's runway 30 near Jinnah Gardens, completely broke up and burst into flames at about 18:50L (13:50Z). 10 houses on the ground were destroyed, their occupants are reported safe however, the crash site extends over an area of about 1000 meters, the main wreckage came to rest about 4km short of the runway. All occupants of the aircraft perished in the crash.
 Probable Cause:
The ineffective automated flight deck management in extreme adverse weather conditions by cockpit crew caused the accident. The ineffective automated flight deck management was due to various factors including: incorrect selection of cockpit crew on account of their inadequate flying experience, training and competence level for B737-236A (advanced version of B737-200 series), absence of formal simulator training in respect of FO for handling an automated flight deck, non-existence of cockpit crew professional competence / skill level monitoring system at operator level (Bhoja Air). The cockpit crew incorrect decision to continue the flight for destination and non-adherence to Boeing recommended QRH and FCOM remedial actions /procedures due to non-availability of customized aircraft documents (at Bhoja Air) for B737-236A contributed towards the causation of accident. **The inability of CAA Pakistan** to ensure automated flight deck variance

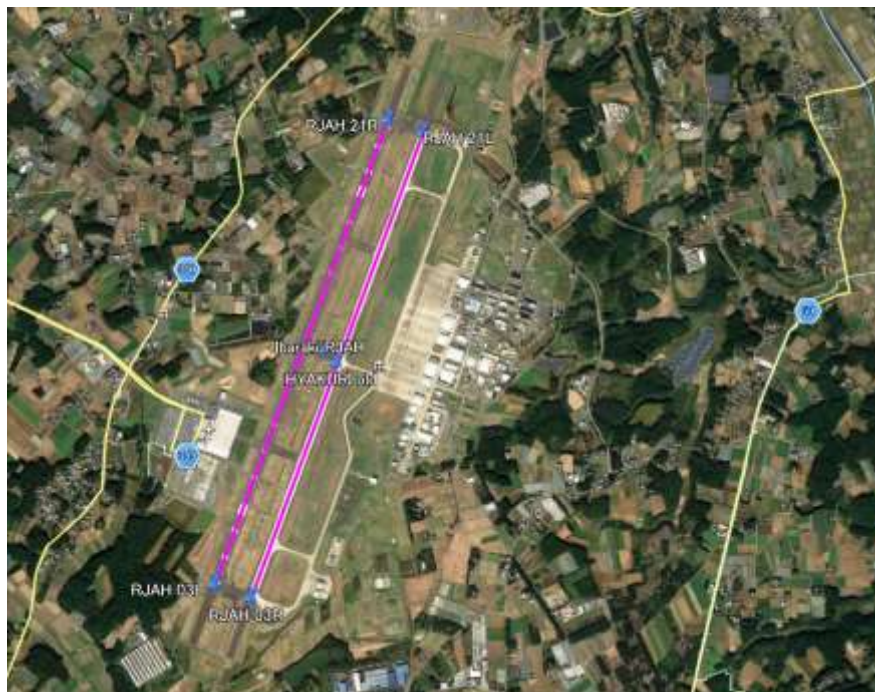
22/04/2012 Ibaraki, Japan, Skymark B737-800, JA73NE, BC-794 Sapporo to Ibaraki landed on **wrong runway**.

茨城空港（茨城県小美玉市）で今月22日、新千歳（北海道）発茨城行きスカイマーク794便（乗員乗客142人）が、管制官の指示と異なる滑走路に誤って着陸していたことが28日、同社などへの取材で分かった。当時、滑走路に他の飛行機はなく、乗員、乗客にけがもなかった。同社や国土交通省東京航空局百里空港事務所によると、同便の機長は22日午後5時半頃、管制官が西側の滑走路への着陸を指示したのに、東側の滑走路に着陸した。茨城空港には、ほぼ南北に延びる2本の滑走路（2700メートル）が約210メートル間隔で並んでいる。機長は着陸後、誘導を受ける際に誤着陸に気づいたという。同社は、23日に国交省に誤着陸を報告。同省は事実関係や原因を調査した上で、改めて報告するよう同社に指示した。（2012年4月28日22時54分 読売新聞）

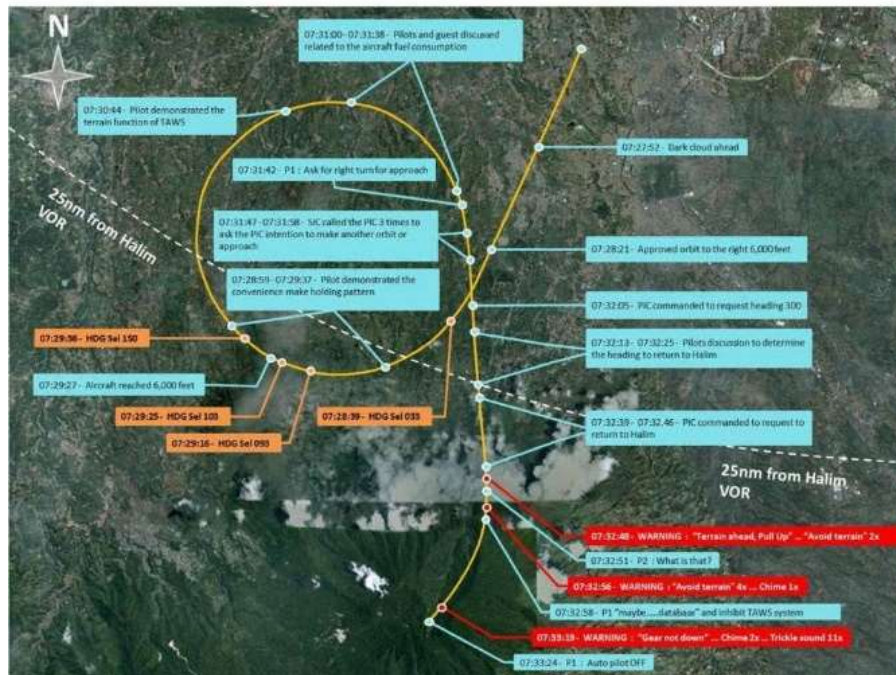
The Air Force said the aircraft impacted the edge of a cliff (top of the cliff at 6250 feet MSL) about 1.7 nm from Cijeruk. Approximate final

position of the aircraft is S6.7102 E106.7447 (initially reported as S6.7045 E106.7373 but updated on May 11th taking the crash site from the western to the eastern cliff).

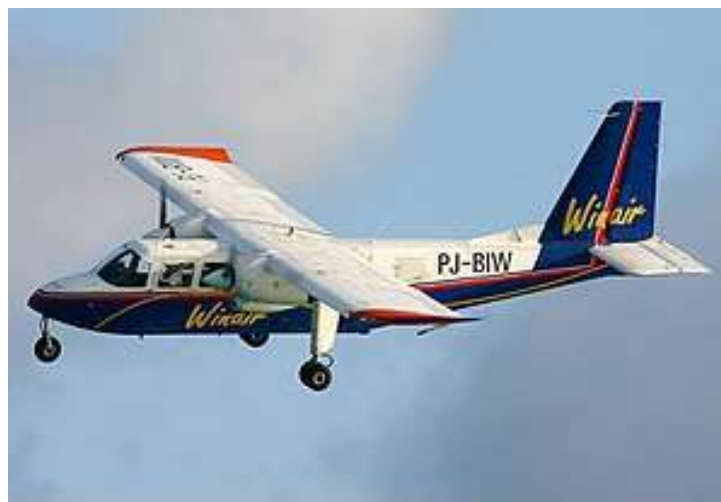
Britten-Norman BN2

A preliminary report released by the East Caribbean Civil Aviation Authority on Oct 13th 2012 states, that the aircraft yawed to the right shortly after becoming airborne and stopped climbing while rolling to the right. The aircraft subsequently lost height and impacted ground right wing tip first at low forward speed and cart wheeled before coming to rest in an upright position. The fuselage section forward of the wing was destroyed, the rest of the aircraft sustained comparatively less damage. The pilot (31, CPL, 710 hours total, 510 hours on type) and two passengers were killed, another passenger survived with serious injuries. Examination of the wreckage showed that the righthand engine was not producing power at the time of impact, investigation of the fuel system showed contamination with significant quantities of water. The righthand propeller was not feathered.

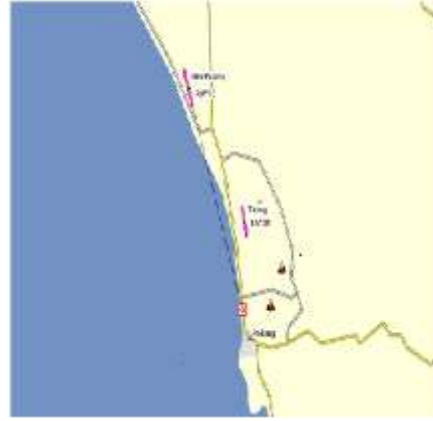
Sriwijaya Boeing 737-400, registration PK-CKD performing flight SJ-21 from Medan (WIMM) to Padang (WIPT) with 96 people on board, was supposed to land on Padang's new Minangkabau International Airport (WIPT), but landed on Padang's former civil, now only military Tabing Airport (WIMG) about 7nm south of Minangkabau International Airport. The landing at about 17:00L was safe.

Location of two, new and old airports
