民間航空機の主な航空事故一覧

Major Air Disasters Involving Commercial Airlines

1937-2024

作成者: 前川 博和 (Hirokazu (Mike) Maekawa)

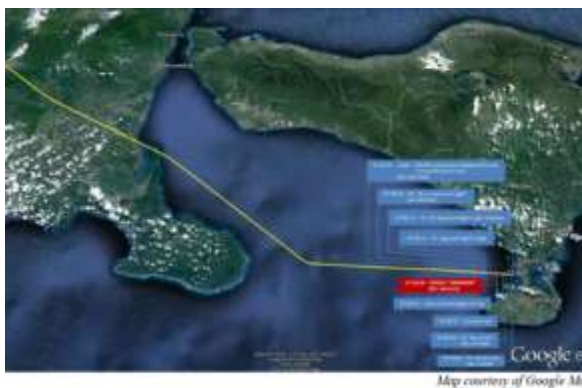
Figure 1: The sequence of events

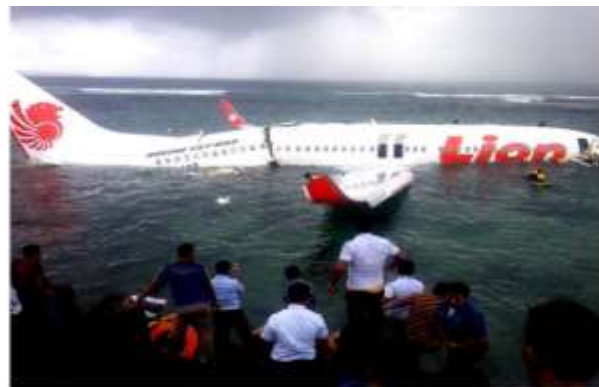
Figure 2: The aircraft after the accident

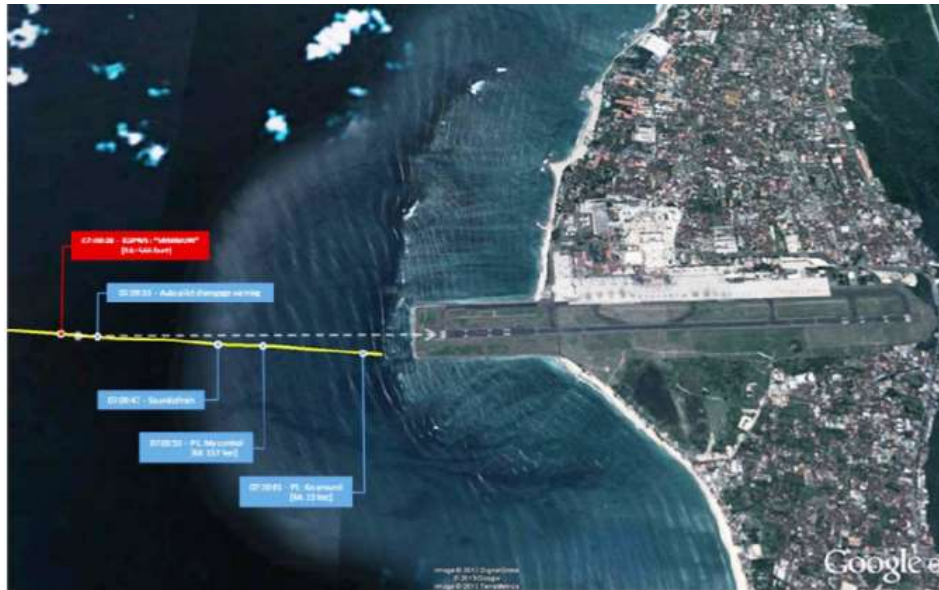
Figure 13: Aircraft flight path superimposed to Google Earth

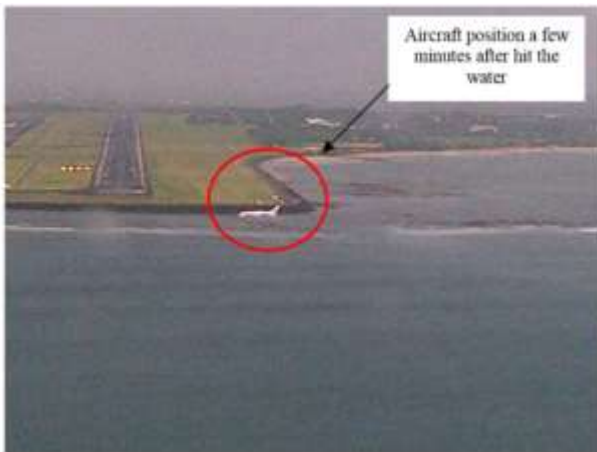
Figure 16: Final aircraft resting position

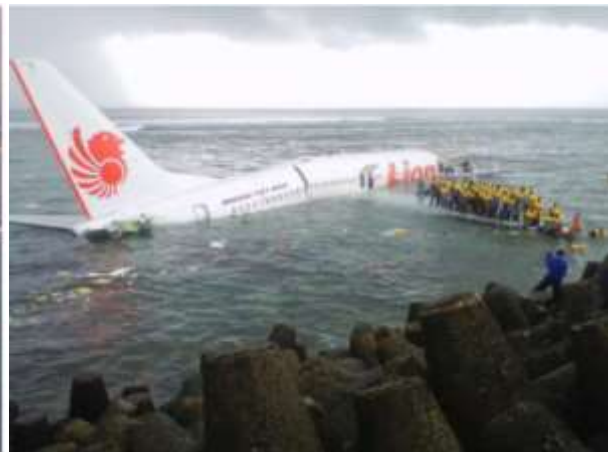
Figure 17: The evacuation process

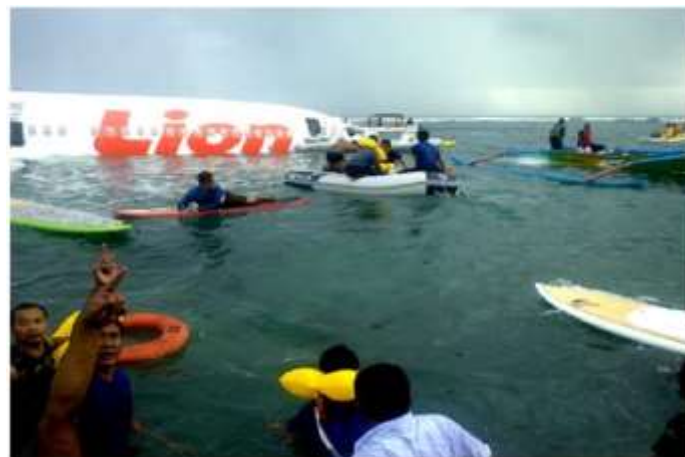
Figure 18: The situation during evacuation process

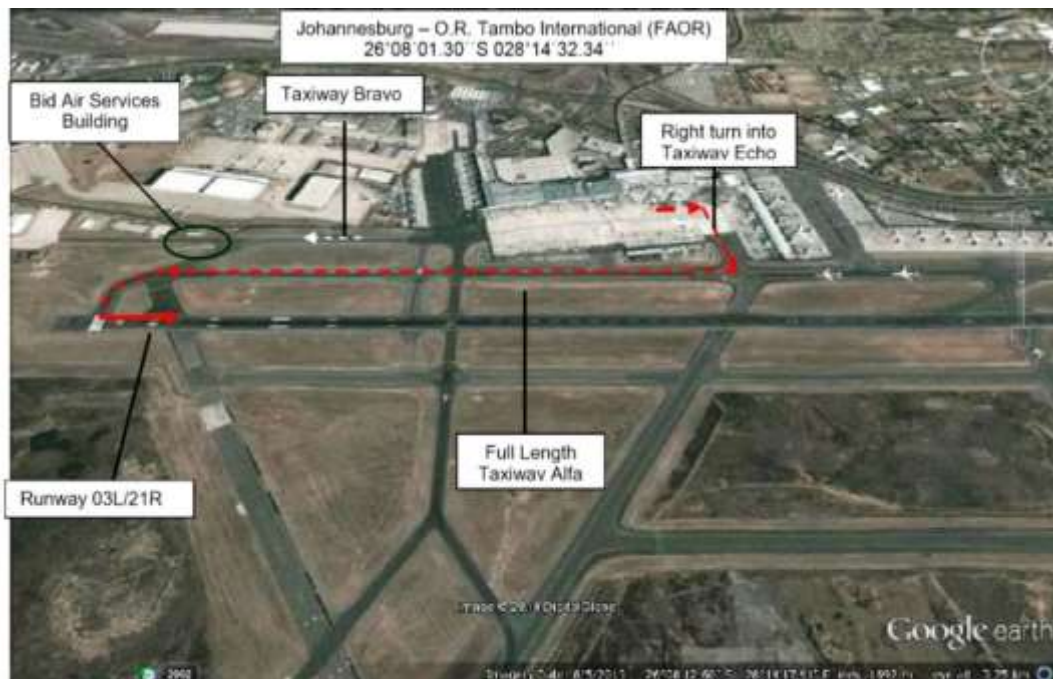
Figure 1 The expected taxi route which the flight crew discussed during the taxi and take-off briefing session

- 22/12/2013 BA B744 at Johannesburg took **wrong taxiway** and buried wing in building, 0/199
British Airways Boeing 747-400, registration G-BNLL performing flight BA-34 from Johannesburg (South Africa) to London Heathrow, EN (UK) with 182 passengers and 17 crew, was taxiing for departure and had been cleared to taxi to holding point runway 03L via taxiway B but missed the turn towards the holding point runway 03L (editorial note: watch the relevant caution on the taxi chart below) and continued on general aviation taxiway M until the right hand wing collided with and sliced an office building. 4 ground staff in the building received minor injuries, none of the aircraft occupants received injuries. The building and aircraft received substantial damage.
Cause: The loss of situational awareness caused the crew to taxi straight ahead on the wrong path, crossing the intersection/junction of Bravo and Mike instead of following Bravo where it turns off to the right and leads to the Category 2 holding point. Following aircraft stand taxilane Mike; they collided with a building on the righthand side of Mike.

Contributory Factors: The crew did not conduct a briefing to discuss the cleared route, nor did they refer to the correct taxiway information in chart 10-6. In combination with the ground movement visual aids, this created confusion and loss of situational awareness when taxiing on taxiway Bravo.

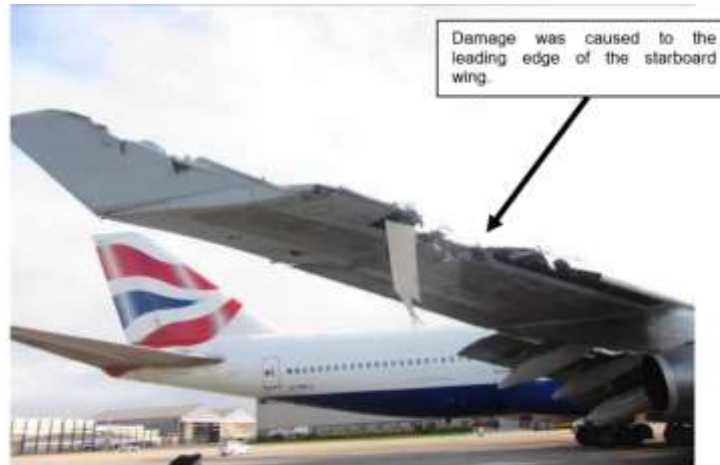
Figure 4 Damage caused to the starboard wing of the BA034 aircraft

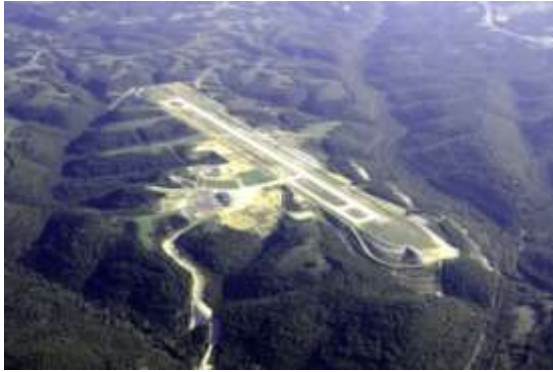
Rwy14/32 (7140ft) Hollister's Branson [KBBG]

Southwest Airlines B737-700, N272WN, WN-4013 Chicago Midway, IL to Hollister Branson Airport, MO with 124 passengers and 5 crew, was on approach to Hollister's Branson Airport [KBBG] but managed to touch down on runway 12 of Hollister/Branson's Graham Clark Airport [KPLK] about 5.5nm north of Branson Airport at about 18:11L (00:11Z Jan 13th) and stopped just at the end of the short runway with the main gear on the "piano keys".

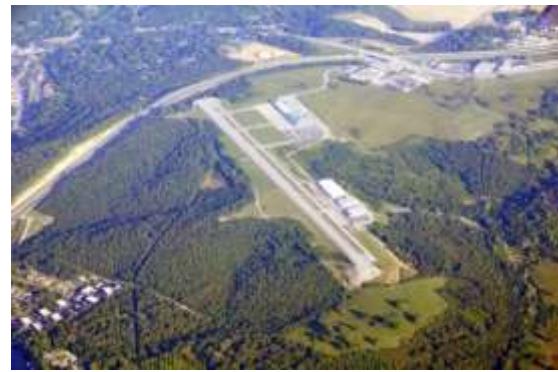
Rwy12/30 (3738ft) Hollister/Branson's Graham Clark [KPLK]

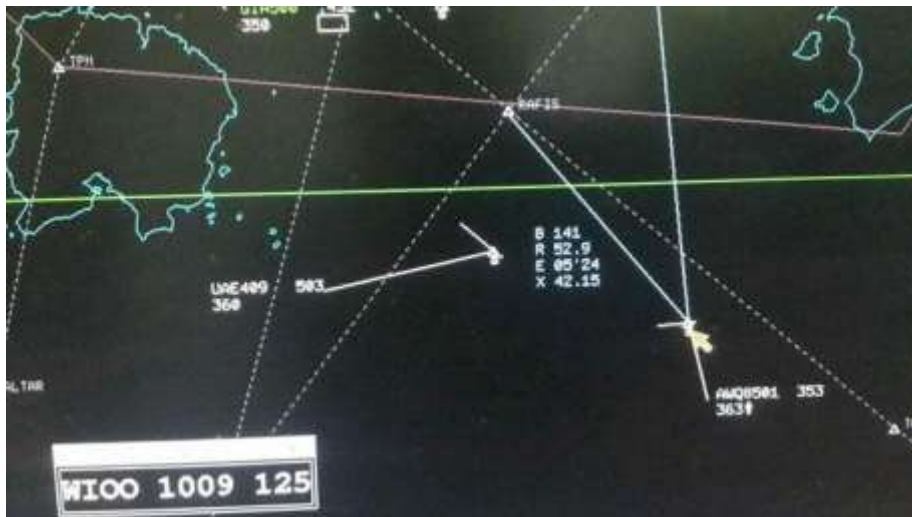
- 28/12/2014 Air Asia flight QZ8501 (AWQ8501) WARR-WSSS has gone missing, ECAM malfunction + Pilot Error, 162/pax155+crew7**
Indonesia Asia A320 over Java Sea on Dec 28th 2014, aircraft lost height and impacted waters (AVH)
Captain of the flight QZ8501 was Iriyanto (ex-F16 pilot) and Ist Officer French man.

- The cracking of a solder joint of both channel A and B resulted in loss of electrical continuity and led to RTLU failure.
- The existing maintenance data analysis led to unresolved repetitive faults occurring with shorter intervals. The same fault occurred 4 times during the flight.

- The electrical interruption to the FAC caused the autopilot to disengage and the flight control logic to change from Normal Law to Alternate Law, the rudder deflecting 2° to the left resulting the aircraft rolling up to 54° angle of bank.

- Subsequent flight crew action leading to inability to control the aircraft in the Alternate Law resulted in the aircraft departing from the normal flight envelope and entering prolonged stall condition that was beyond the capability of the flight crew to recover.

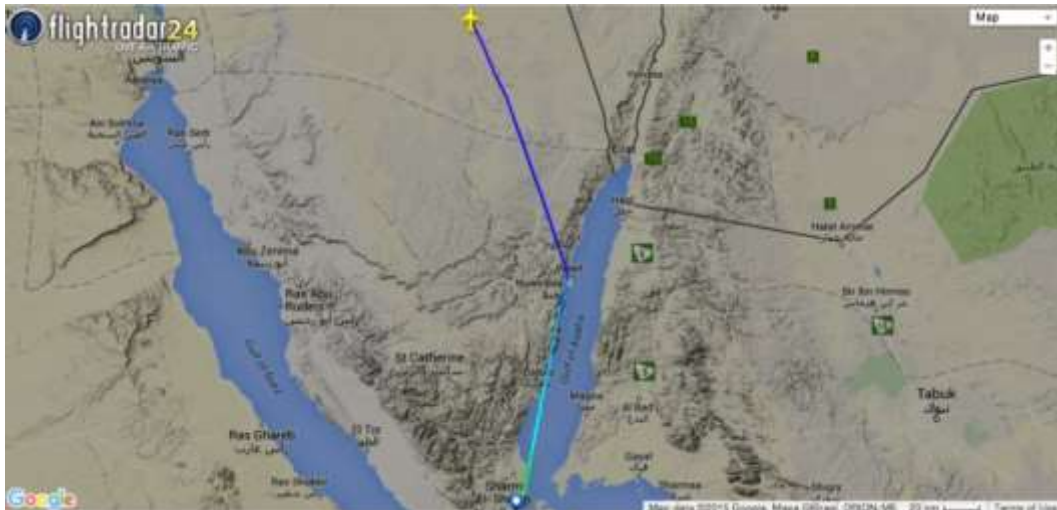
4:13:22z KGL9268 N30.183 E34.161 27925ft 62kts 351mag 6528ft (vertical) AP32000ft

Metrojet (former Kogalym Avia, Kolavia) Airbus A321-200, EI-ETJ, 7K-9268 from Sharm el Sheikh (Egypt) to St. Petersburg (Russia) with 217 passengers and 7 crew, was climbing through FL307 out of Sharm el Sheikh over the Sinai Peninsula (Position N30.16 E34.17, 60nm south of Al-Arish) at 04:12Z when the aircraft disappeared from radar. Wreckage of the aircraft was later located in mountainous terrain about 20nm south of Al-Arish (Sinai, Egypt).

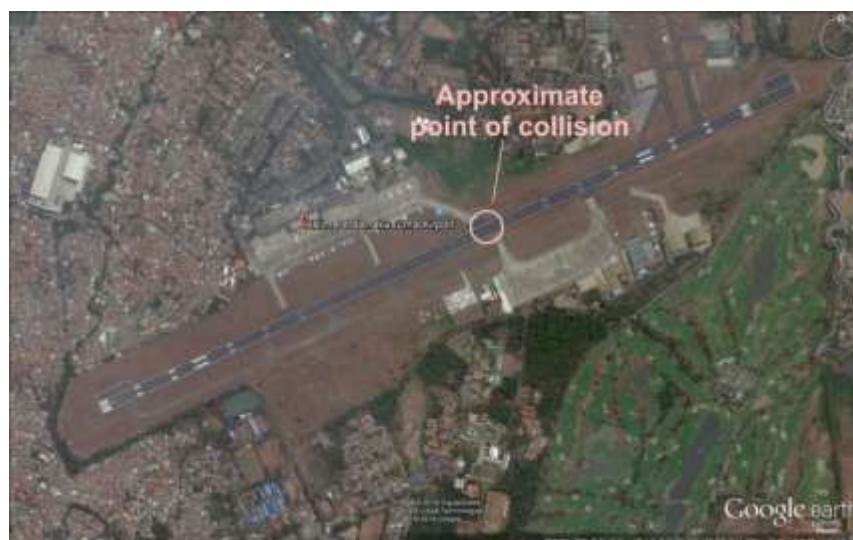
WIHH R/W 06/24

Batik Air B737-800, PK-LBS, ID-7703 from Jakarta Halim Perdanakusuma to Ujung Padang (INA) with 49 passengers and 7 crew, was in the takeoff roll on rwy 24 at 19:55L (12:55Z) when its left wing tip entangled with the vertical tail and left wing of a Transnusa ATR ATR-42-600, PK-TNJ crossing the rwy under tow and separated the most of the vertical tail plane as well as the left wing from the ATR, the left wing tank ruptured open. Both aircraft caught fire. The B737 was evacuated via slides. Fire engines responded and were able to put the fires out in a matter of minutes. No injuries, both aircraft received substantial damage.

On Apr 14th 2016 the French BEA reported based on preliminary information from NTSC Indonesia, that the Batik B737-800 had been **cleared** to enter rwy 24 via taxiway C and backtrack the rwy. In the meantime the tug driver of the Transnusa ATR requested clearance to cross the rwy from the north to the south apron and **received clearance to taxi via taxiway C, rwy 06/24 and taxiway G**. While crossing the rwy the tug driver saw the B737 accelerate for takeoff and attempted to steer the tug and aircraft to the right rwy shoulder, however the left wing of the Boeing collided with the vertical stabilizer and left wing of the ATR. The Boeing rejected takeoff and came to a stop 400 meters past the point of collision.

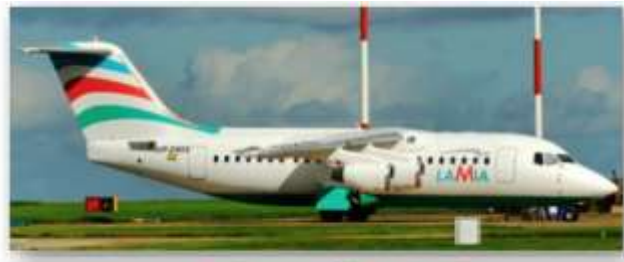
General appearance of the AVRO 146-RJ85

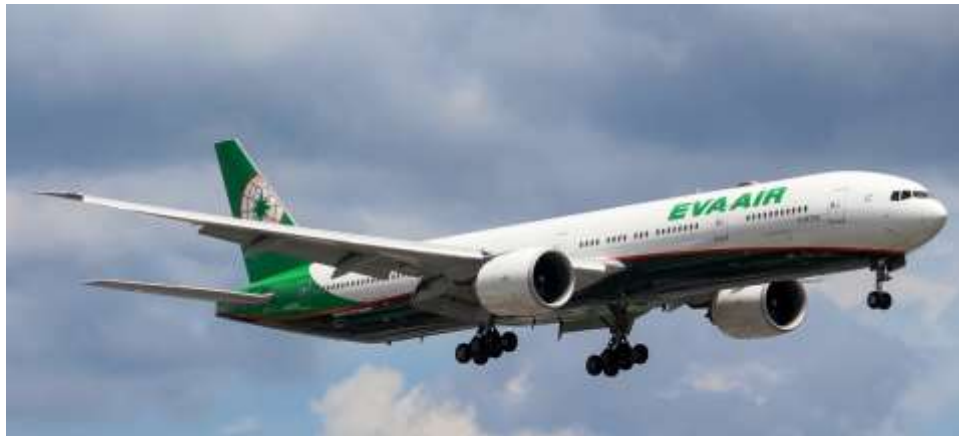
16/12/2016 Los Angeles, CA, Eva B773, ATC instructs turn **left instead of right**, loss of separation, confusion, **Near CFIT**

Eva Air B777-300, B-16726, flight BR-15 (scheduled Dec 15th, actual Dec 16th) from Los Angeles, CA (USA) to Taipei (Taiwan), departed LAX rwy 07R, contacted departure and was instructed to climb to 7000 feet, heading 090. The aircraft was subsequently instructed to climb to 7000 feet and turn left heading 180. The crew correctly acknowledged the instruction and turned left. Shortly after BR-15 an Air Canada Boeing 787-800, C-GHPX performing flight AC-788 (scheduled dep Dec 15th, actual dep 16th) from LAX to Toronto, ON (Canada), departed Los Angeles' rwy 06R, was instructed to climb to 7000 feet and join GABRE departure (which involves a left turn to the north). A conflict arose between AC-788 and BR-15, when BR-15 unexpectedly turned to the north, the controller instructed BR-15 to turn right heading 180. The crew acknowledged turn right heading 180, but continued to turn left. With raised voice the controller instructed BR-15 to stop climb. In an attempt to resolve the situation the controller now instructed **BR-15 to turn left** onto a heading 270, the aircraft continued to the north however. "What are you doing now" the controller asked and instructed to turn southbound NOW, crew asked "confirm heading", "turn southbound NOW", "left or right?" In the mean time the controller instructed AC-788 to climb to 12000 feet and expedite the climb, AC-788 complied and continued to Toronto for a safe landing without further incident.

BR-15 still continued to the north at about 4900-5000 feet, mountains rising there to 6653 feet. The controller instructed BR-15 to climb to 7000 feet, abeam of Pasadena, CA (USA) the crew finally began to turn right, which brought the aircraft even closer to Mount Wilson (peak

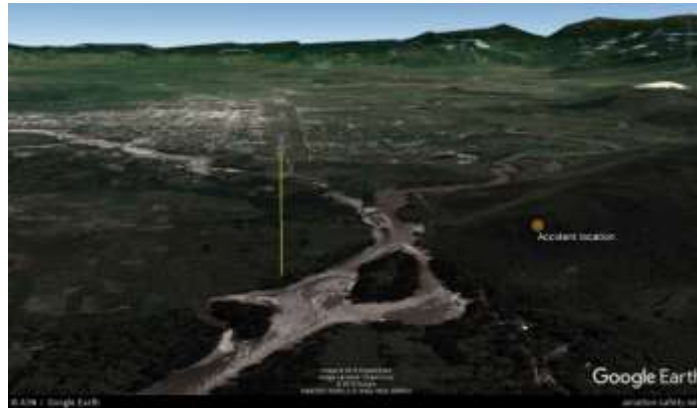
18/12/2016 Wamena, INA, C-130, from TIM/WAYY to Wamena Airport (WMX/WAJW) crashed, CFIT, 13/13

Lockheed C-130H Hercules was destroyed when it impacted mountainous terrain near Wamena, Papua, Indonesia. All 13 on board were killed. The aircraft left Timika at 05:35 and was expected to arrive at Wamena at 06:13. It was approaching runway 33 at the time of the accident. The aircraft went through the center line of the final approach and impacted the south slope of the hills to the right of the center line, about 0.9 NM from the runway threshold at about 5,700 ft, Wamena EL is 5,085 ft.

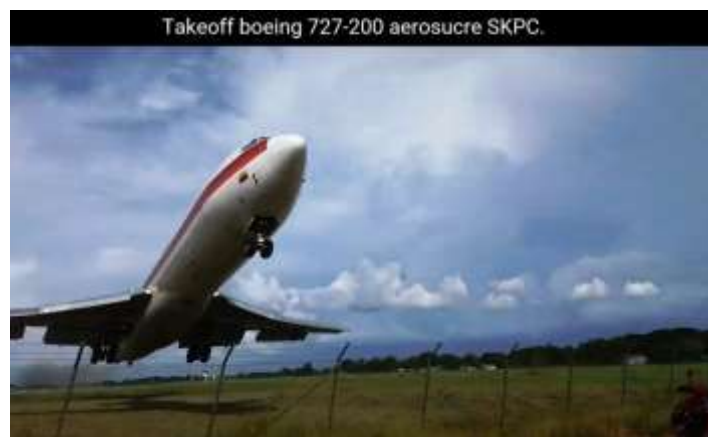
20/12/2016 B727 From Puerto Carreño-Germán Olano Airport (PCR/SKPC), Colombia, crashed after tkof, 5/6

B727 cargo plane, operated by Aerosucre Colombia, was destroyed when it crashed shortly after takeoff from Puerto Carreño Airport in Colombia. One of the six crew members survived the accident. The aircraft took off from rwy 24, a 1780 m long rwy, about 17:20.

Videos circulating online show the accident aircraft on takeoff. The airplane fails to lift off the rwy and crosses the airport perimeter fence and road in a nose up attitude. The aircraft then became airborne and is seen in a right hand turn losing altitude until it impacted flat terrain, bursting into flames. Distance from the end of the rwy to the perimeter road is 95 meters. Aerocivil reports the aircraft crashed 10 miles from the airport. A video posted on Youtube in October 2016 shows a takeoff of an Aerosucre Boeing 727 at Puerto Carreño Airport barely clearing the perimeter fence.

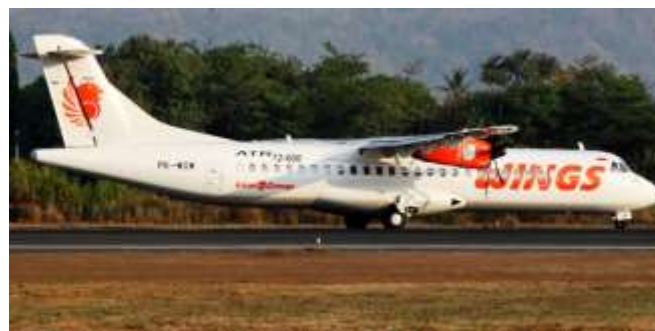
25/12/2016 Semarang, INA, rwy excursion, main gear collapse. 0/68

Wings Abadi ATR-72-212A, PK-WGW, IW-1896 from Bandung to Semarang (Indonesia) with 64 passengers and 4 crew, landed on Semarang's rwy 13 in rain at about 18:24L (11:24Z), but veered right off the rwy and came to a stop with the right main gear collapsed. There were no injuries, the aircraft sustained substantial damage.

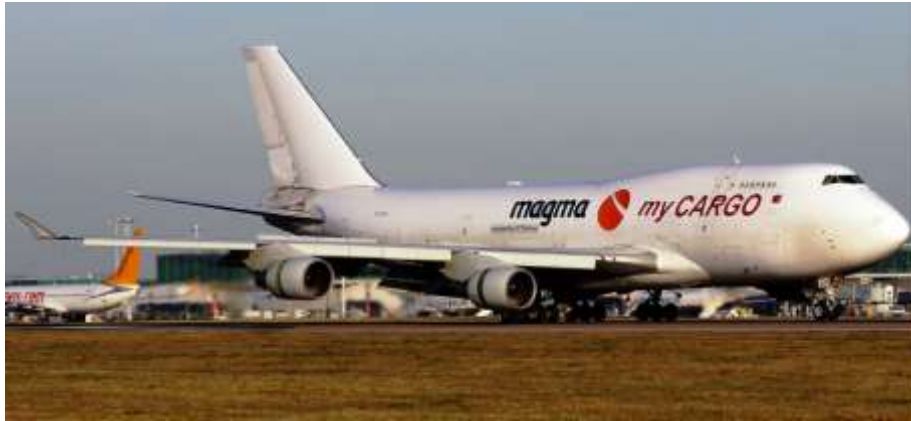
16/01/2017 Bishkek, Kyrgyzstan (UAFM), MyCargo B744 impacted terrain on go around, **4/4+35(on gnd)=39**

MyCargo Airlines B747-400 freighter on behalf of Turkish Airlines, TC-MCL performing flight TK-6491 from Hong Kong (China) to Bishkek with 4 crew, was on final approach to Bishkek's rwy 26 at 07:18L (01:18z) when the aircraft went around from very low height but did not climb out to safety, impacted terrain about 1100 meters/3600 feet past the rwy end and went through a couple of houses of a village. All 4 crew on board the 747 as well as 35 people on the ground perished, 8 people on the ground received injuries and were taken to hospitals.

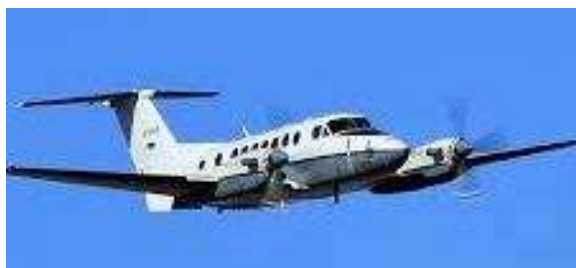
JGSDF LR2 (Super King Air 350)

15/05/2017 Hakodate, Japan, **JGSDF LR2** (Super King Air 350) **CFIT**, approx. 33km West of HWE at about 1147L, 4/4

LR-2 reconnaissance aircraft of Northern Army Aviation Group, Japan Ground Self-Defense Force, carrying four persons, was en route to pick up a patient and is feared to have crashed. The accident airplane lost radar contact at 18 NM west of Hakodate Airport at 3000 feet. The wreckage and four bodies were found in a forest the next day. Elevation of the accident site is 300 to 400 meters (1000-1300 ft), though the last ATC instruction was 'maintain 3500 feet'. The FDR of the accident plane had removed due to electrical malfunction, however, the CVR was operating at the time of the accident.

防衛省は、今年5月に北海道で自衛隊機が墜落し4人が死亡した事故について、**操縦士の操作ミス**が原因だとする調査結果を公表した。この事故は今年5月、陸上自衛隊のLR2連絡偵察機が北海道北斗市の山中に墜落し、搭乗していた4人の隊員が死亡したもの。調査結果によると、操縦士が誤って自動操縦機能を解除したうえ、それを知らせる警報や表示に気付かず、手動操縦に切り替わったことを認識していなかった。さらに、悪天候で視界が悪い中、機体が山に接近していることを知らせる警報にも気付かず、墜落を手動で回避しなかったという。機体に故障などはなかったとしている。防衛省は、操縦士の訓練などを徹底し再発防止に取り組むとしている。

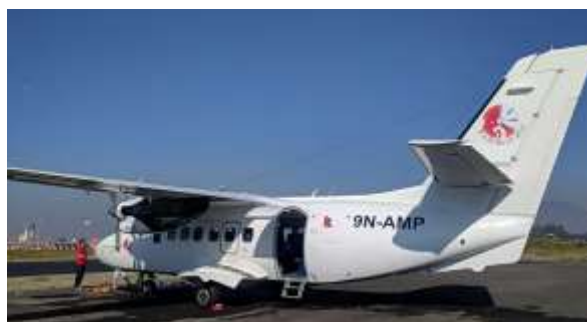
LET L-410

27/05/2017 Lukla, Nepal, Summit L410 contacted trees and impacted ground before rwy, 2/3

Summit Air (former Goma Air) Let L-410, 9N-AKY from Kathmandu to Lukla (Nepal) with 3 crew, was on final approach to Lukla's rwy 06 at about 14:04L (08:19Z) when the aircraft contacted a tree short of the rwy and contacted ground about 3 m/10 ft below the rwy level. The aircraft slid down the slope before coming to a rest about 200 meters below the rwy level. The captain and the first officer died as result of the accident, another crew member received injuries. Nepali Police reported the aircraft touched branches of a tree, suffered technical problems and impacted ground about 3 m below the rwy level just before 14:00L (08:15Z).

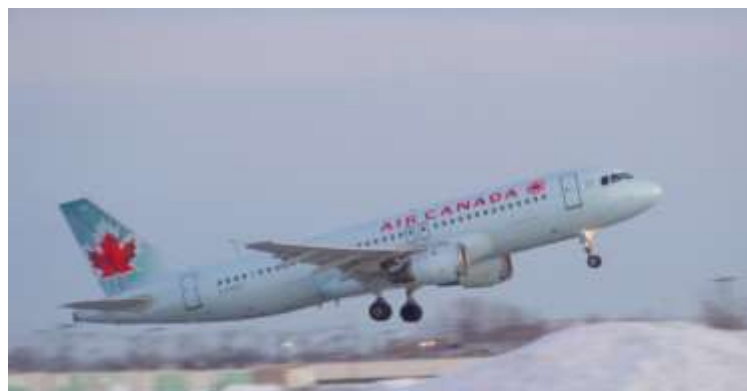
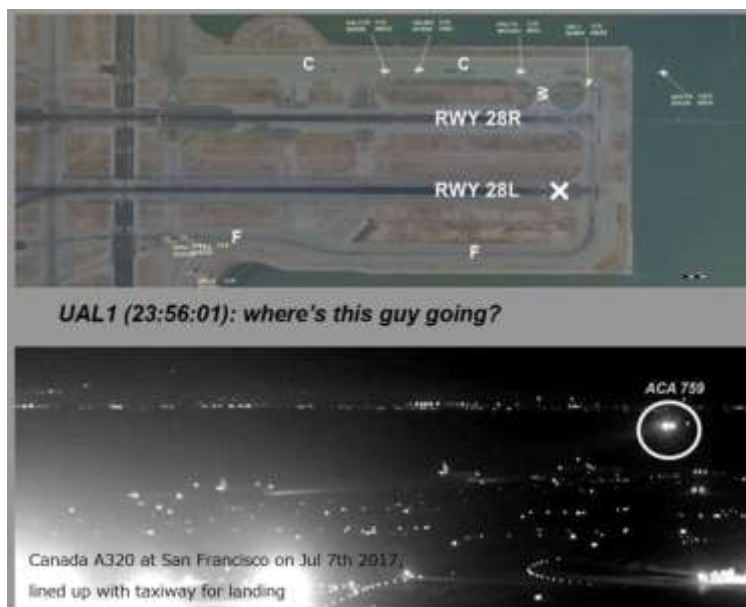
Air Canada A320-200

07/07/2017 **KSFO Canada A320 at San Francisco lined up with taxiway for landing**
 Air Canada A320-200, C-FKCK, AC-759 from Toronto, ON (Canada) to San Francisco, CA (USA) with 140 people on board, was on final approach to rwy 28R in night conditions being cleared to land at about 23:56L (06:56Z Jul 8th), when a short time after reading back the landing clearance the crew queried tower to confirm they were cleared to land advising they were seeing lights on the rwy, tower advised the rwy was clear and they were cleared to land indeed. Another voice chimed in calling they were lined up with the taxiway, tower immediately instructed AC-759 to go around as result commenting it looked like they were lined up for taxiway C. The aircraft went around from below 100 feet AGL. Other flight crew taxiing their aircraft on taxiway C commented the A320 was flying straight over them. The A320 positioned for another approach and landed safely about 15 minutes later.

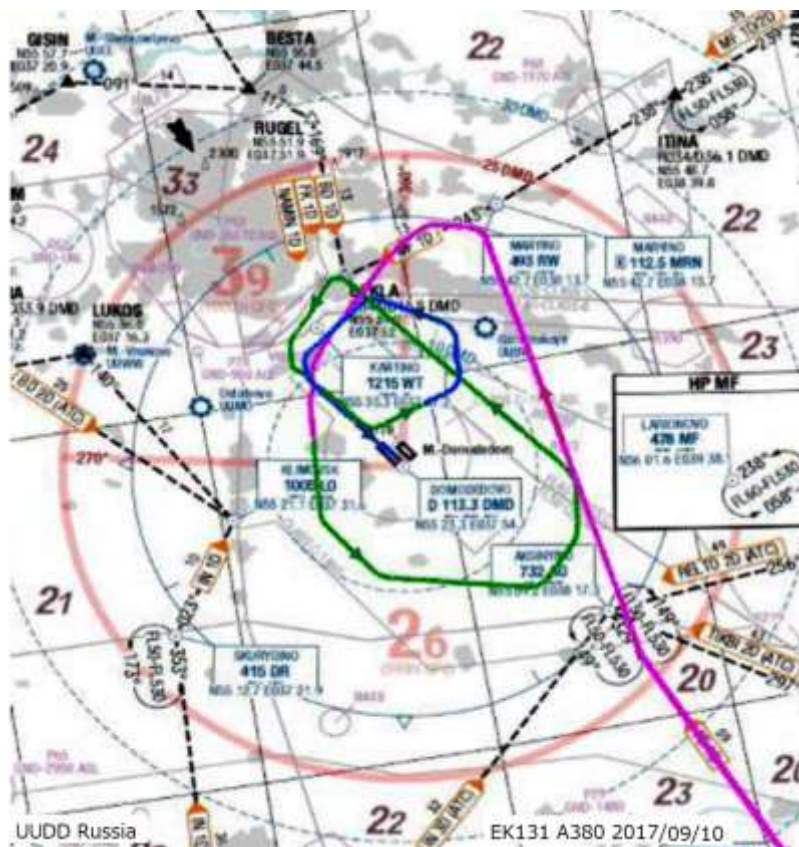
Incident Report: by UAE GCAA

UAE General Civil Aviation Authority (GCAA) reports: during approach to UUDD, the aircraft was cleared for the rwy 14R ILS approach when it was on the base leg. The aircraft descended below its cleared altitude of 500m QFE prior to establishing on the localizer. The Radar Controller alerted EK131 to stop the descent. The flight crew then performed a go-around and requested vectors for a second approach. During the go-around, **the minimum radio altitude reached was 395 ft above ground level**, and EGPWS “**Glideslope**” and “**Terrain Ahead - Pull Up**” alerts were activated.

The flight crew flew one go-around and one discontinued approach and landed on runway 14R from the third approach. The go-around, discontinued and landing are shown in figure above. The trajectory in magenta depicts the first approach and go-around, the green line illustrates the second approach and discontinued approach, and the third approach and landing is shown by the blue line.

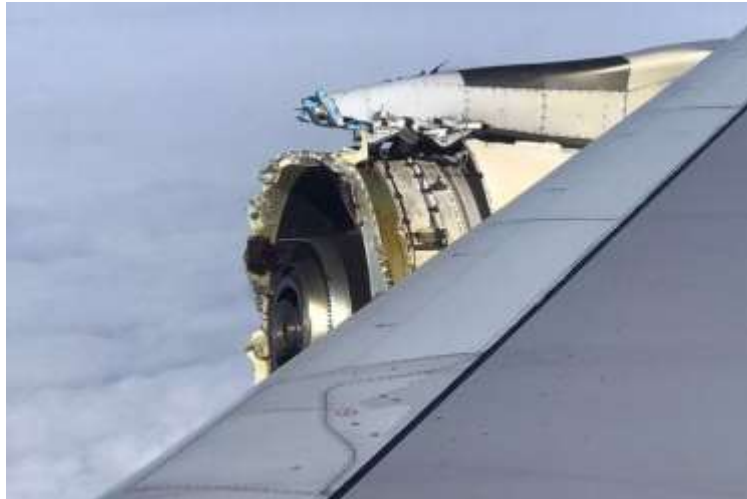
uncontained engine failure

01/10/2017 AF66 CDG-LAX diverts - **uncontained engine failure** over Atlantic, no pax & crew injury.

A388 F-HPJE operating from Paris-CDG to LAX as AFR 066 diverted to YVR (Goose Bay) due to in-flight engine N°4 problem
The aircraft took-off at about 0945z/30SEP and landed at YVR at 1545.

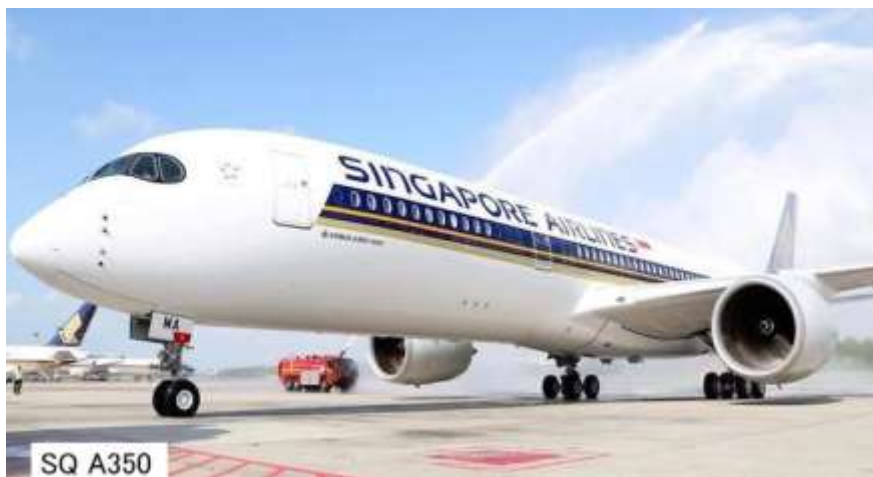
WHAT WENT WRONG

04/12/2017 Singapore (SQ) A359 at Mumbai (Bombay) go-around on final approach portrayed as approach to **wrong airport**.

10.25am, Mon
 Juhu air traffic control (ATC) calls Mumbai ATC on hotline and says, 'Aircraft approaching too close to Juhu'
An alternative direction and an alternative navigational aid were in use at Mumbai airport

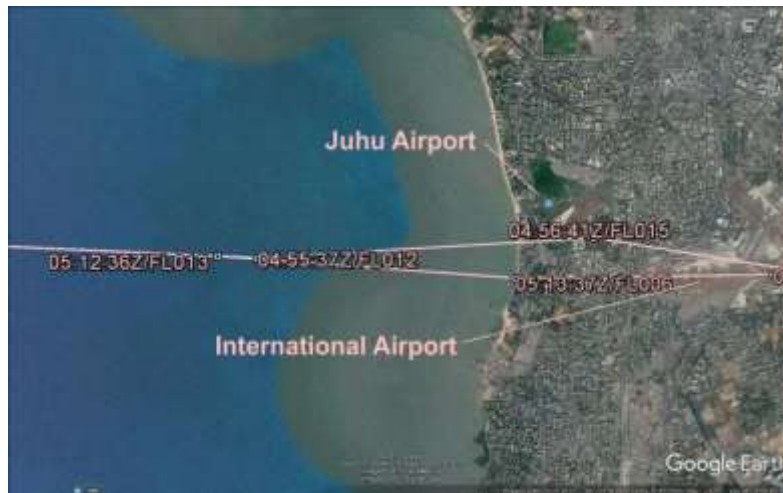
Singapore Airlines A350-900, 9V-SMH, SQ-422 from Singapore to Mumbai (India), was cleared for the approach to Mumbai International Airport's rwy 09 and was descending through about 1000 ft MSL when the crew initiated a go around, positioned for another approach to rwy 09 of the Airport and landed safely on that rwy about 18 minutes later.

The airline reported: "Singapore Airlines SQ422, an Airbus A350, operating from Singapore to Mumbai on 04 December, was scheduled to land on Rwy 09 at Chhatrapati Shivaji Intl Airport at 1035L. Due to poor visibility conditions, the crew discontinued the approach to Rwy 09 at approximately 1000 ft, in accordance with standard operating procedures. Mumbai ATC then vectored the flight for a subsequent approach onto Rwy 09 and the flight landed uneventfully at 1048L. At no time did the pilots of SQ422 mistake Juhu airport as Chhatrapati Shivaji International Airport."

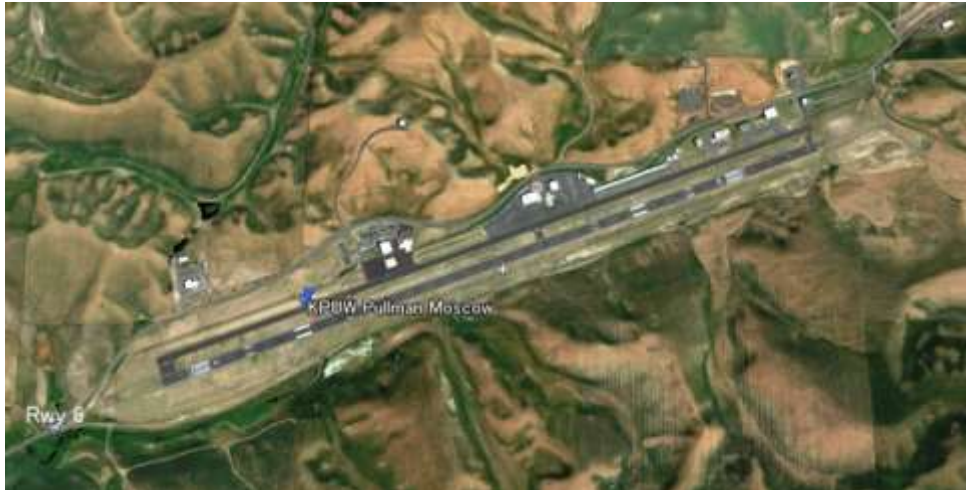
29/12/2017 Pullman Moscow, WA, USA, KPUW, Horizon DH8D at landed **on taxiway, 0/46**

Horizon de Havilland Dash 8-400 on behalf of Alaska Airlines, N412QX, flight QX-2184/AS-2184 from Seattle to Pullman Moscow, Washington (USA) with 42 pax and 4 crew, was on final approach to the uncontrolled aerodrome of Pullman and Moscow in night conditions intending to land on rwy 06, when the crew aligned the aircraft with the parallel taxiway to the left of the rwy and landed on the taxiway, that was unoccupied at that time. The aircraft rolled out without further incident.

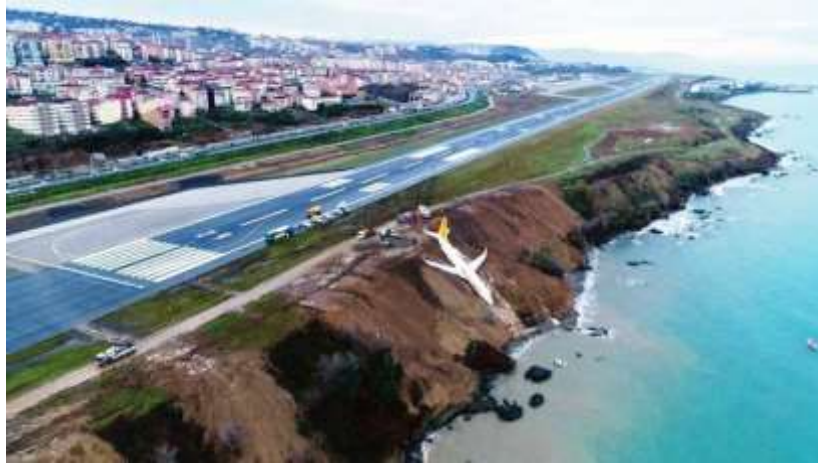
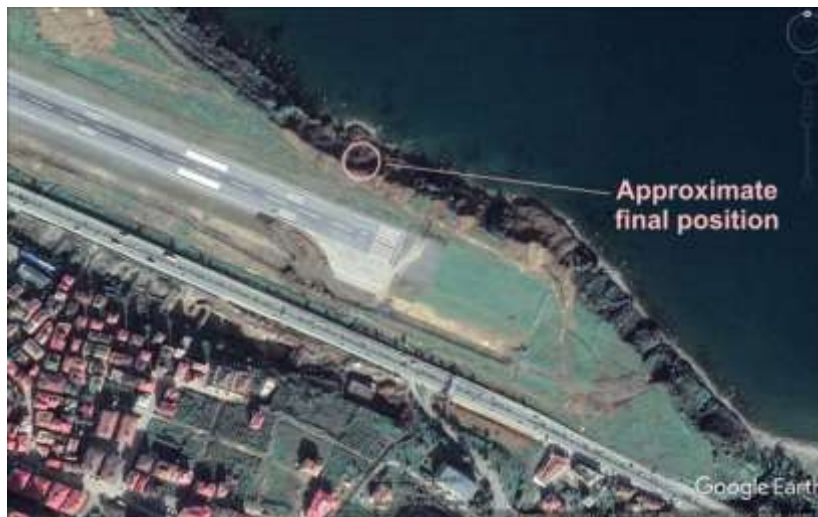
13/01/2018 Trabzon, Turkey, Pegasus B738, rwy excursion, 0/168

Pegasus B737-800, TC-CPF PC-8622 from Ankara to Trabzon (Turkey) with 162 passengers and 6 crew, landed on Trabzon's rwy 11 at 23:26L (20:26Z) but veered left off the rwy, went down a slope and came to a stop on soft ground just short of the sea about 60 meters before the rwy end and about 60 meters to the left of the left rwy edge. The aircraft was evacuated. There were no injuries, the aircraft sustained substantial damage. Wx: LTCG 132050Z 25001KT 2800 -RA BR BKN004 BKN025 08/07 Q1021 BECMG TL2100 3200=

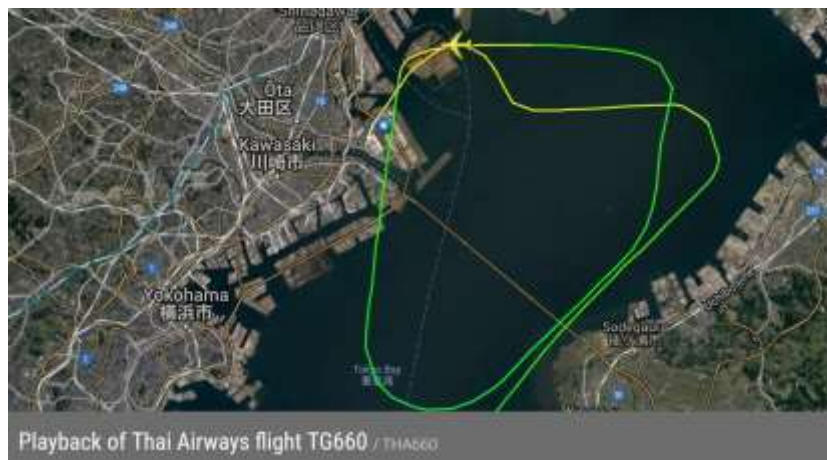
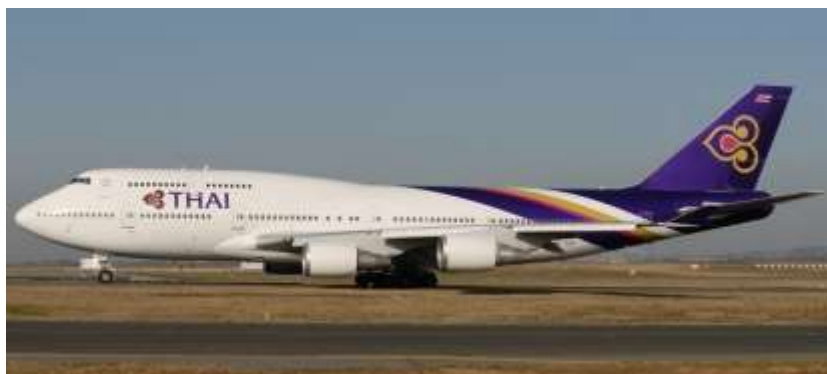
11/04/2018 Haneda airport, Tokyo, TG660 EGPWS showed too low.

B747-400 of Thai Airways International, THA/TG660 from Bangkok/Suvarnabhumi, Thailand to Tokyo/Haneda, Japan, experienced "Too Low" **EGPWS warning** during a night time approach to rwy 16L of Haneda. The airplane was at 8 km northeast of Haneda and descended to 170 m (560 ft) at the time of the incident. The Boeing executed a go-around, and made a safe landing on rwy 22 about 15 minutes later at 00:04 LT of 12 April. No personal injuries were reported. JTSA launched an investigation as a serious incident on 17th April, six days after the incident.

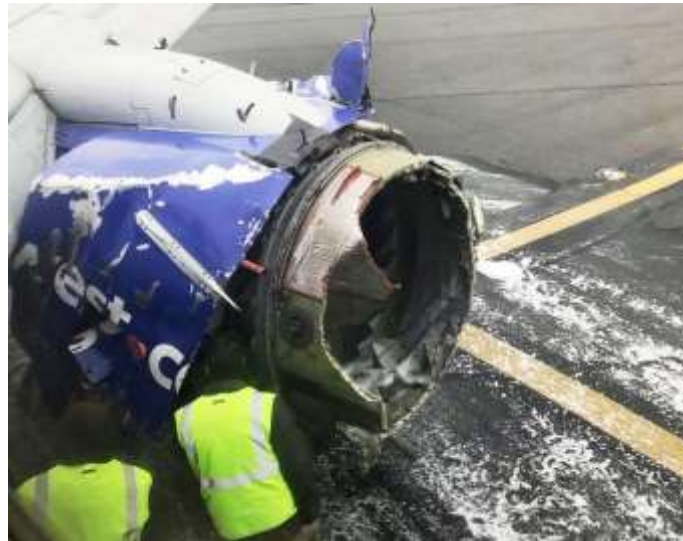
17/04/2018 Southwest Airlines B737-700, WN1380 diverted to Philadelphia, Pennsylvania, USA, after suffering an in-flight uncontained engine failure.

An engine on Southwest Airlines exploded, killing one passenger

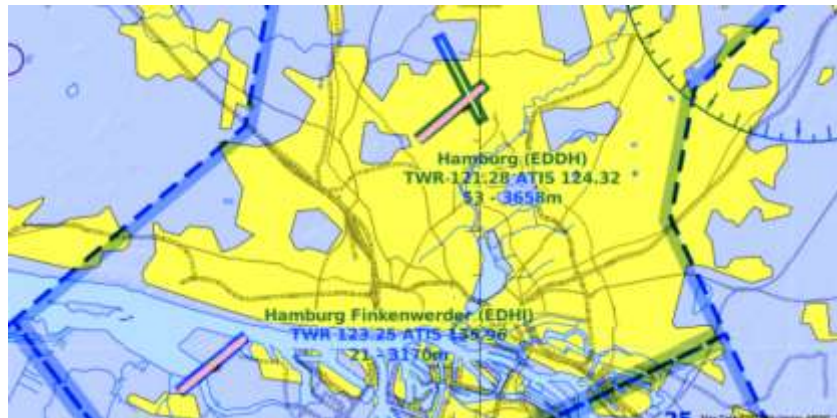
Spanish LCC Vueling A320-200, EC-KDG, VY-1820 Barcelona, SP (Spain) to Hamburg Fuhlsbüttel (フールスビュッテル), was on approach to Hamburg's International Airport **Fuhlsbüttel (EDDH)**. ILS for rwy 05 as well as NDB approach were out of service, the approach minima had been raised due to obstacles near the rwy 05. Aircraft were cleared for RNP approaches to rwy 05, the Vueling crew however performed a visual approach to rwy 05 and lined up with **Finkenwerder (フィンケンヴェルダール: EDHI)** rwy 05 (about 15km away).

ATC intervened, instructed the crew to turn left and not to descend. The crew shifted their flight path slightly to the left, climbed 200 feet, **now aligned with the rwy 05 of Fuhlsbüttel** and continued for a safe landing on the correct rwy.

EDDH and EDHI airports in Frankfurt, Germany

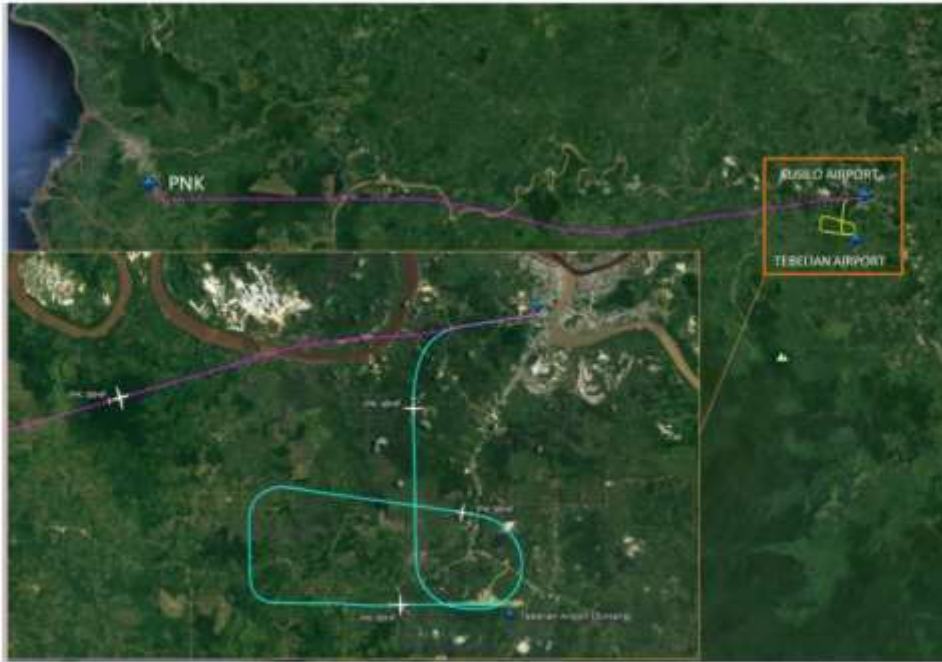
Figure 2: The flight track as recorded on the FDR. Purple line indicated the flight from Pontianak to Susilo Airport, and the blue line indicated the flight from Susilo Airport to Tebelian Airport.

Wings Air ATR-72-212A, PK-WHF, IW-1370 from Pontianak to Sintang Tebelian (WOS Indonesia), landed safely on Sintang's former Susilo Airport. Susilo Airport had been in use until April 26th 2018. On April 26th 2018 00:00Z (07:00L) the new Tebelian Airport (rwy 09/27 length 1660 meters) located about 11km south replaced Susilo Airport (rwy 08/26 length 1300 meters) maintaining the ICAO and IATA identifiers of Susilo Airport, Susilo Airport was shut down. (Old Sintang Susilo: N0.063619E111.473428)

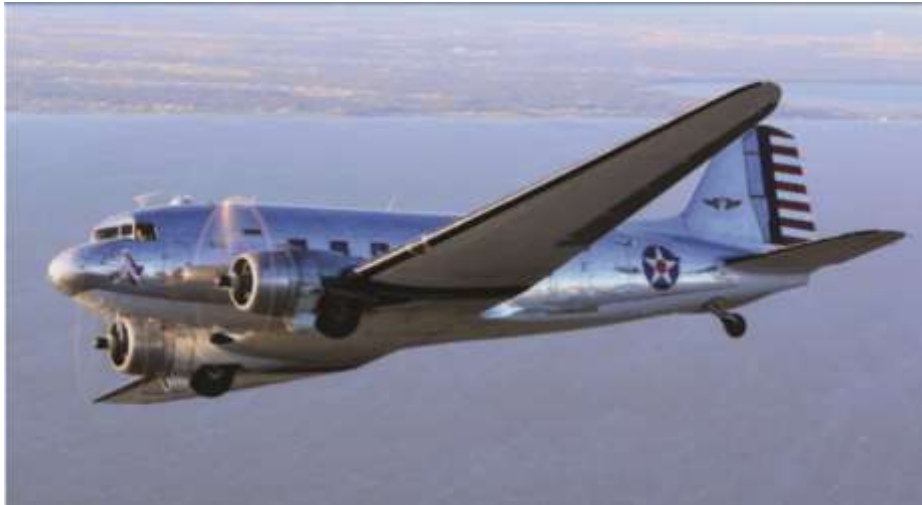
Commemorative Air Force, Highland Lakes Squadron C-47B (DC-3)

Examination of the accident site revealed that the airplane came to rest upright on a heading of about 113° magnetic, about 145 ft east of the left side, and 2,638 ft from the approach end of runway 19. The postimpact fire consumed the fuselage from the nose cone aft to about 3 ft forward of the left side cargo door along with a majority of the wing center section.

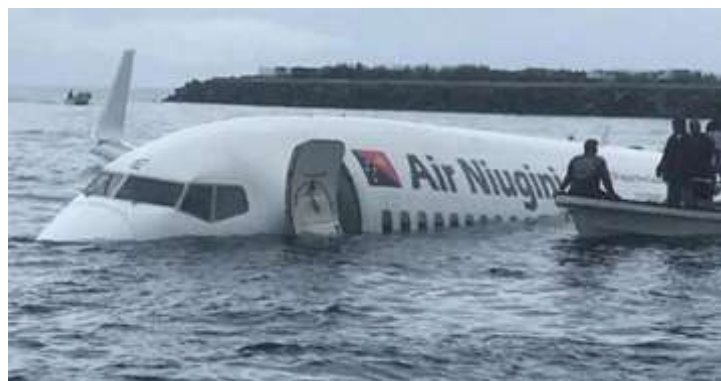
Air Niugini B737-800, P2-PXE PX-73 Pohnpei to Chuuk (Micronesia) with 35 pax and 12 crew, was on final approach to Chuuk's rwy 04 in poor weather when the aircraft came too low and touched down into the sea and came to a stop about 150 meters left abeam of rwy threshold.

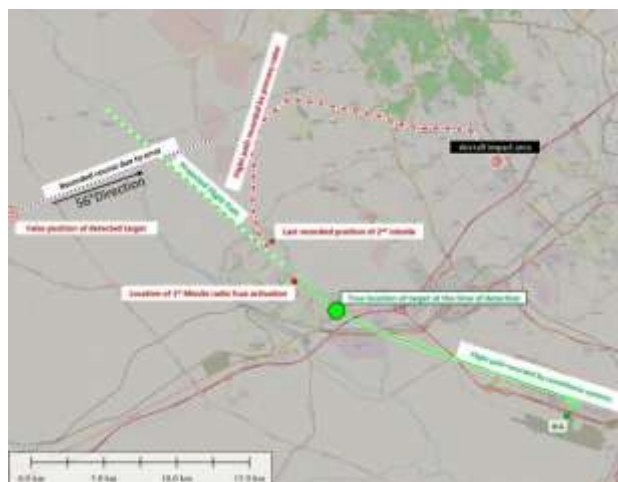
Complete flight trajectory and missile last positions (Graphics: Iran's AIB):

Mar 17th 2021 Iran's CAO released their **final report**, concluding the probable causes of the crash were: **The air defense's launching two surface-to-air missiles at the flight PS752, UR-PSR aircraft**, the detonation of the first missile warhead in proximity of the aircraft caused damage to the aircraft systems, and the intensification of damage led the aircraft to crash into the ground and explode instantly. Other Contributing Factors- The mitigating measures and defense layers in risk management proved to be ineffective due to the occurrence of an unanticipated error in threat identifications, and ultimately failed to protect the flight safety against the threats caused by the alertness of defense forces.

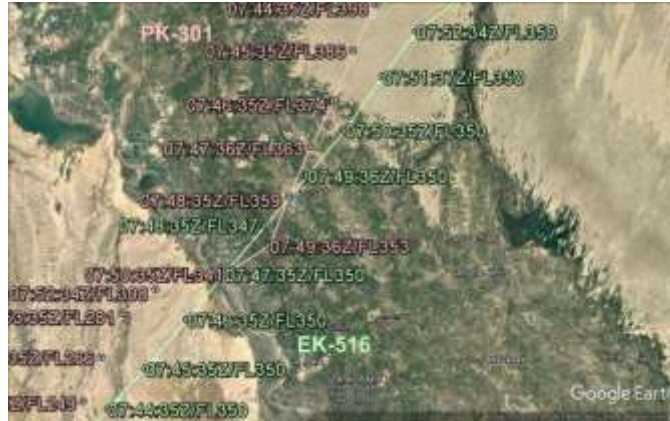
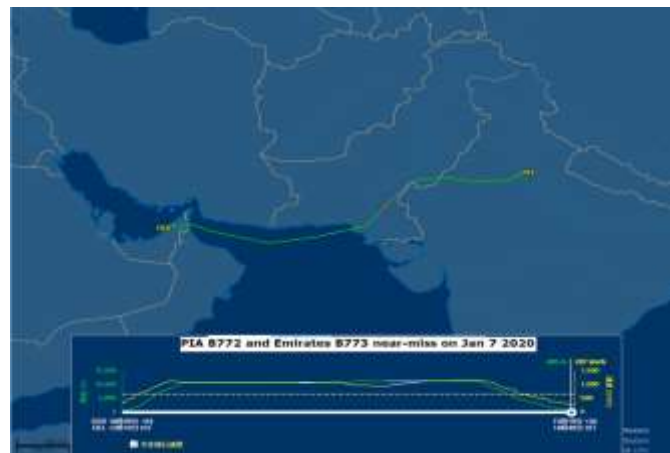
below FL360 about 106nm northeast of Karachi. According to ADS-B data the horizontal separation reduced to about 1nm at about 07:48:50Z while due to TCAS activations and compliance with the resolution advisories the vertical separation was kept at about 1000 feet. About 106m northeast of Karachi, about 45 seconds after point of closest approximation, the Emirates had returned to FL350, the PIA Boeing was descending through FL353, the horizontal separation between the aircraft had increased to 13mn again. Pakistan's CAA reported a near collision occurred and suspended three air traffic controllers involved into the occurrence.

Emirates B777-300ER, A6-EPS, flight EK-516 from Dubai (United Arab Emirates) to Delhi (India), at FL350 about 50nm northeast of Karachi tracking into a northeasterly heading. About 90nm northeast of Karachi the Emirates Boeing received a TCAS resolution advisory to descend due to the PIA Boeing descending at high sink rate, the Emirates crew complied with the advisory, the PIA Boeing received a TCAS resolution advisory to reduce rate of descent about 110nm northeast of Karachi. The PIA Boeing continued to descend, descended to

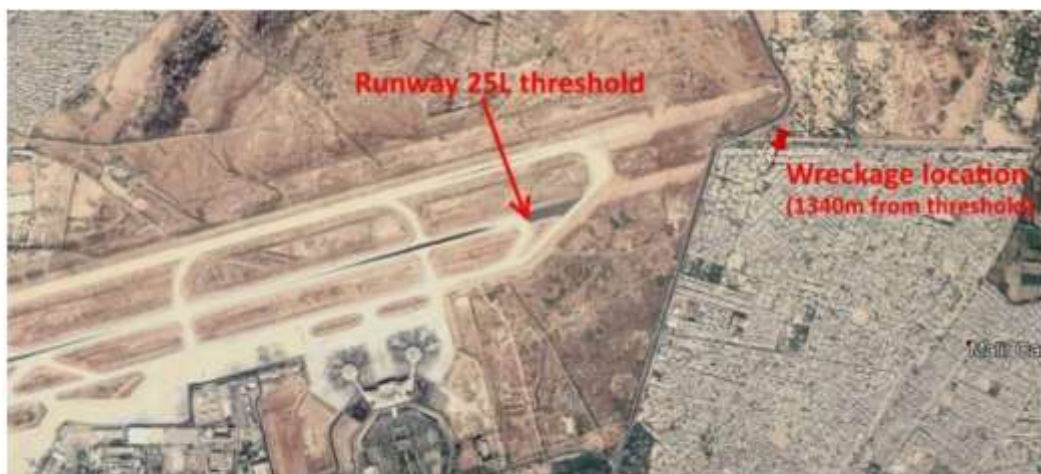
Fig 1: Google Earth crash site location (direction of flight from right to left)

20/05/2020 Karachi, Pakistan, PIA A320-214, AP-BLD, Lahore (OPLA) to Karachi (OPKC), PK8303, 97/99, 8 crew (Capt, F/O, 6 FA) + 91 pax. At 14:35 the aircraft performed an ILS approach for rwy 25L and touched down **without landing gears**, resting on the engines. Both engines scrubbed the runway at high speed. Flight crew initiated a go-around and informed "Karachi Approach" that they intend to make a second approach. About 4 minutes later, during downwind leg, at an altitude of around 2,000 ft, flight crew declared an emergency and stated that both engines had failed. The aircraft started losing altitude. It crashed in a populated area, short of rwy 25L by about 1,340 meters. An immediate subsequent post impact fire initiated. Out of 99 souls on-board, **97 were fatally injured** and 2 pax survived. On ground 4 persons were injured however 1 out of these reportedly expired later at a hospital. **One on ground killed.**

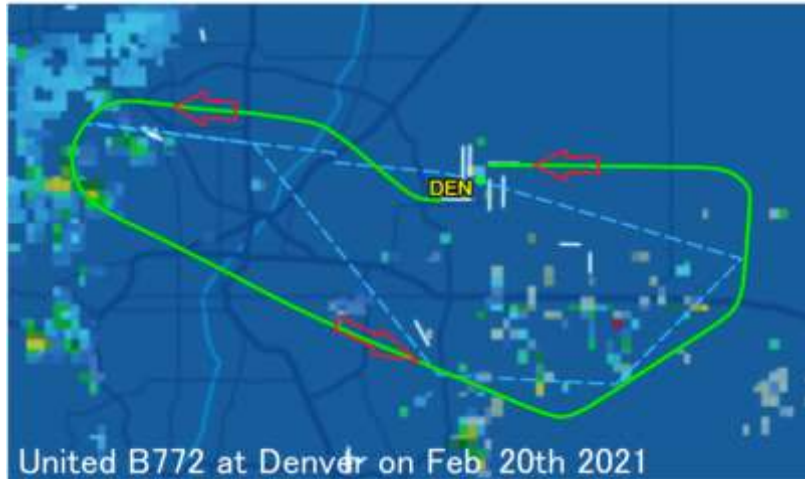
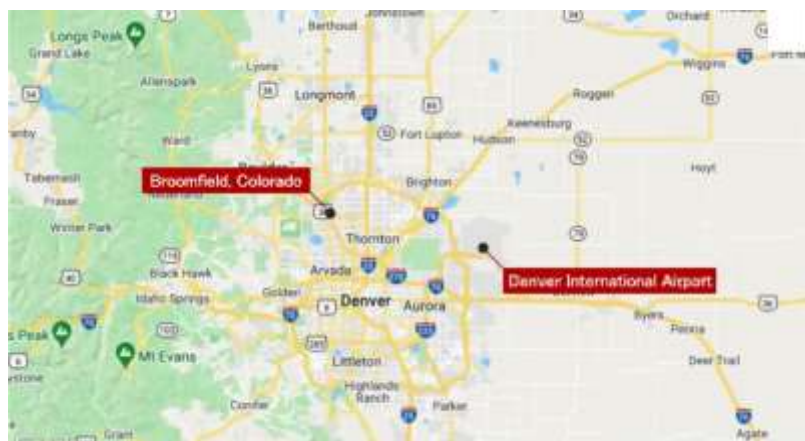
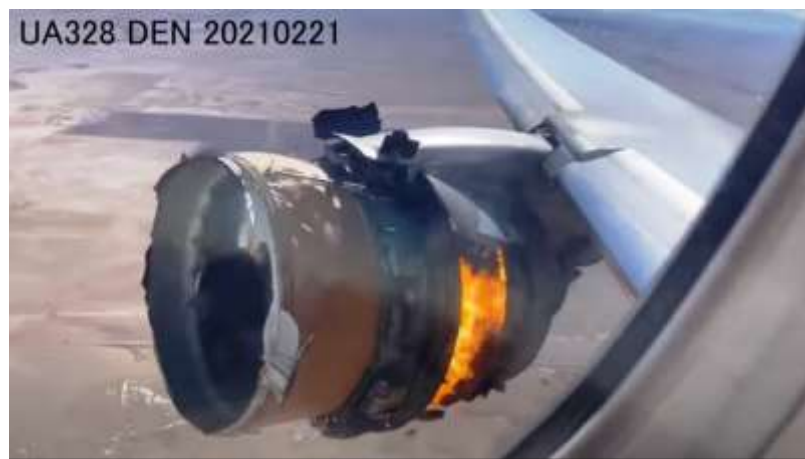
Contained Engine Failure

UAL B777-200, N772UA flight UA-328 from Denver, CO to Honolulu, HI (USA) with 229 pax and 10 crew, was in the initial climb out of Denver's rwy 25 when the righthand engine's (PW4077) inlet separated associated with the failure of the engine. The crew declared Mayday reporting an engine failure. The aircraft stopped the climb at about 13000 feet, the crew requested to return to Denver after running the
