民間航空機の主な航空事故一覧

Major Air Disasters Involving Commercial Airlines

1937-2024

作成者: 前川 博和 (Hirokazu (Mike) Maekawa)

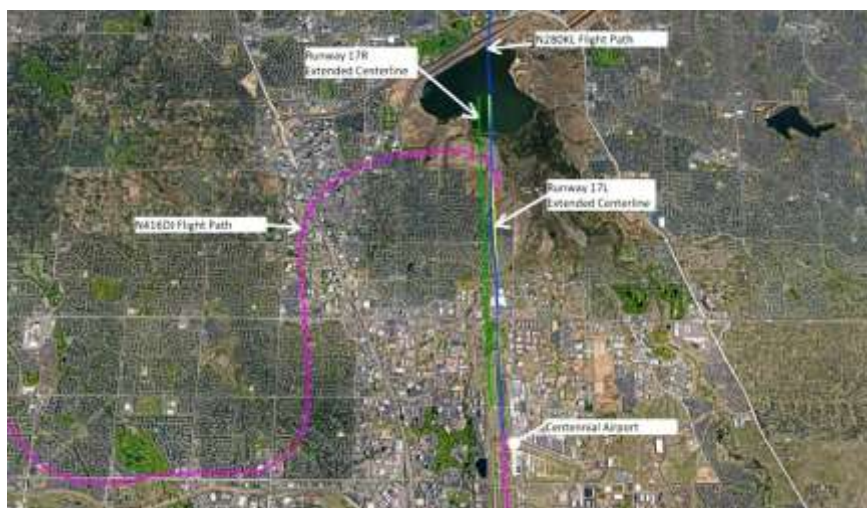
17L/35R : 10001 x 100 ft / 3048 x 30 m	Asphalt / Grooved	El: 5793.0 / 5884.9	Traffic Pattern: Left / Right
17R/35L: 7001 x 75 ft / 2134 x 23 m	Asphalt / Grooved	El: 5803.7 / 5868.7	Traffic Pattern: Right / Left

SR22 N416DJ and Key Lime Air Flight 970, Swearingen SA-226-TC Metro II N280KL cargo flight, collided on approach to Centennial Airport in Colorado. (E1:5884.9 ft. / 1793.7 m. Var 08E (2015) :1.5 miles SE of DENVER, CO.) The Cirrus made a safe off-airport parachute-assisted landing, while the Key Lime pilot landed safely at Centennial despite the loss of a section of the cabin roof, damage to the empennage, and failure of one engine. There were no injuries.

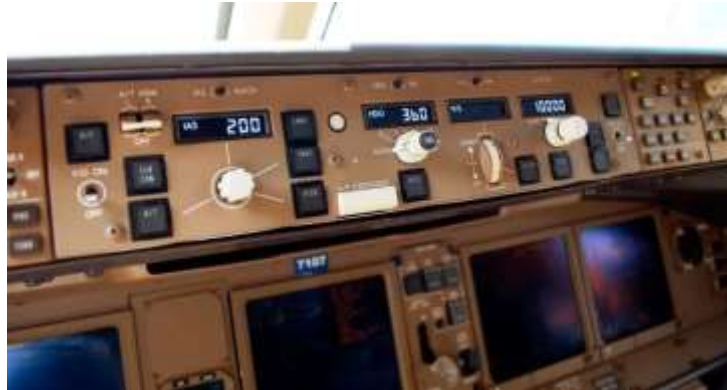
B777-300-mode-control-panel

On Dec 27th 2021 Emirates Airlines released a crew alert to their pilots following the occurrence suggesting the crew had not picked up [the previous flight crew had left the altitude setting at the Master Control Panel at airport elevation/00000 ft causing the flight director to not indicate takeoff rotation and climb out but instead indicate to maintain that altitude \(ALT mode\).](#)

CREW ALERT
*****
CO1408/21 COMPANY NOTAM - B777 MCP POWER UP DEFAULTS AND AFTER
LANDING/ SHUT DOWN MCP CHANGES
CREWS ARE REMINDED THAT THERE ARE NO FCOM NORMAL PROCEDURE (NP)
REQUIREMENTS TO CHANGE THE MCP AFTER LANDING OR SHUTDOWN.
THERE HAVE BEEN TIMES WHEN THE MCP "ALTITUDE WINDOW" HAS BEEN SET
TO THE AIRPORT ELEVATION WHICH MAY CAUSE ISSUES ON THE SUBSEQUENT
DEPARTURE. THE FCOM 4.10.2 STATES THAT THE AFDS WILL ENGAGE IN
"ALT" WHEN THE FIRST FLIGHT DIRECTOR SWITCH IS TURNED ON, IF THE
MCP SELECTED ALTITUDE IS WITHIN 20 FEET OF THE DISPLAYED BARO
ALTITUDE. CREWS SHALL NOT SET AIRPORT ELEVATION ON THE MCP AFTER
LANDING OR SHUT DOWN.
- FTPB 27DEC21

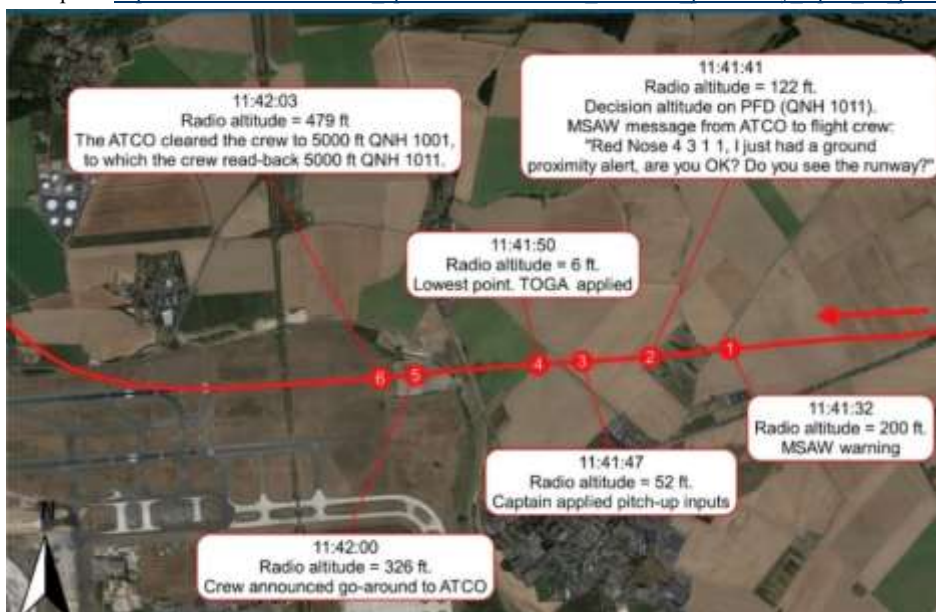
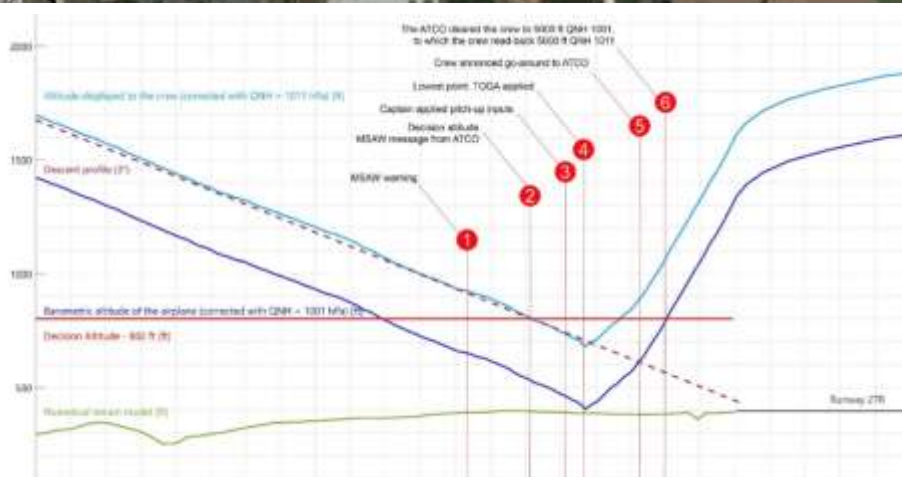
AvHerald reports: Getjet Airlines Malta Airbus A320-200 on behalf of Norwegian, registration 9H-EMU performing flight D8-4311 from Stockholm (Sweden) to Paris Charles de Gaulle (France), was on an RNP approach to CDG's runway 27R, however, with an erroneous Altimeter setting, instead of QNH 1001 hPa the crew had selected 1011hPa). The approach was thus performed below the glide path and eventually triggered a **Minimum Safe Altitude Warning (MSAW)** at the controller's desk. In response the crew initiated a go around at low height, without having acquired visual contact with the ground, and positioned for another approach. The second approach was also performed below the glideslope, the crew however acquired visual contact, corrected their trajectory and landed without further incident about 16 minutes after the go around.

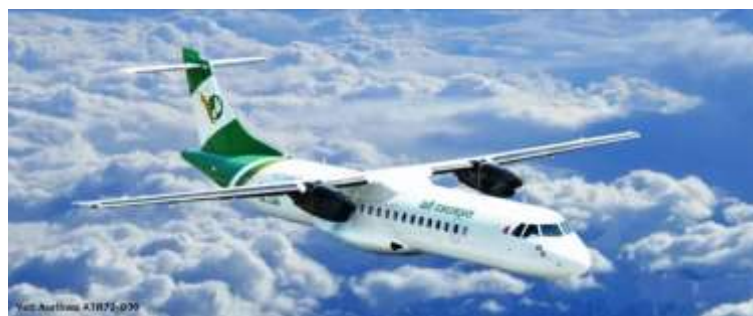
Yeti Airlines AT-72

Yeti AT72 crashed on Jan 15th 2023, **found**, lost height on final approach, both propellers went into feather by **human error**.

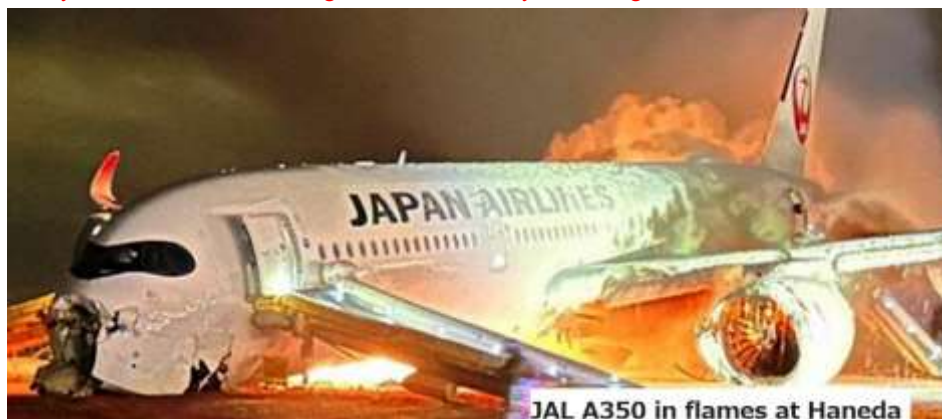
Haneda Airport Runway Layout (Red star indicates collision point)

JAL A350-900, JA13XJ, JL516 from Sapporo to Tokyo Haneda (Japan) with 367 pax and 12 crew, landed on Haneda's rwy 34R at 1747i (0847Z) in night time conditions but collided with a Japan Coast Guard Dash 8-300, JA722A (Coast Guard code MA722) on the rwy shortly after touchdown and burst into flames. The A350 came to a stop off the righthand edge of the rwy about 1680 m/5510 ft down the rwy and was evacuated. All occupants were able to evacuate. The other aircraft carrying 6 people also burst into flames, 5 of the six occupants are confirmed dead. Both aircraft burned down. 15 pax of the A359 received injuries, the captain of the Dash 8 received serious injuries. The aircraft fires were extinguished about 8 hrs after the collision.

A350 was carrying 367 pax (incl 8 children) and 12 crew, all of them evacuated from the aircraft. The JAL516 crew had received and read back landing clearance. After the collision and coming to a stand still three emergency slides were used to evacuate the occupants of the aircraft. The cause may have been a misunderstanding of ATC instructions by the JCG flight crew.
